Town of Newmarket Agenda

Heritage Newmarket Advisory Committee

- 6.1. 425/431 Davis Drive (Union Hotel) - Fenestration Assessment

Condition and Recommendations for 425-a

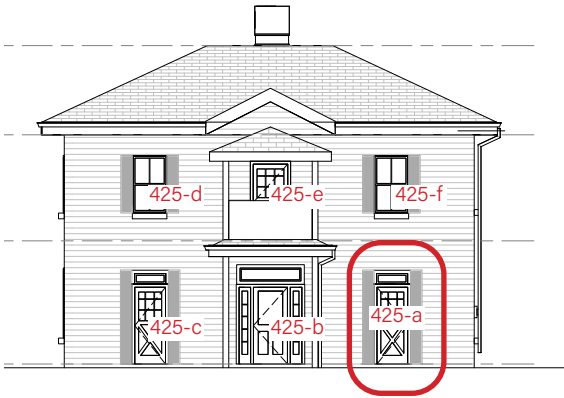
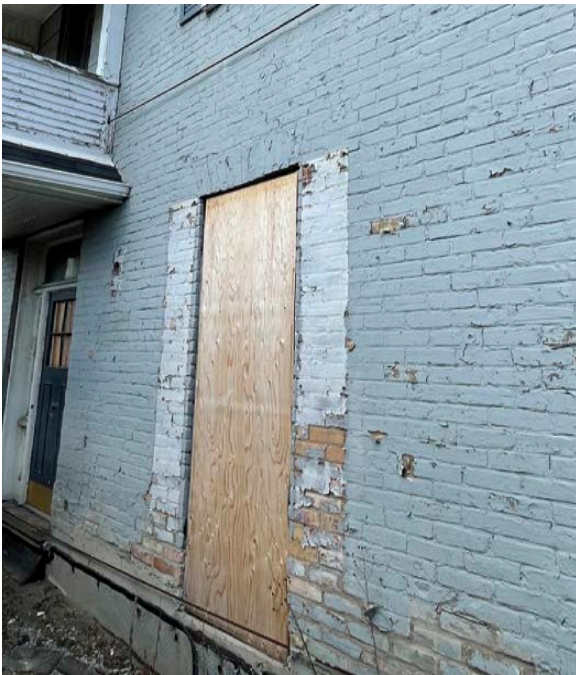
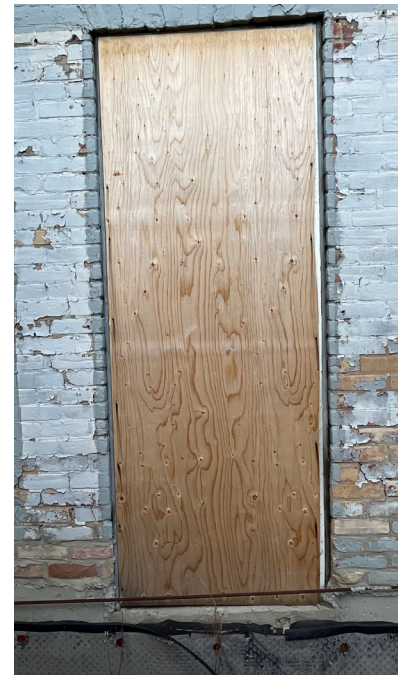
Glass does not exhibit the surface irregularities of historic glass production methods, which indicates that it was produced either by the float glass method (post 1960) or possibly the rolled glass method (post 1920).

Remove and replace with new historically inspired energy efficient wood door and transom which is part of a comprehensively designed fenestration style.

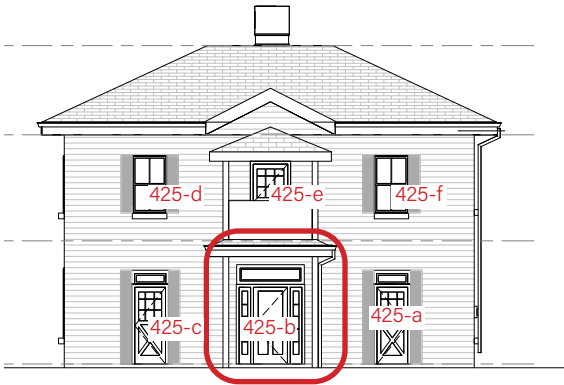
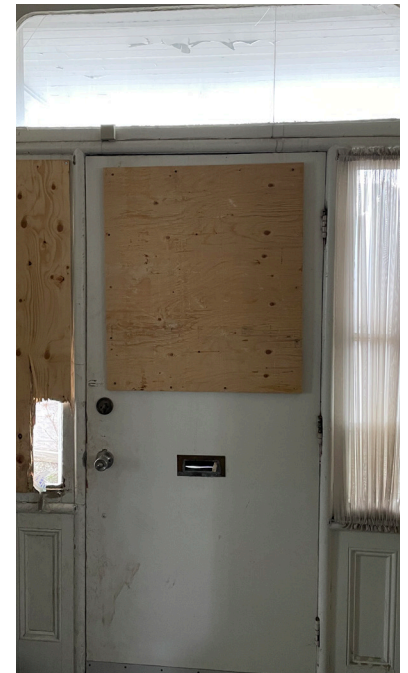
Condition and Recommendations for 425-b

Glass does not exhibit the surface irregularities of historic glass production methods, which indicates that it was produced either by the float glass method (post 1960) or possibly the rolled glass method (post 1920). Some glass lites are broken.

Remove and replace door with new historically inspired energy efficient wood door with lite which matches the other fenestration.

Remove and replace sidelights and transom using solid wood construction which replicates the existing design. Paint wood to coordinate with other fenestration elements.

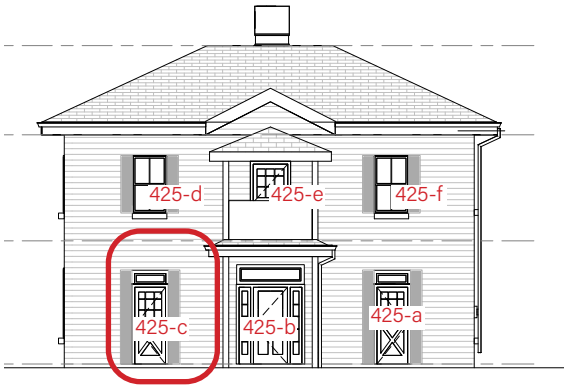
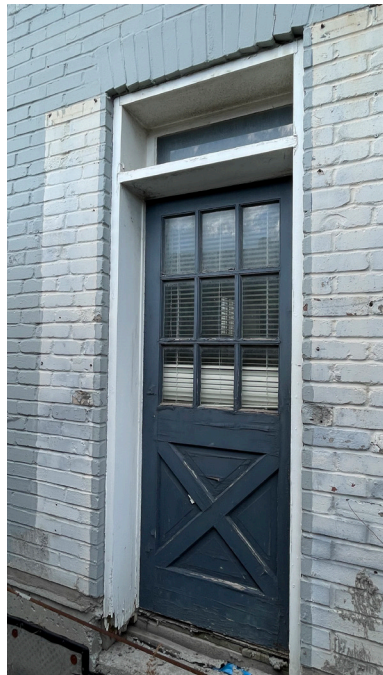
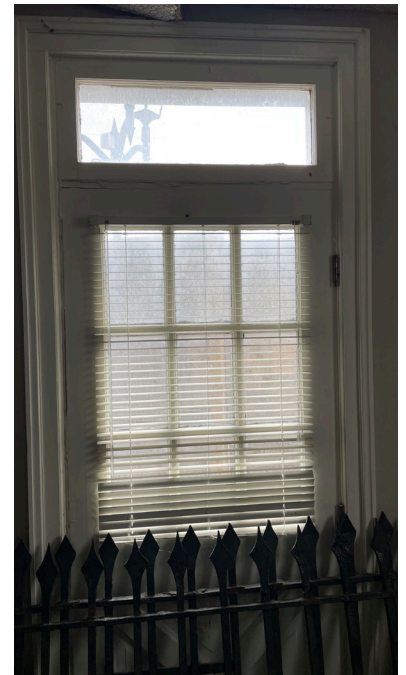
Condition and Recommendations for 425-c

Glass does not exhibit the surface irregularities of historic glass production methods, which indicates that it was produced either by the float glass method (post 1960) or possibly the rolled glass method (post 1920).

Remove and replace with new historically inspired energy efficient wood door and transom which is part of a comprehensively designed fenestration style.

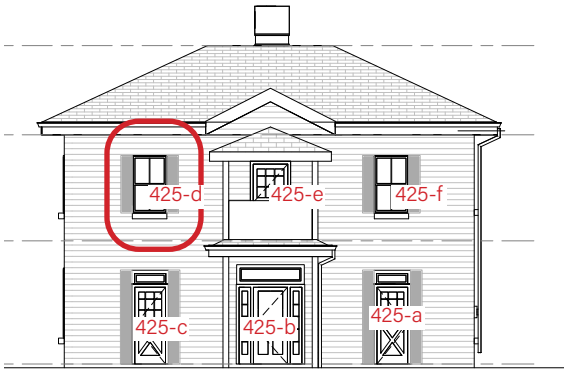
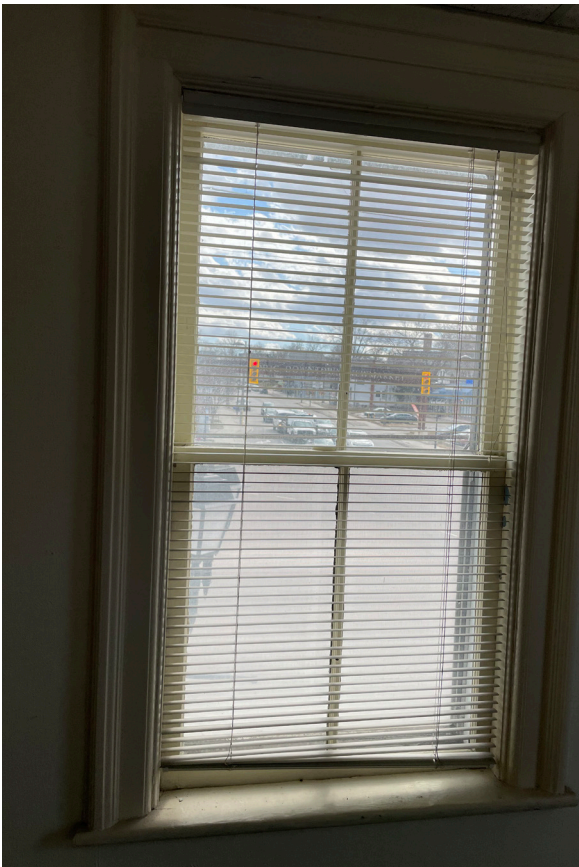
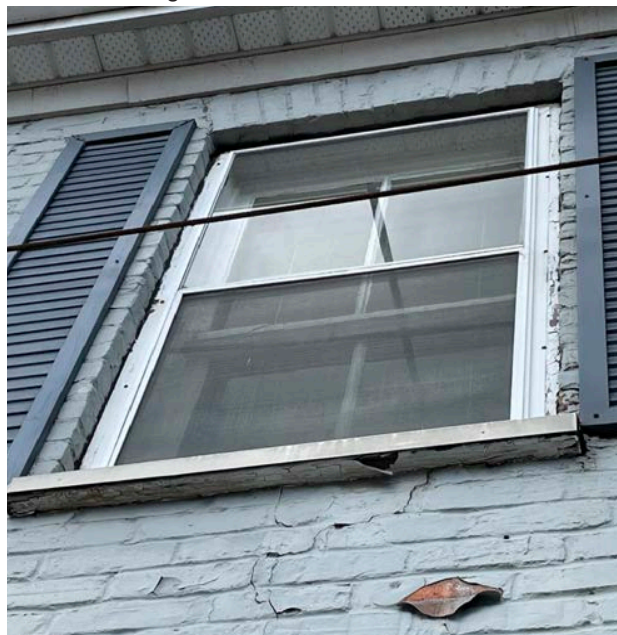
Condition and Recommendations for 425-d

Sill height is 28 1/2" above floor which is a falling safety hazard when the sash is open.

Exterior wood sill paint is extensively deteriorated and wood is exposed to the elements and rotted on the ends. Sill is embedded into brick which will be removed and so cannot be retained.

Remove and replace with new historically inspired energy efficient wood window with insect screen. Wood muntins shall replicate the existing configuration which divides each sash vertically into two.

Limit sash opening travel to <4" to eliminate falling hazard at low sill.

Provide new composite Hardie-Trim sill and apron over new Hardie Board cladding.

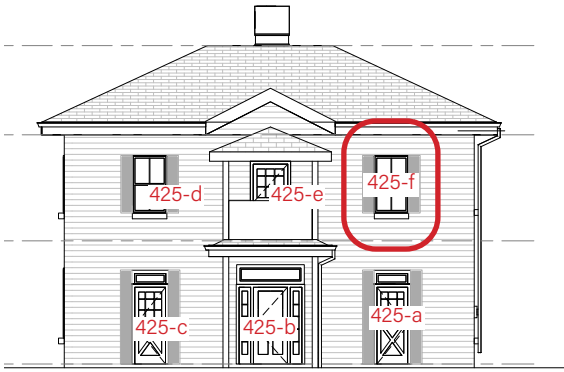
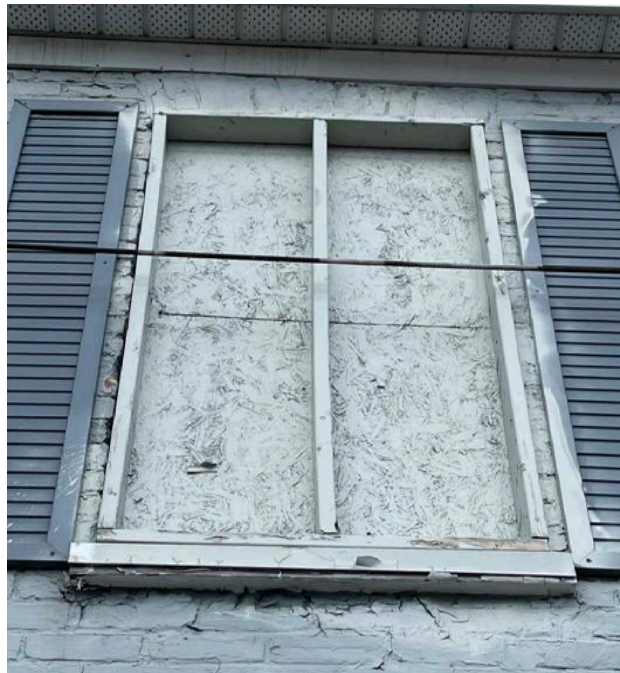
Condition and Recommendations for 425-f

Window is missing.

Install new, historically inspired energy efficient wood window with insect screen. Wood muntins shall replicate the existing configuration of the building's typical windows, which divides each sash vertically into two. Limit sash opening travel to <4" to eliminate falling hazard at low sill. Provide new composite Hardie-Trim sill and apron over new Hardie Board cladding.

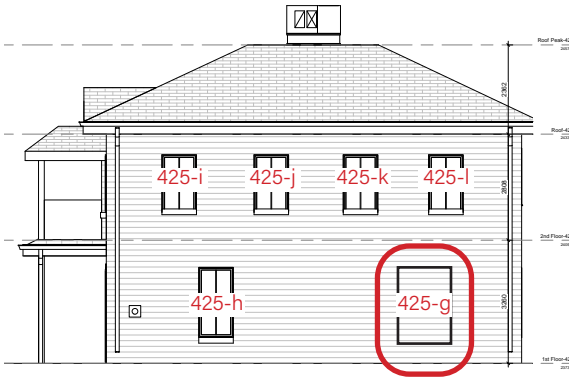
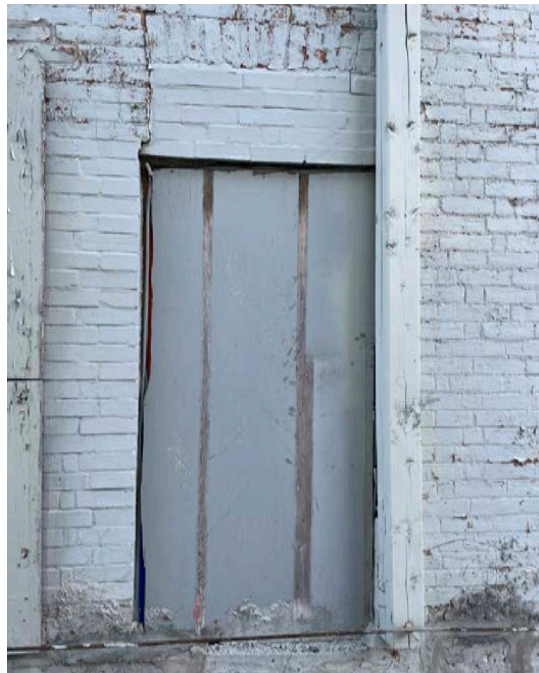
Condition and Recommendations for 425-g

Window is missing.

Limit sash opening travel to <4" to eliminate falling hazard at low sill.

Reconstruct sill

Provide new composite Hardie-Trim sill and apron over new Hardie Board cladding.

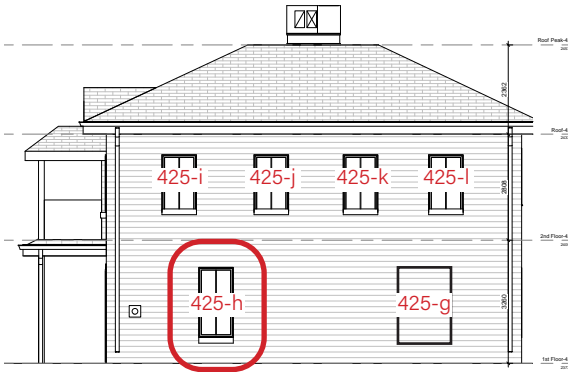
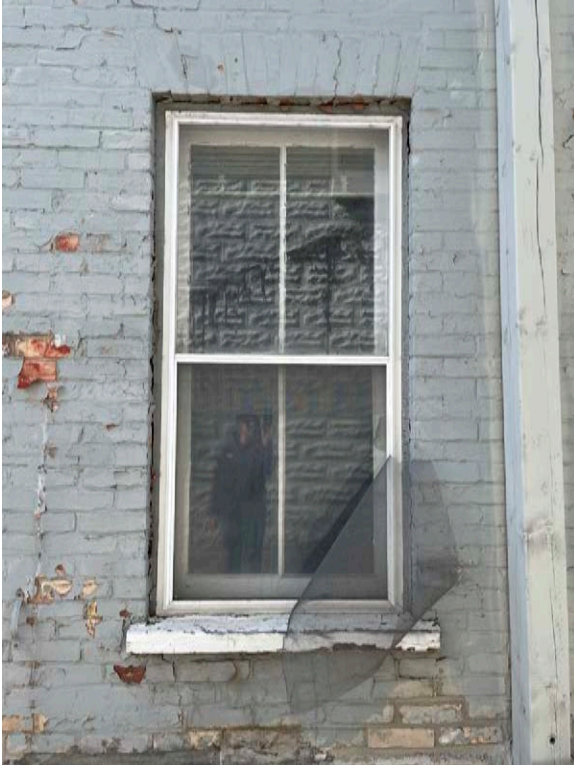
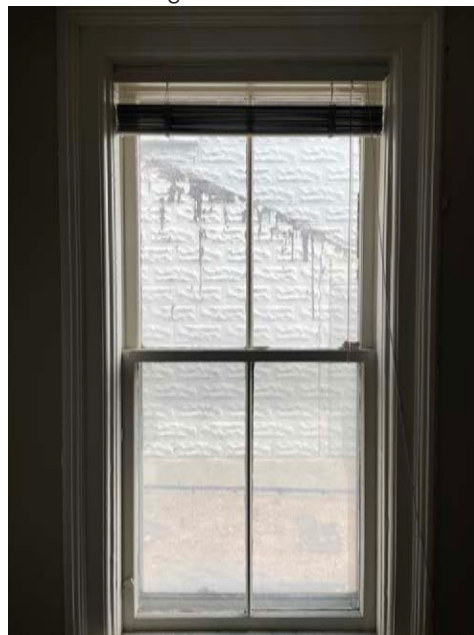
Condition and Recommendations for 425-h

Sill height is 27 1/4" above floor which is a falling safety hazard when the sash is open.

Exterior wood sill paint is extensively deteriorated and wood is exposed to the elements and rotted on the ends. Sill is embedded into brick which will be removed and so cannot be retained.

Remove and replace with new historically inspired energy efficient wood window with insect screen. Wood muntins shall replicate the existing configuration which divides each sash vertically into two.

Limit sash opening travel to <4" to eliminate falling hazard at low sill.

Provide new composite Hardie-Trim sill and apron over new Hardie Board cladding.

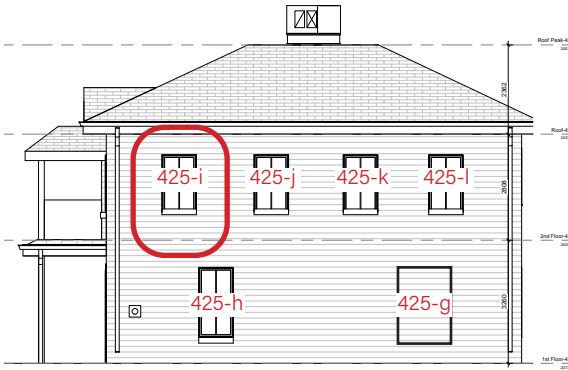
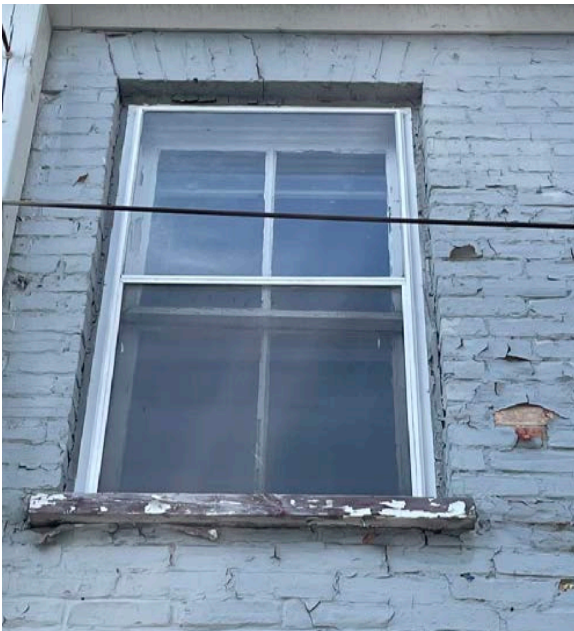
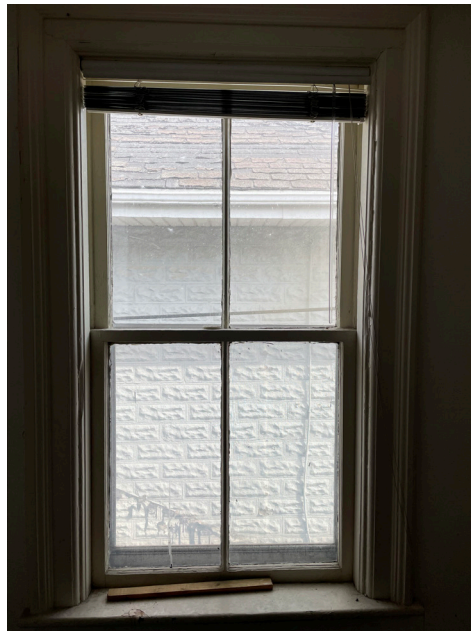
Condition and Recommendations for 425-i

Sill height is 28 1/2" above floor which is a falling safety hazard when the sash is open.

Exterior wood sill paint is extensively deteriorated and wood is exposed to the elements and rotted on the ends. Sill is embedded into brick which will be removed and so cannot be retained.

Remove and replace with new historically inspired energy efficient wood window with insect screen. Wood muntins shall replicate the existing configuration which divides each sash vertically into two.

Limit sash opening travel to <4" to eliminate falling hazard at low sill.

Provide new composite Hardie-Trim sill and apron over new Hardie Board cladding.

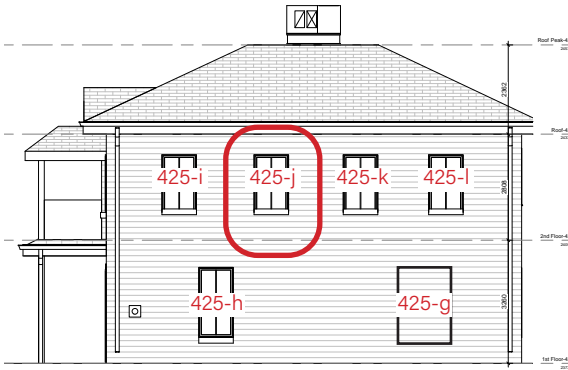
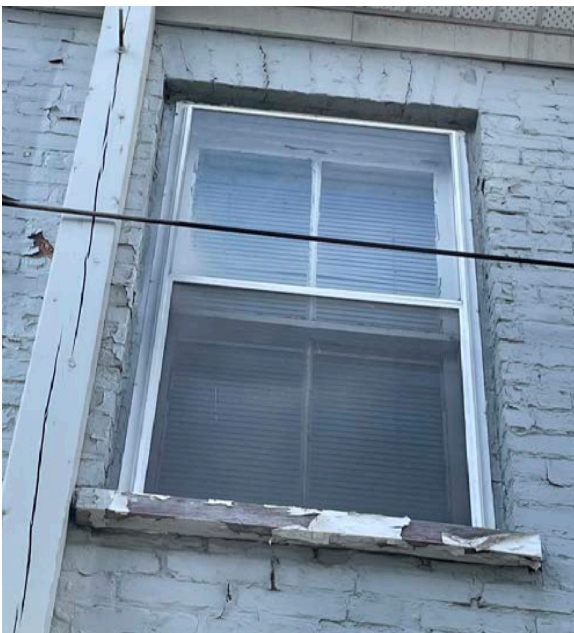
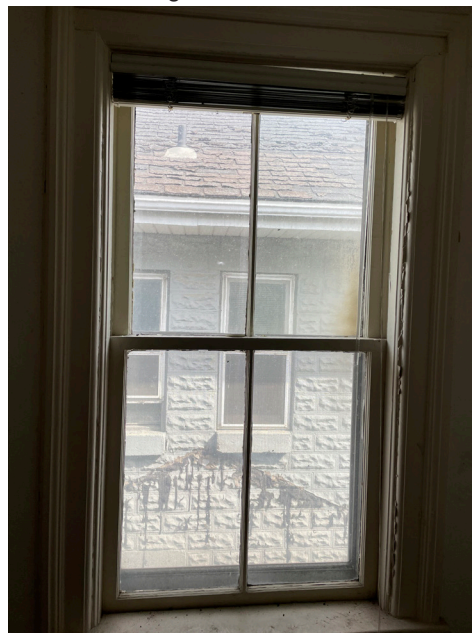
Condition and Recommendations for 425-j

Sill height is 28 1/2" above floor which is a falling safety hazard when the sash is open.

Exterior wood sill paint is extensively deteriorated and wood is exposed to the elements and rotted on the ends. Sill is embedded into brick which will be removed and so cannot be retained.

Remove and replace with new historically inspired energy efficient wood window with insect screen. Wood muntins shall replicate the existing configuration which divides each sash vertically into two.

Limit sash opening travel to <4" to eliminate falling hazard at low sill.

Provide new composite Hardie-Trim sill and apron over new Hardie Board cladding.

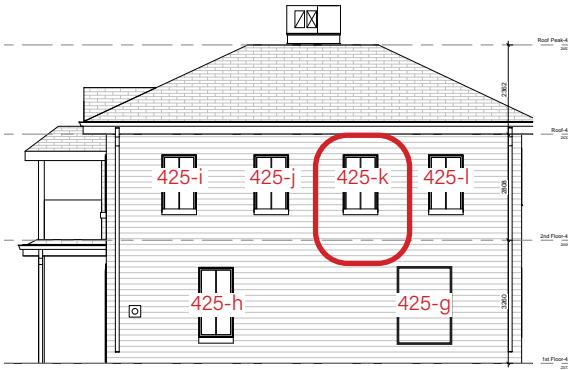
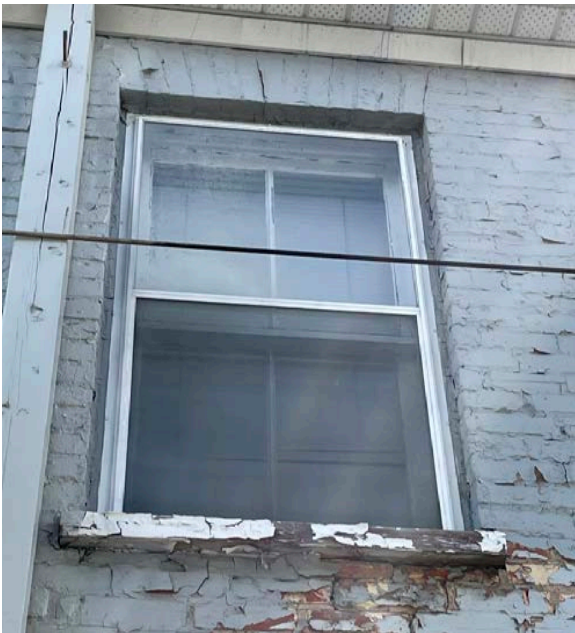
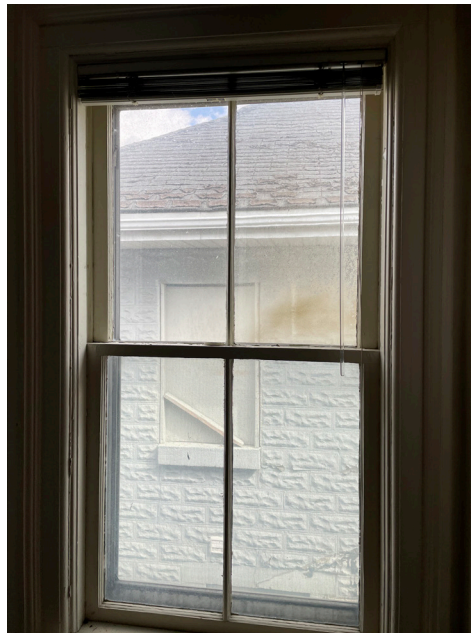
Condition and Recommendations for 425-k

Sill height is 28 1/2" above floor which is a falling safety hazard when the sash is open.

Exterior wood sill paint is extensively deteriorated and wood is exposed to the elements and rotted on the ends. Sill is embedded into brick which will be removed and so cannot be retained.

Remove and replace with new historically inspired energy efficient wood window with insect screen. Wood muntins shall replicate the existing configuration which divides each sash vertically into two.

Limit sash opening travel to <4" to eliminate falling hazard at low sill.

Provide new composite Hardie-Trim sill and apron over new Hardie Board cladding.

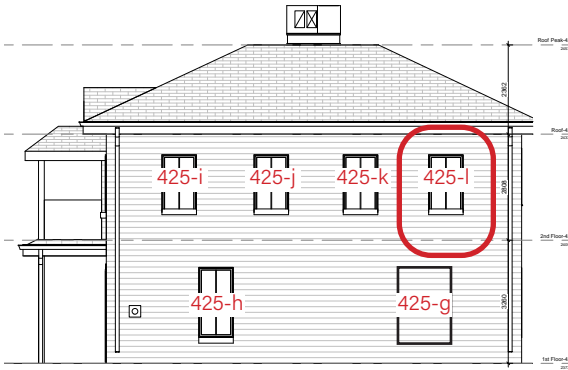
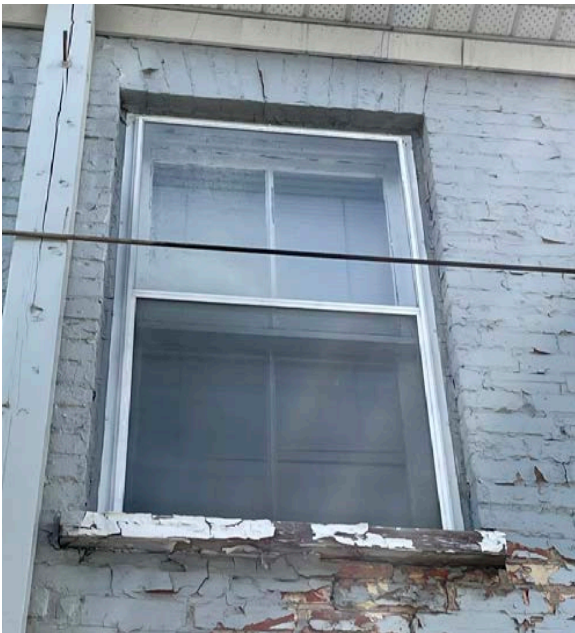
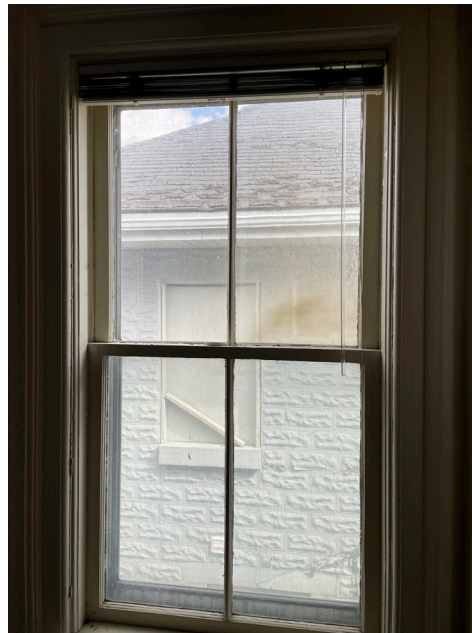
Condition and Recommendations for 425-l

Sill height is 28 1/2" above floor which is a falling safety hazard when the sash is open.

Exterior wood sill paint is extensively deteriorated and wood is exposed to the elements and rotted on the ends. Sill is embedded into brick which will be removed and so cannot be retained.

Remove and replace with new historically inspired energy efficient wood window with insect screen. Wood muntins shall replicate the existing configuration which divides each sash vertically into two.

Limit sash opening travel to <4" to eliminate falling hazard at low sill.

Provide new composite Hardie-Trim sill and apron over new Hardie Board cladding.

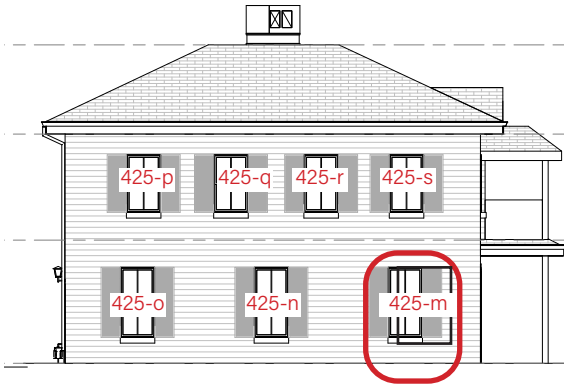
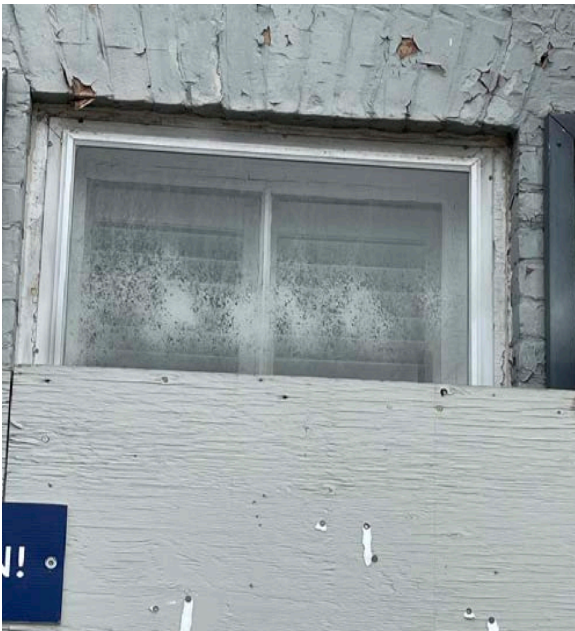
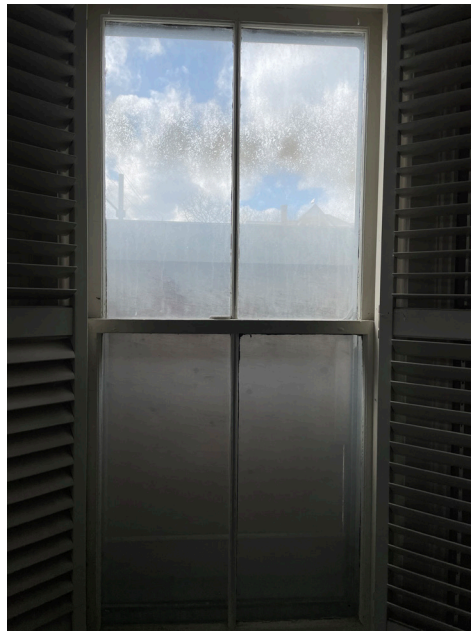
Condition and Recommendations for 425-m

Sill height is 27 1/4" above floor which is a falling safety hazard when the sash is open.

Exterior wood sill paint is extensively deteriorated and wood is exposed to the elements and rotted on the ends. Sill is embedded into brick which will be removed and so cannot be retained.

Remove and replace with new historically inspired energy efficient wood window with insect screen. Wood muntins shall replicate the existing configuration which divides each sash vertically into two.

Limit sash opening travel to <4" to eliminate falling hazard at low sill.

Provide new composite Hardie-Trim sill and apron over new Hardie Board cladding.

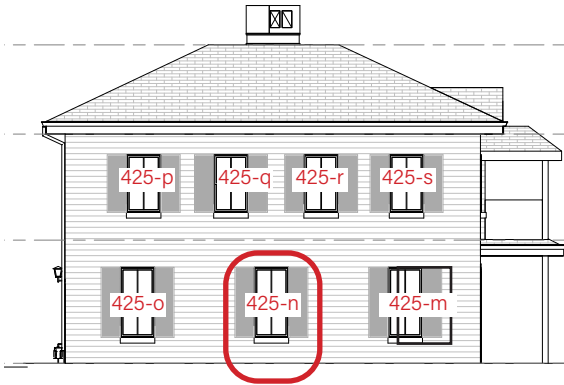
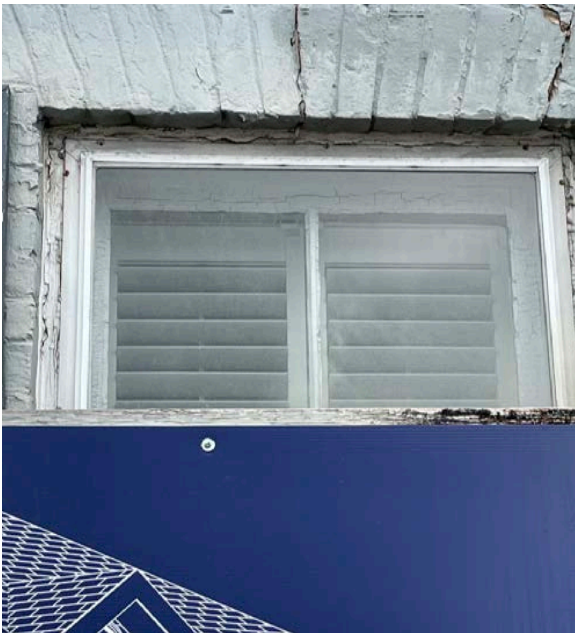
Condition and Recommendations for 425-n

Sill height is 27 1/4" above floor which is a falling safety hazard when the sash is open.

Exterior wood sill paint is extensively deteriorated and wood is exposed to the elements and rotted on the ends. Sill is embedded into brick which will be removed and so cannot be retained.

Remove and replace with new historically inspired energy efficient wood window with insect screen. Wood muntins shall replicate the existing configuration which divides each sash vertically into two.

Limit sash opening travel to <4" to eliminate falling hazard at low sill.

Provide new composite Hardie-Trim sill and apron over new Hardie Board cladding.

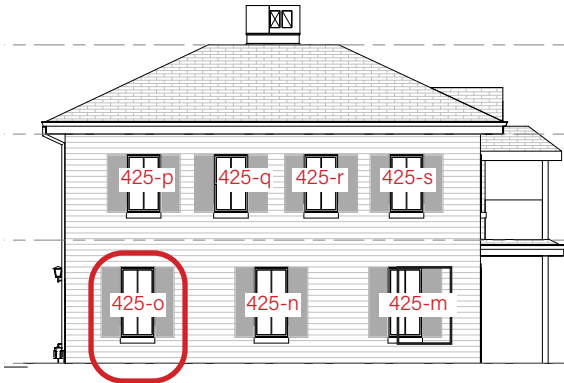
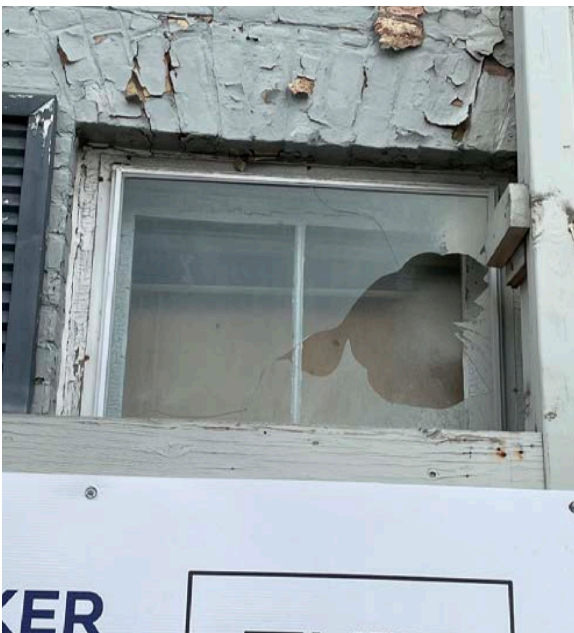
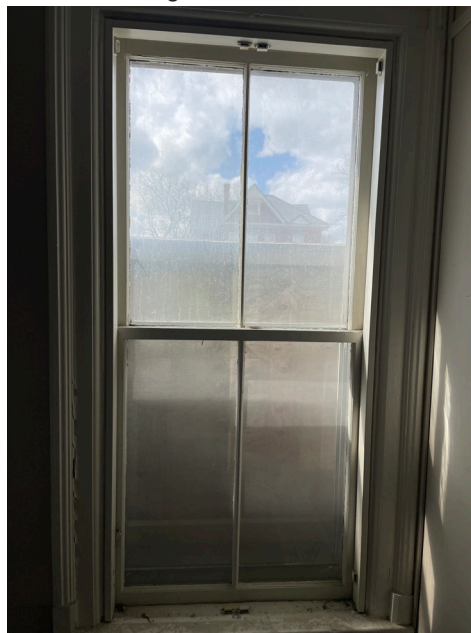
Condition and Recommendations for 425-o

Sill height is 27 1/4" above floor which is a falling safety hazard when the sash is open.

Exterior wood sill paint is extensively deteriorated and wood is exposed to the elements and rotted on the ends. Sill is embedded into brick which will be removed and so cannot be retained.

Remove and replace with new historically inspired energy efficient wood window with insect screen. Wood muntins shall replicate the existing configuration which divides each sash vertically into two.

Limit sash opening travel to <4" to eliminate falling hazard at low sill.

Provide new composite Hardie-Trim sill and apron over new Hardie Board cladding.

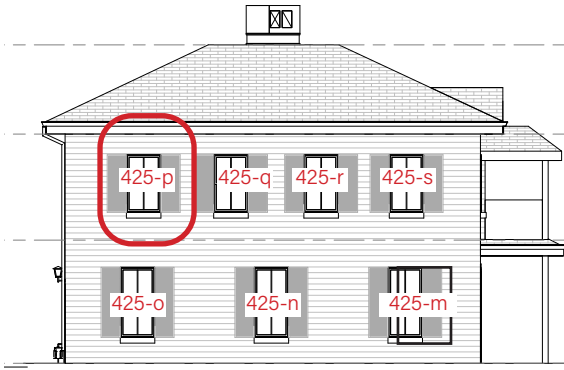
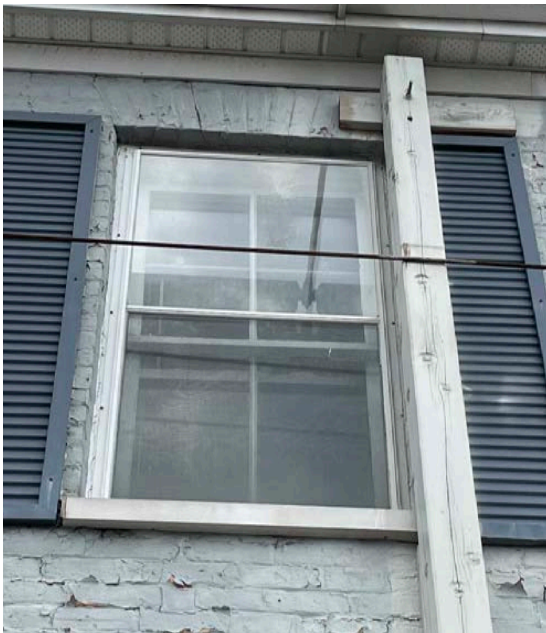
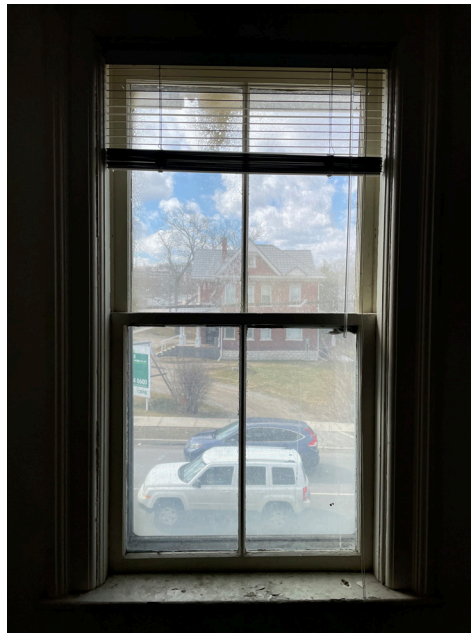
Condition and Recommendations for 425-p

Sill height is 28 1/2" above floor which is a falling safety hazard when the sash is open.

Remove and replace with new historically inspired energy efficient wood window with insect screen. Wood muntins shall replicate the existing configuration which divides each sash vertically into two.

Limit sash opening travel to <4" to eliminate falling hazard at low sill.

Provide new composite Hardie-Trim sill and apron over new Hardie Board cladding.

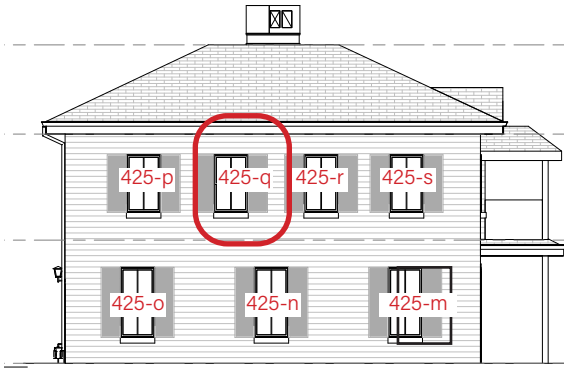
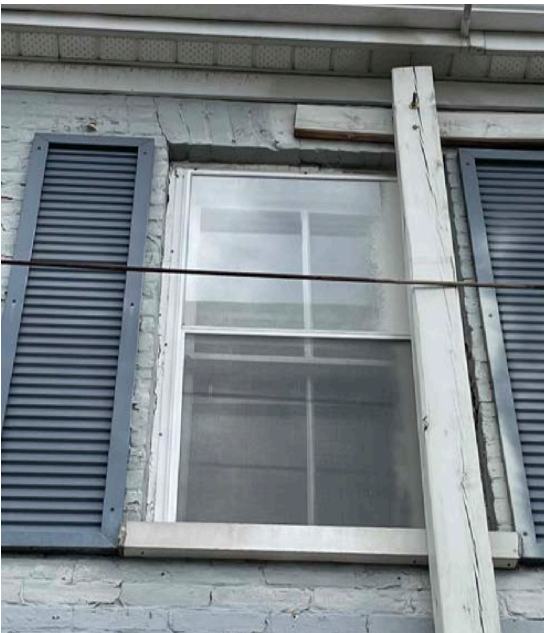
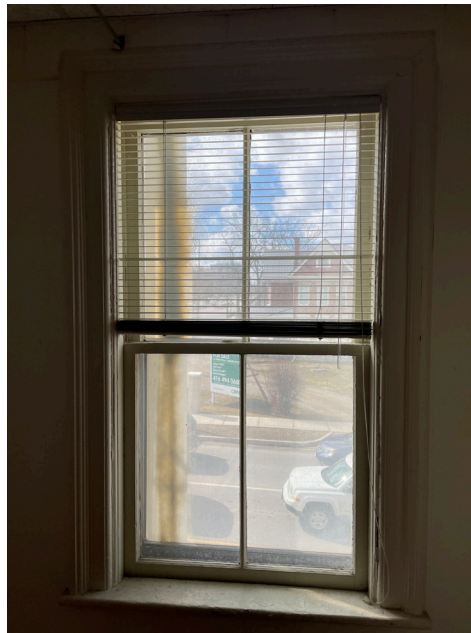
Condition and Recommendations for 425-q

Sill height is 28 1/2" above floor which is a falling safety hazard when the sash is open.

Remove and replace with new historically inspired energy efficient wood window with insect screen. Wood muntins shall replicate the existing configuration which divides each sash vertically into two.

Limit sash opening travel to <4" to eliminate falling hazard at low sill.

Provide new composite Hardie-Trim sill and apron over new Hardie Board cladding.

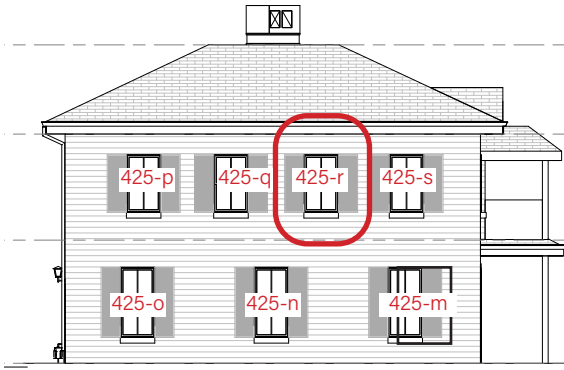
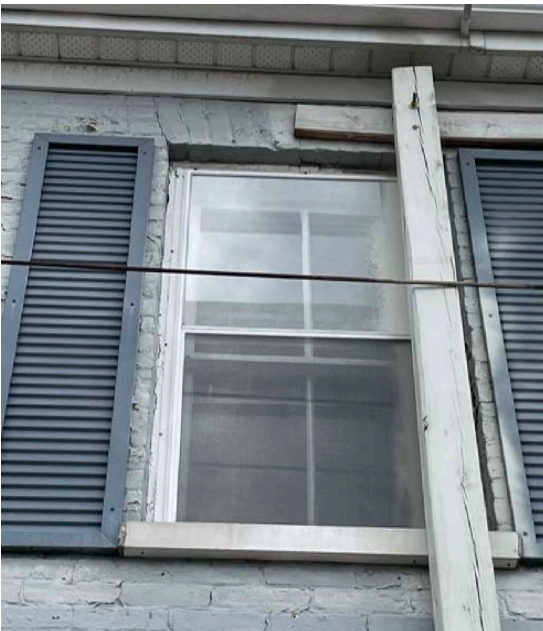
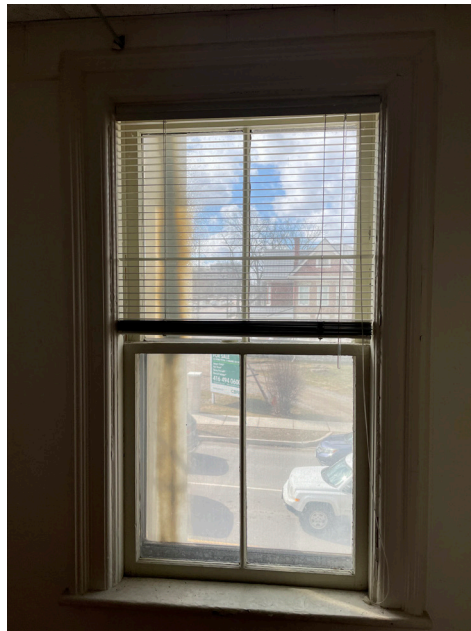
Condition and Recommendations for 425-r

Sill height is 28 1/2" above floor which is a falling safety hazard when the sash is open.

Remove and replace with new historically inspired energy efficient wood window with insect screen. Wood muntins shall replicate the existing configuration which divides each sash vertically into two.

Limit sash opening travel to <4" to eliminate falling hazard at low sill.

Provide new composite Hardie-Trim sill and apron over new Hardie Board cladding.

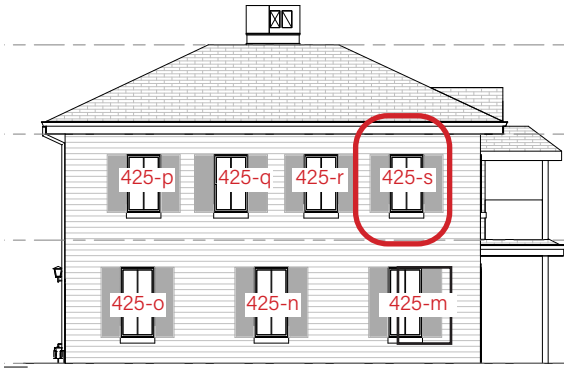
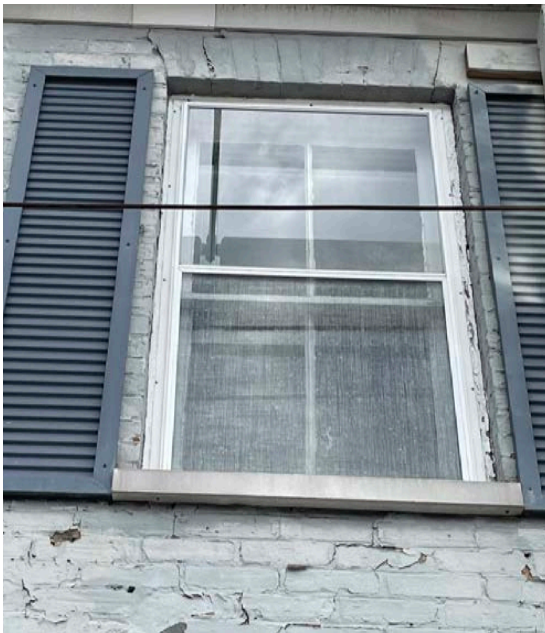
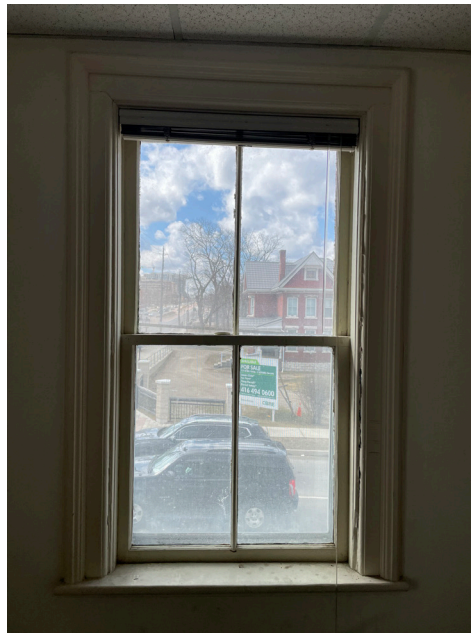
Condition and Recommendations for 425-s

Sill height is 28 1/2" above floor which is a falling safety hazard when the sash is open.

Remove and replace with new historically inspired energy efficient wood window with insect screen. Wood muntins shall replicate the existing configuration which divides each sash vertically into two.

Limit sash opening travel to <4" to eliminate falling hazard at low sill.

Provide new composite Hardie-Trim sill and apron over new Hardie Board cladding.

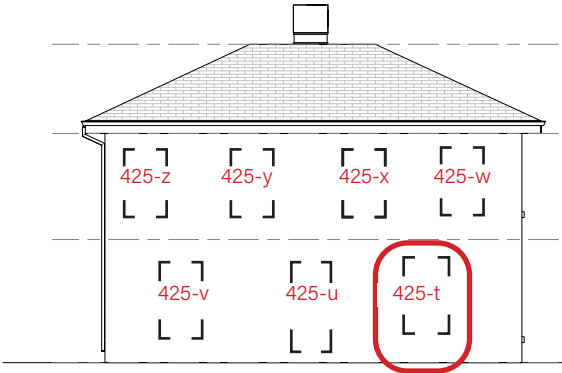
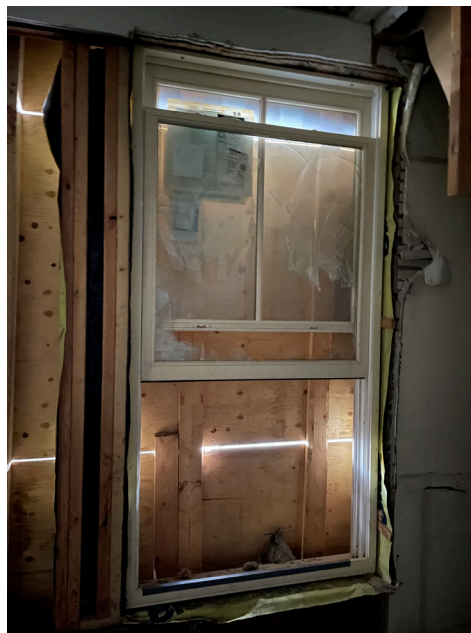
Condition and Recommendations for 425-t

Modern window technology which provides good energy performance. U=1.82 (SI), SHGC = 0.53, Transmittance = 0.60, Air leakage = 0.5 (SI).

Sill height is 27 1/2" above floor which is a falling safety hazard when the bottom sash is open.

Retain this item. Paint to match other fenestration. Provide new composite Hardie-Trim sill and apron over new Hardie Board cladding. Limit sash opening travel to <4" to eliminate falling hazard at low sill.

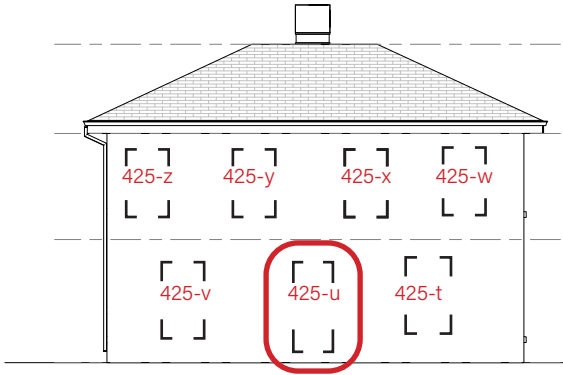
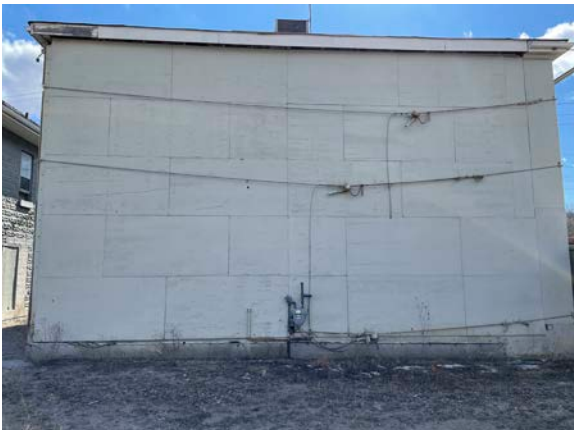
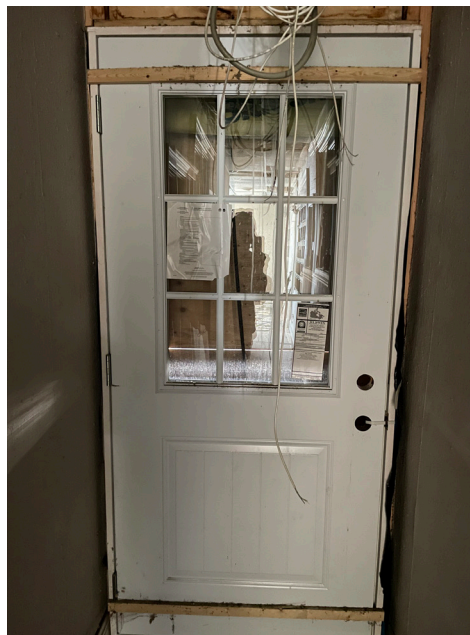
Condition and Recommendations for 425-u

Modern window technology which provides good energy performance. U=1.82 (SI), SHGC = 0.53, Transmittance = 0.60, Air leakage = 0.5 (SI).

Retain this item. Paint to match other fenestration. Provide new composite Hardie-Trim over new Hardie Board cladding.

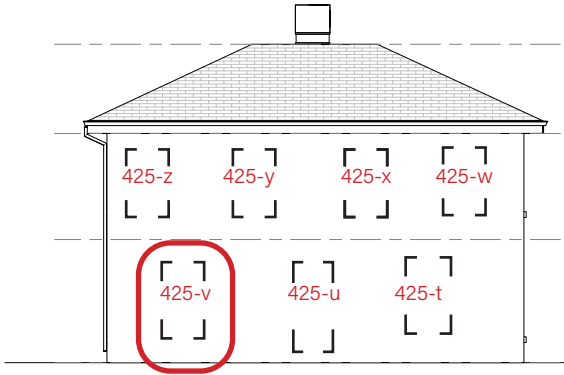
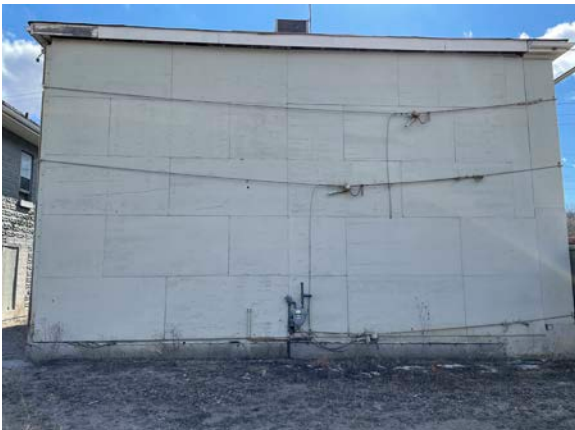
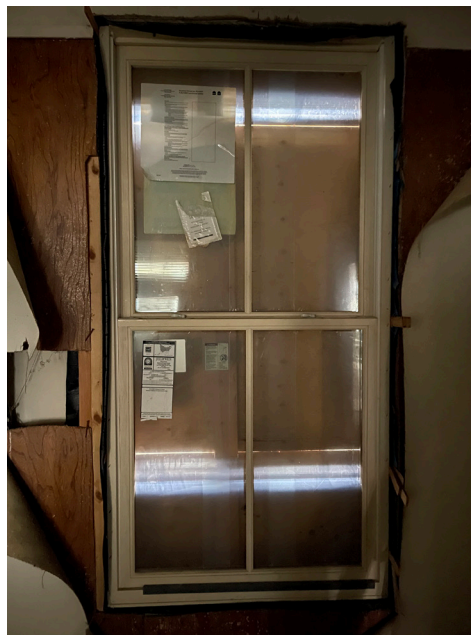
Condition and Recommendations for 425-v

Modern window technology which provides good energy performance. U=1.82 (SI), SHGC = 0.53, Transmittance = 0.60, Air leakage = 0.5 (SI).

Sill height is 27 1/2" above floor which is a falling safety hazard when the bottom sash is open.

Retain this item. Paint to match other fenestration. Provide new composite Hardie-Trim sill and apron over new Hardie Board cladding. Limit sash opening travel to <4" to eliminate falling hazard at low sill.

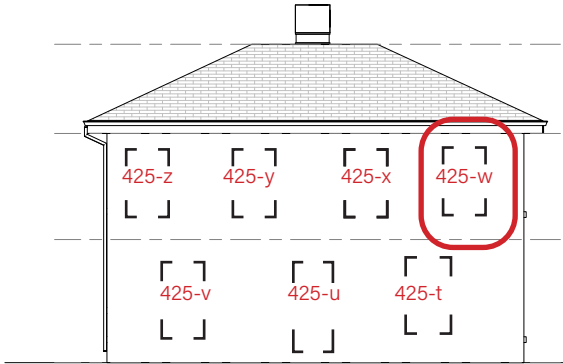
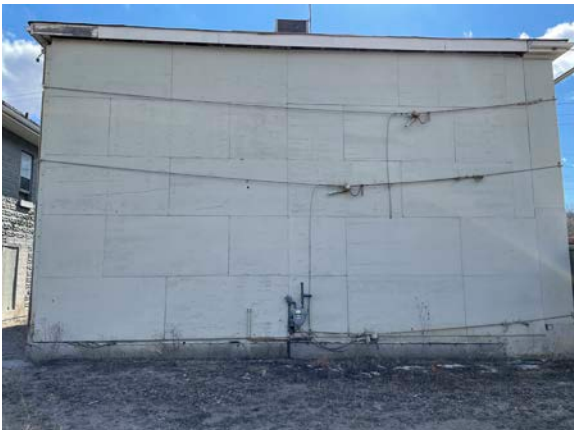
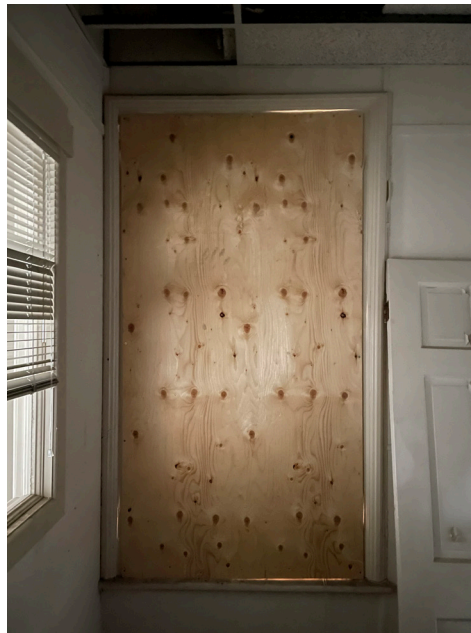
Condition and Recommendations for 425-w

No window.

Provide new Jeld-Wen window to match other windows on this facade. Paint to match other fenestration. Provide new composite Hardie-Trim sill and apron over new Hardie Board cladding.

Limit lower sash opening travel to <4" to eliminate falling hazard at low sill.

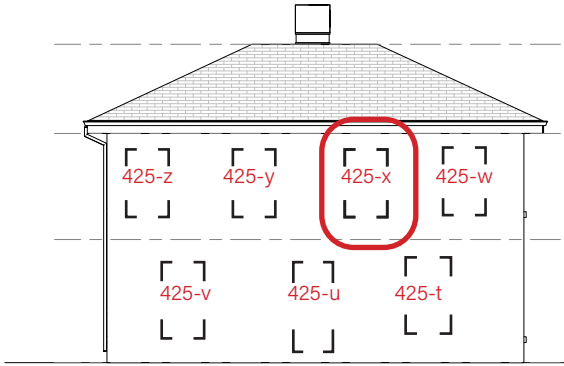
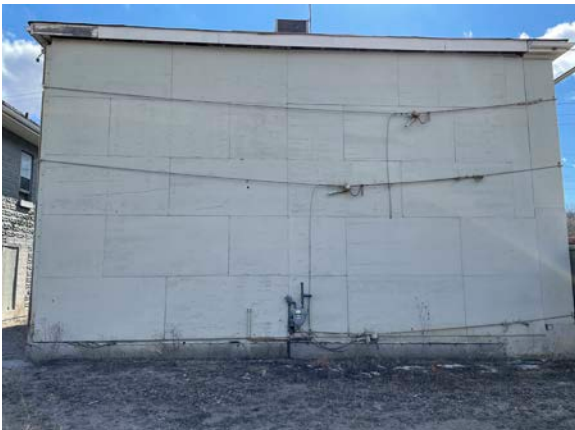
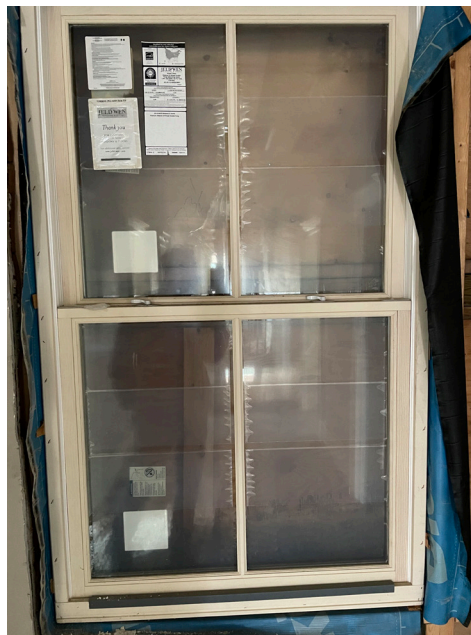
Condition and Recommendations for 425-x

Modern window technology which provides good energy performance. U=1.82 (SI), SHGC = 0.53, Transmittance = 0.60, Air leakage = 0.5 (SI).

Sill height is 28 1/2" above floor which is a falling safety hazard when the bottom sash is open.

Retain this item. Paint to match other fenestration. Provide new composite Hardie-Trim sill and apron over new Hardie Board cladding. Limit sash opening travel to <4" to eliminate falling hazard at low sill.

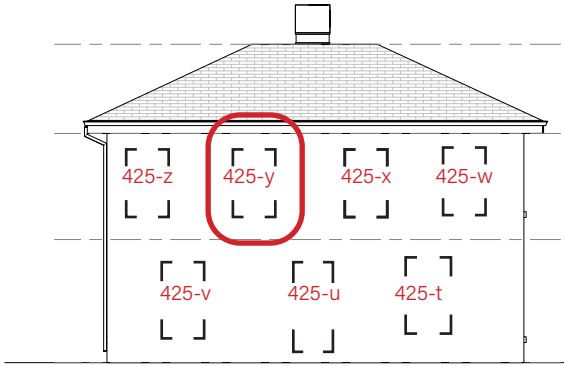
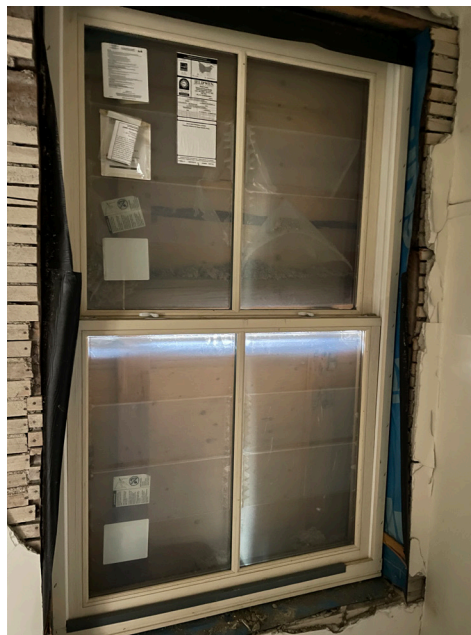
Condition and Recommendations for 425-y

Modern window technology which provides good energy performance. U=1.82 (SI), SHGC = 0.53, Transmittance = 0.60, Air leakage = 0.5 (SI).

Sill height is 28 1/2" above floor which is a falling safety hazard when the bottom sash is open.

Retain this item. Paint to match other fenestration. Provide new composite Hardie-Trim sill and apron over new Hardie Board cladding. Limit sash opening travel to <4" to eliminate falling hazard at low sill.

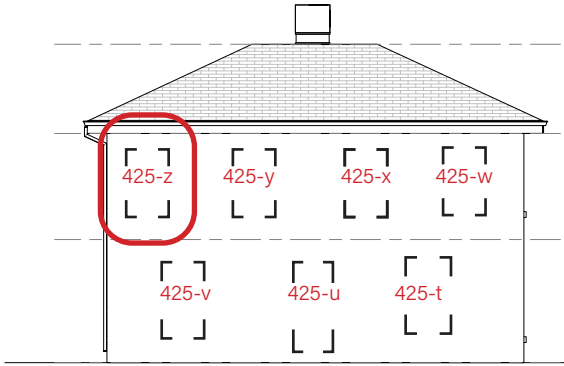
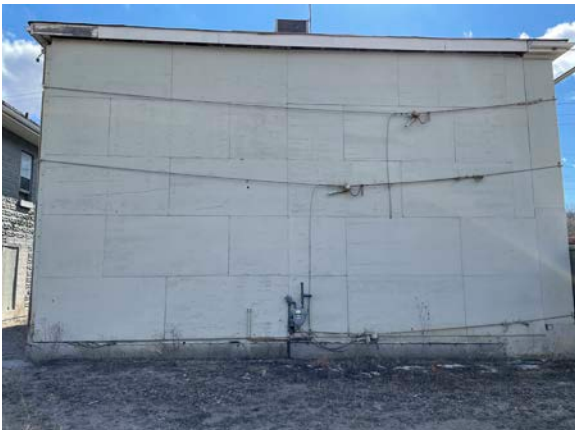
Condition and Recommendations for 425-z

Modern window technology which provides good energy performance. U=1.82 (SI), SHGC = 0.53, Transmittance = 0.60, Air leakage = 0.5 (SI).

Sill height is 28 1/2" above floor which is a falling safety hazard when the bottom sash is open.

Retain this item. Paint to match other fenestration. Provide new composite Hardie-Trim sill and apron over new Hardie Board cladding. Limit sash opening travel to <4" to eliminate falling hazard at low sill.
