**RE: REVIEW OF THE EXISTING RESIDENTIAL STRUCTURE AT 578 LYDIA STREET, NEWMARKET,
ONTARIO
OUR JOB No. 190042**

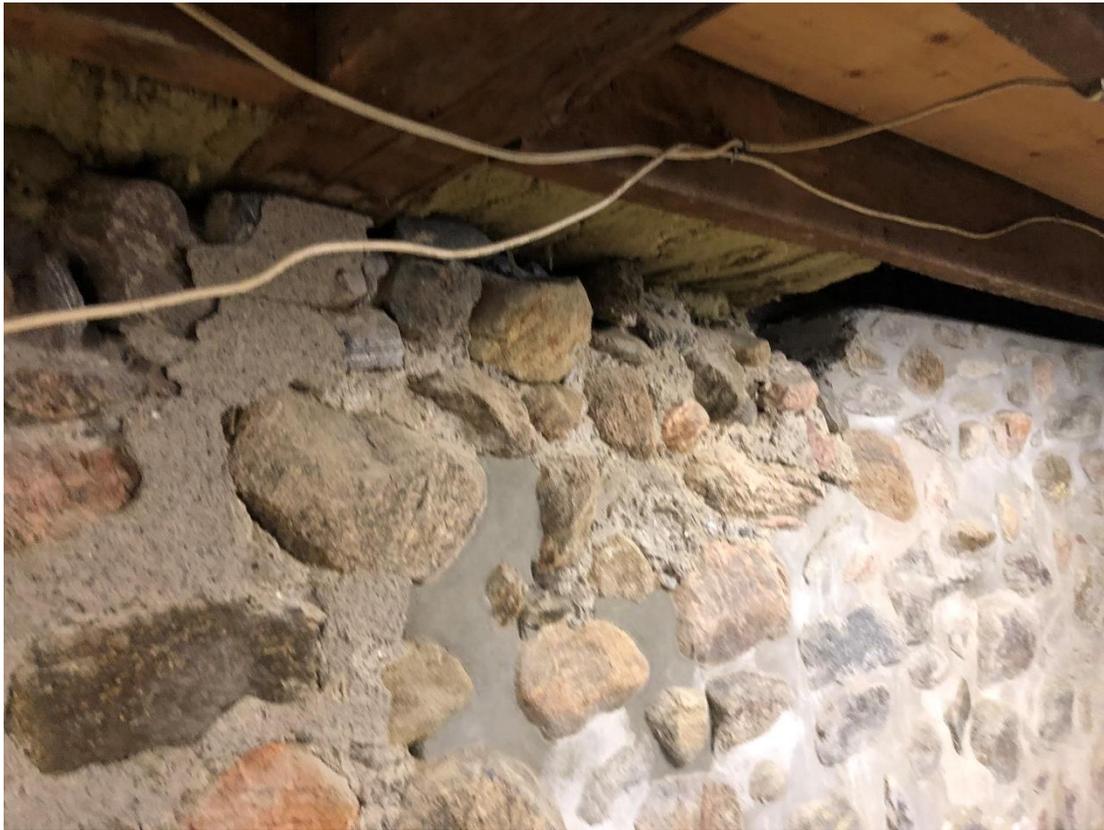
The current structure is a detached single-family dwelling and appears to be century old. The foundation walls consist of 13" thick field-stone rubble foundation wall with no evidence of strip footings. Portion of the basement appears to have been lowered and stabilized by bench footing. It appears that the mortar in foundation wall has been repointed in some areas. The condition of the foundation wall in these areas appear to be in a satisfactory condition. However, loose stone and loss of mortar bed is evident in other areas of the basement. It was also noted that floor system was not anchored to top of foundation wall.

Photo 1 - Existing field-stone rubble foundation wall with loss of mortar and loose stone at top of foundation wall.

1. The rubble foundation wall may require additional stability measures for vibrations introduces during construction;
2. New footings/underpinning may be required to transfer new loads into underlying soils;

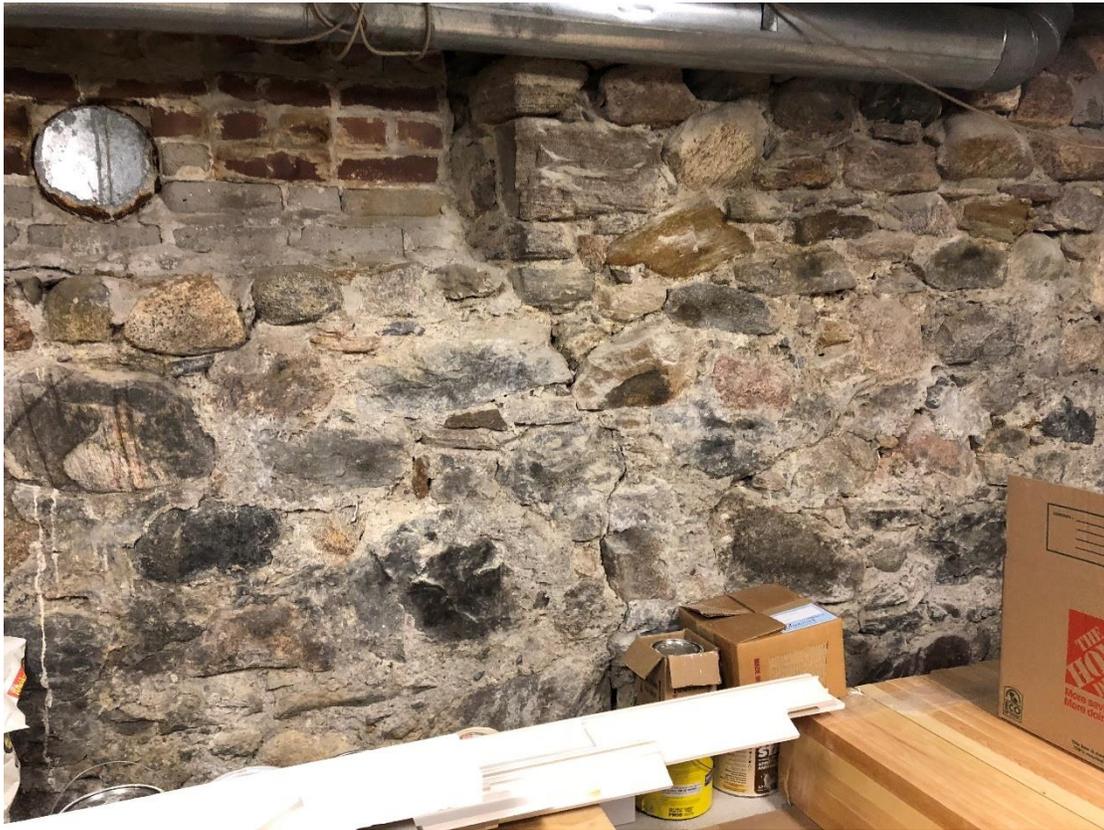
At few locations along the foundation wall, efflorescence stains and vertical cracking extending from previous window opening were evident. It is not known at this time if waterproofing is applied on the exterior of the foundation wall. However, efflorescence stains suggest that water has been penetrating through the basement foundation walls. It is also not clear at this time if a slip joint is present between field-stone foundation wall and soil interface.

Photo 2 - Existing field-stone rubble foundation wall with evidence of efflorescence stains and vertical crack extending from previous window opening.

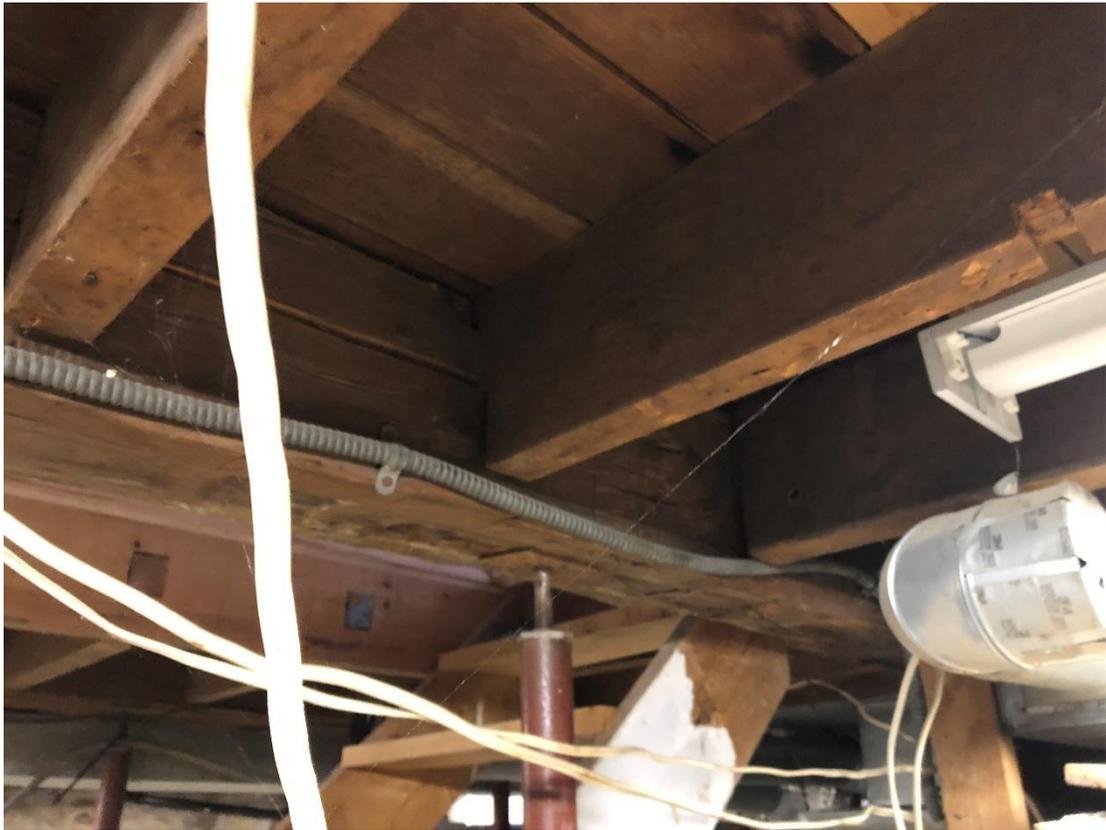
The floor construction is a platform-type construction with timber joists of varying sizes attached to supporting beams with mortise and tenon type connections. This type of connection tends to introduce holes of varying sizes in the main beams supporting tributary joists. It was also evident that few of the main beams for ground floor framing were supported by steel posts supported from the existing slab-on-grade. It is typical construction to have spread footings below steel posts for to transfer these concentrated loads. There is no evidence of spread footings.

Photo 3 - Existing framing for ground floor and mortise and tenon joint into main structural beam.

3. New wall piers and spread footings may be required to account for any point loads that may be introduced as part of renovations;
4. Existing mortise and tenon joints may require new hangers to connect tributary joists to main beams;
5. Holes present in main beams will require further analysis and possible reinforcement to comply with current codes and standards;
6. Excavation along the exterior foundation wall for waterproofing maybe required;
7. New excavation may lead to further instability of the rubble foundation walls;
8. A slip joint at the interface of field-stone foundation wall and soil may be required to negate frost heaving effects; and
9. New spread footings may be required under existing steel posts if existing slab-on-grade is not adequate to accept new loads due to the proposed renovations/alterations.

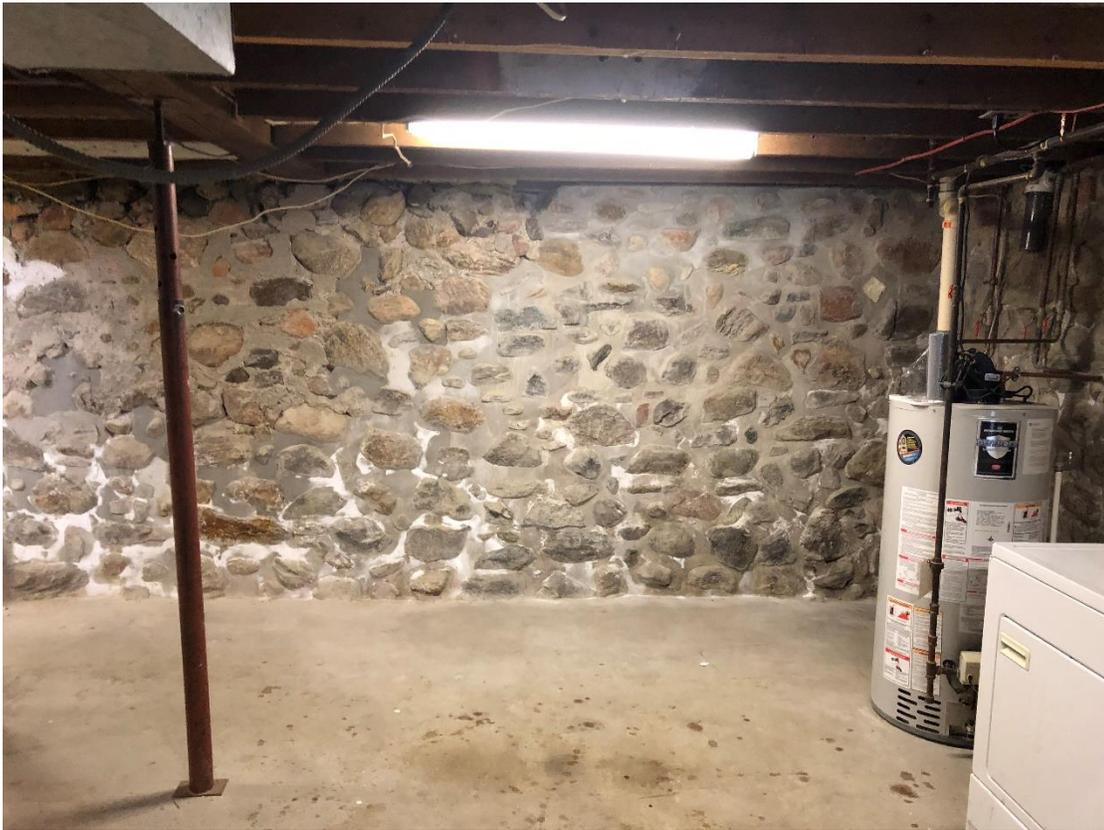
Photo 4 - Existing steel post supported from slab-on-grade with no evidence of spread footing.
