## CULVERT CONDITION ASSESSMENT REPORT

| Road Name: | Millard Avenue | | |
| Location: | Approximately 140 m East of Queen Street, at Haskett Park | | |

| Date of Inspection: | January 19, 2017 |

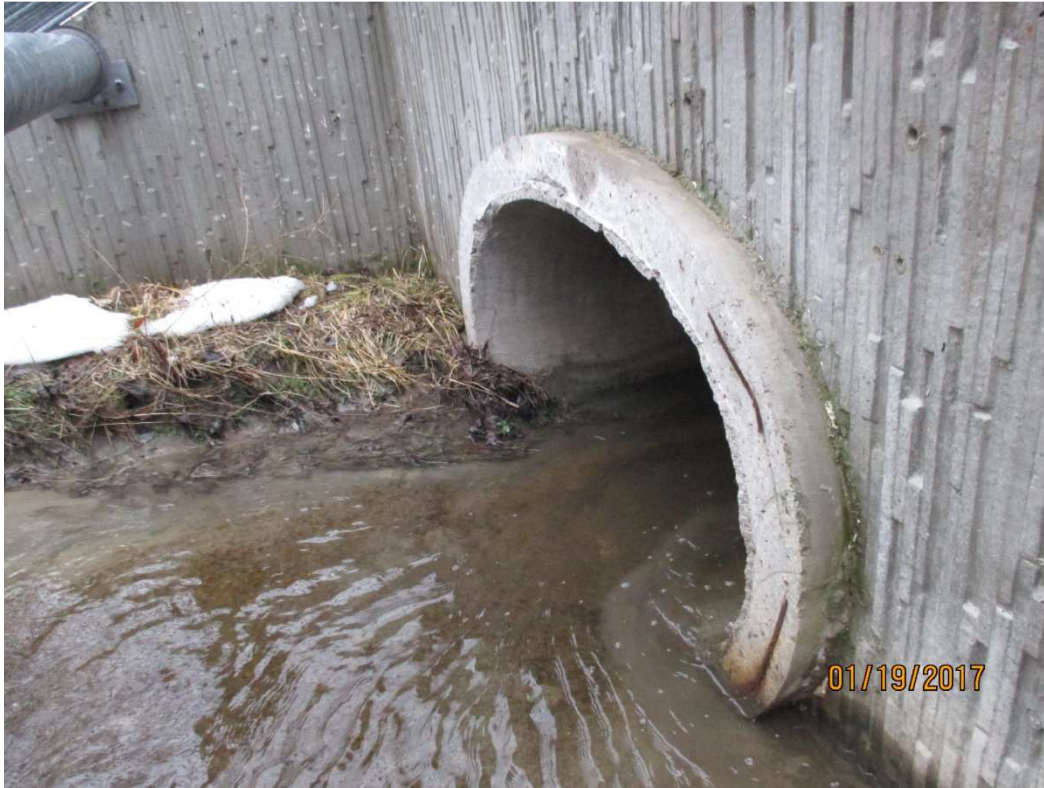
Photo 1 – Inlet of West Culvert Pipe - Concrete Ellipse

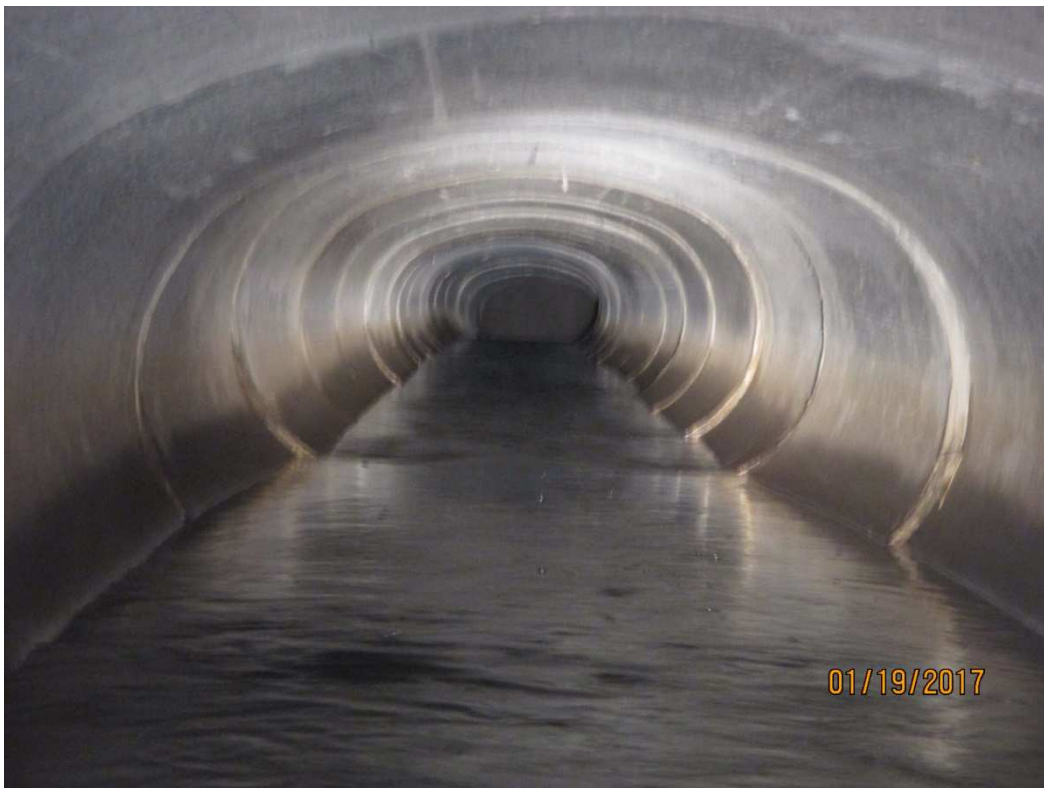
Photo 2 – West Pipe (Concrete Ellipse) Looking Downstream

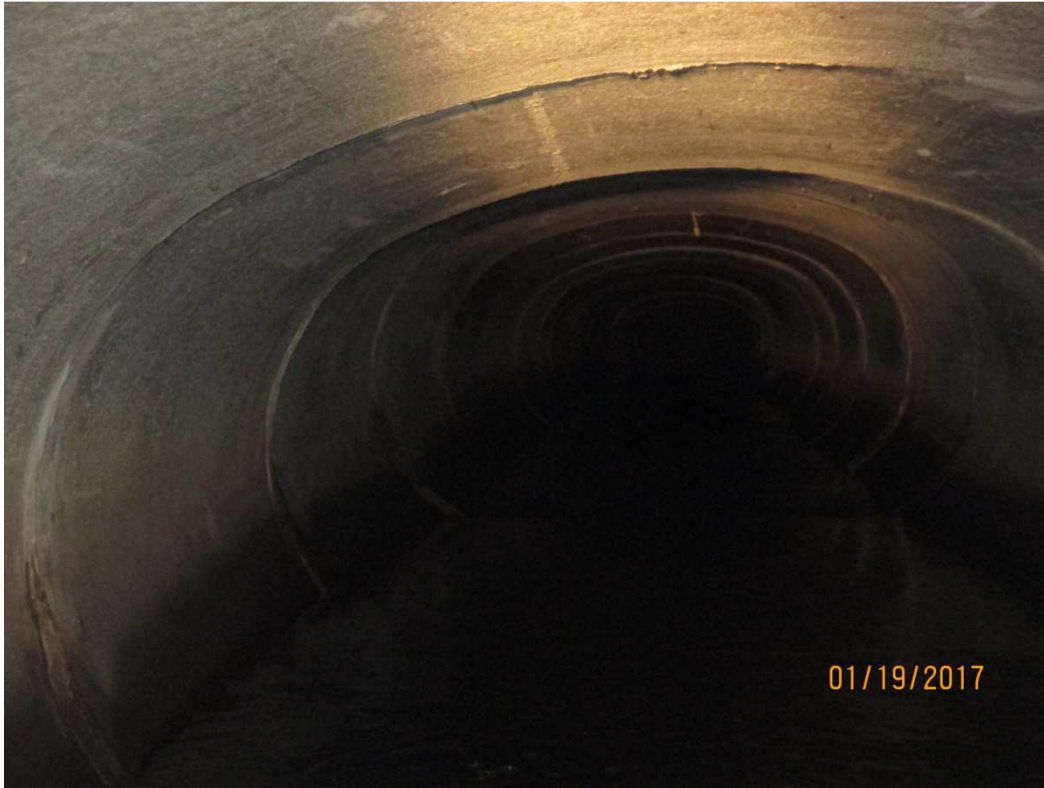
| Comments: | <ul style="list-style-type: none"> <li>• 1535 X 975 Horizontal Concrete Ellipse (based on construction drawings)</li> <li>• Condition based on visible portions (limited inspection of ends only)</li> <li>• Infiltration and displaced segments of pipe noted</li> <li>• Pipe has vertical bends near pipe outlet</li> <li>• Pipe does not pass through drop maintenance hole structure</li> </ul> | | | | | |

Photo 3 – West Pipe (Concrete Ellipse) Displaced Pipe Segment

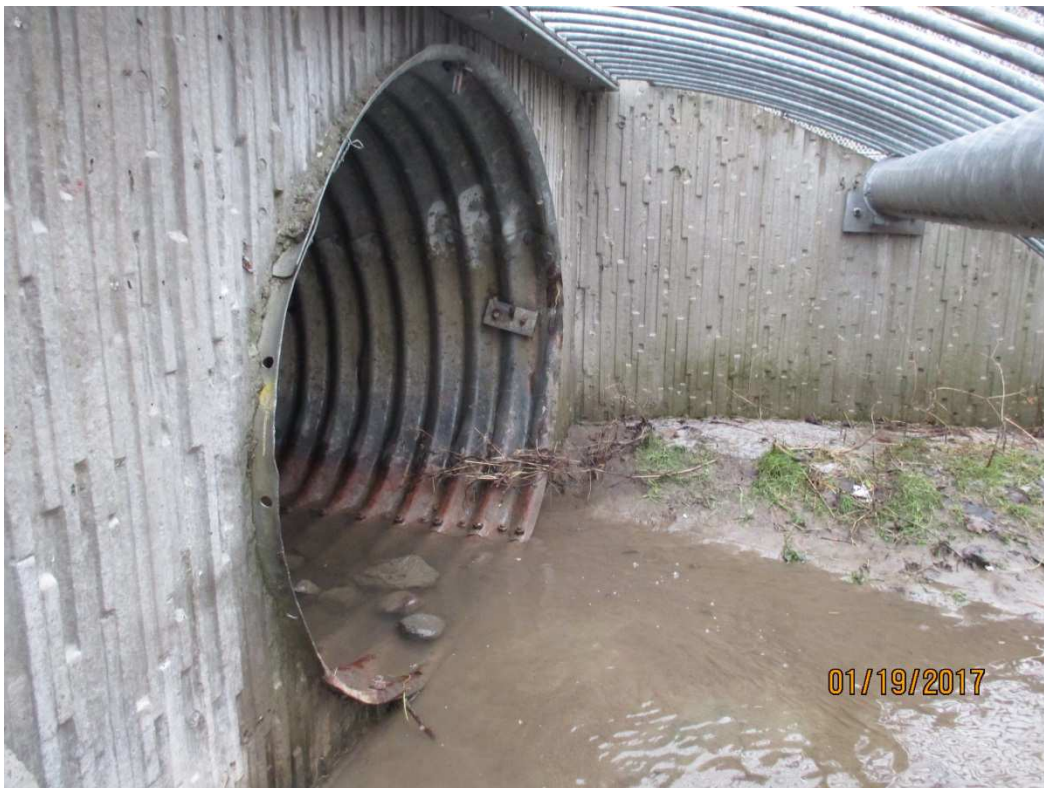
Photo 4 – Inlet of East Culvert Pipe – Multi Plate Corrugated Steel Pipe Arch

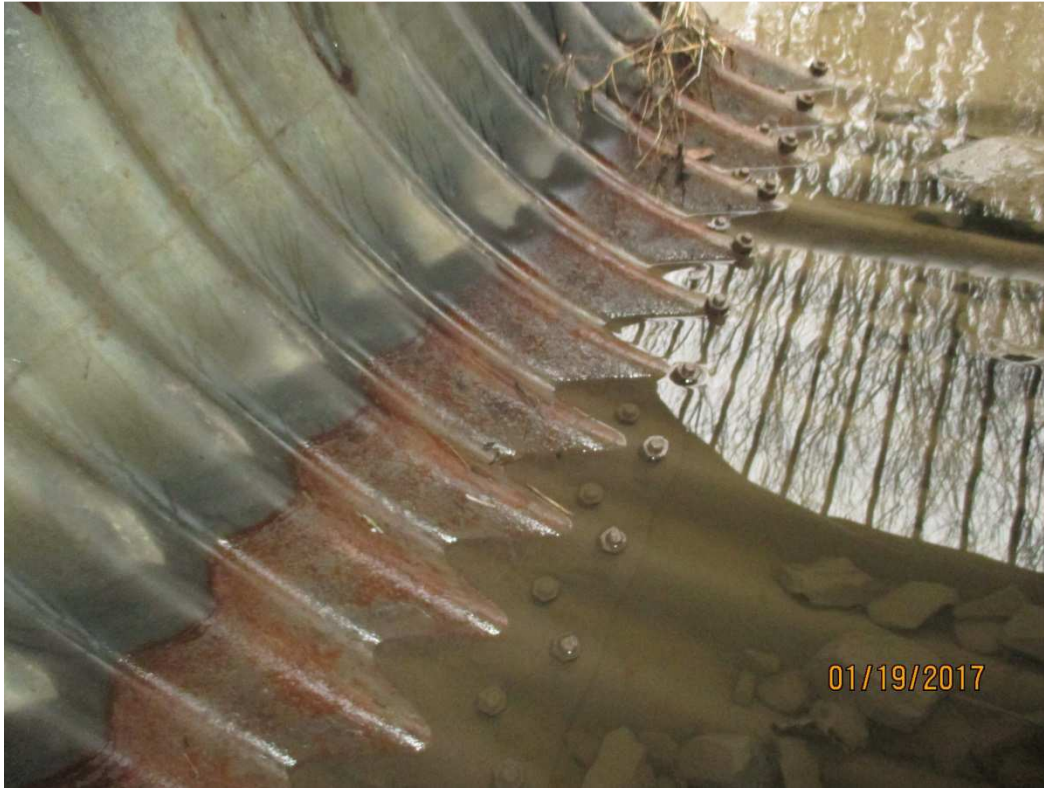
Photo 5 –Corrosion of Culvert Invert near Inlet

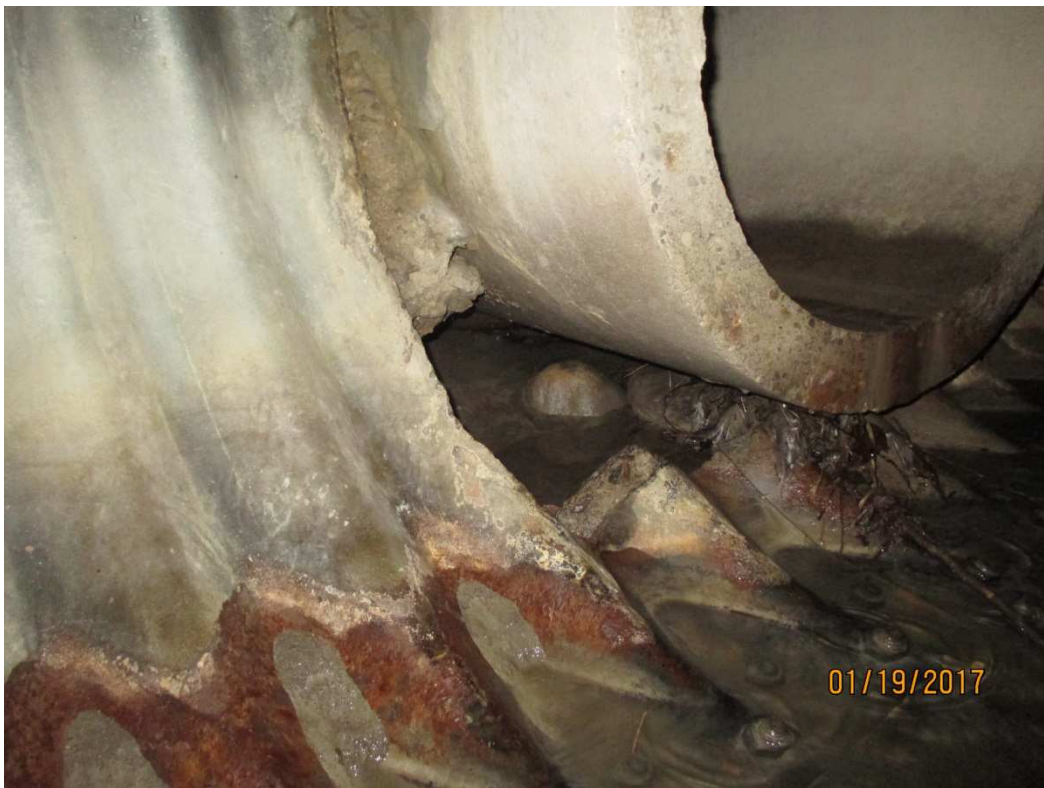
Photo 6 – Oversized Cut and Missing Parging at Storm Pipe Penetration

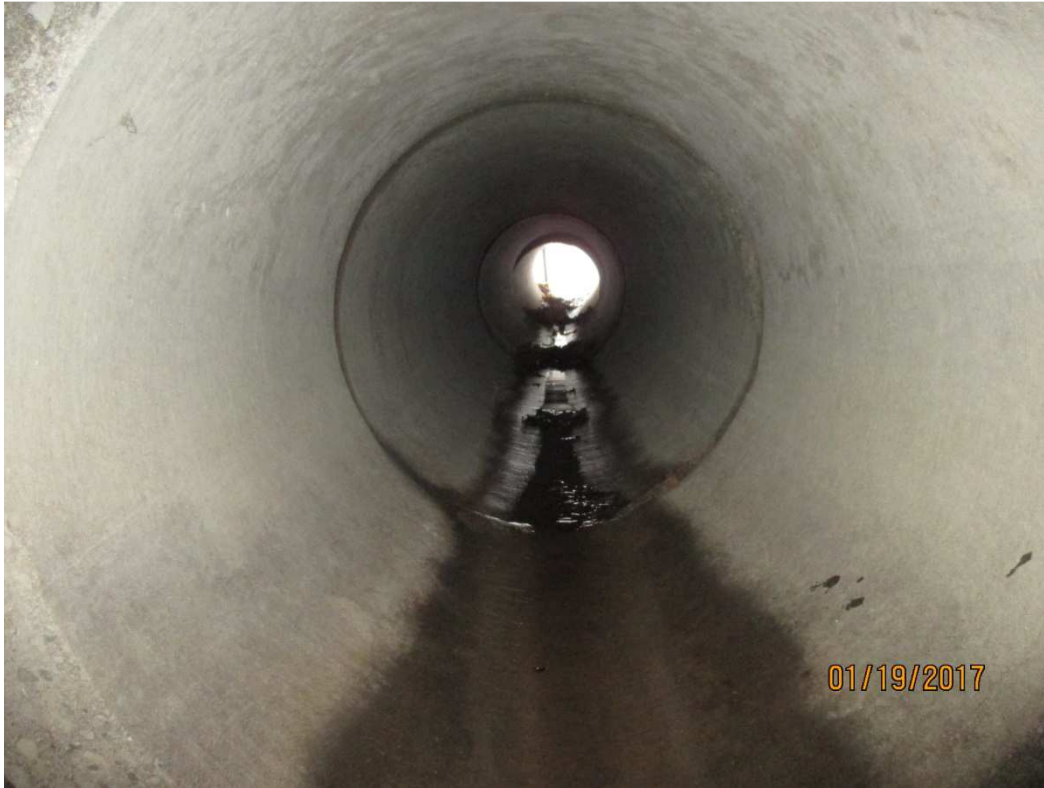
Photo 7 – Looking Up Storm Pipe Penetration – Note Displaced Pipe Segments

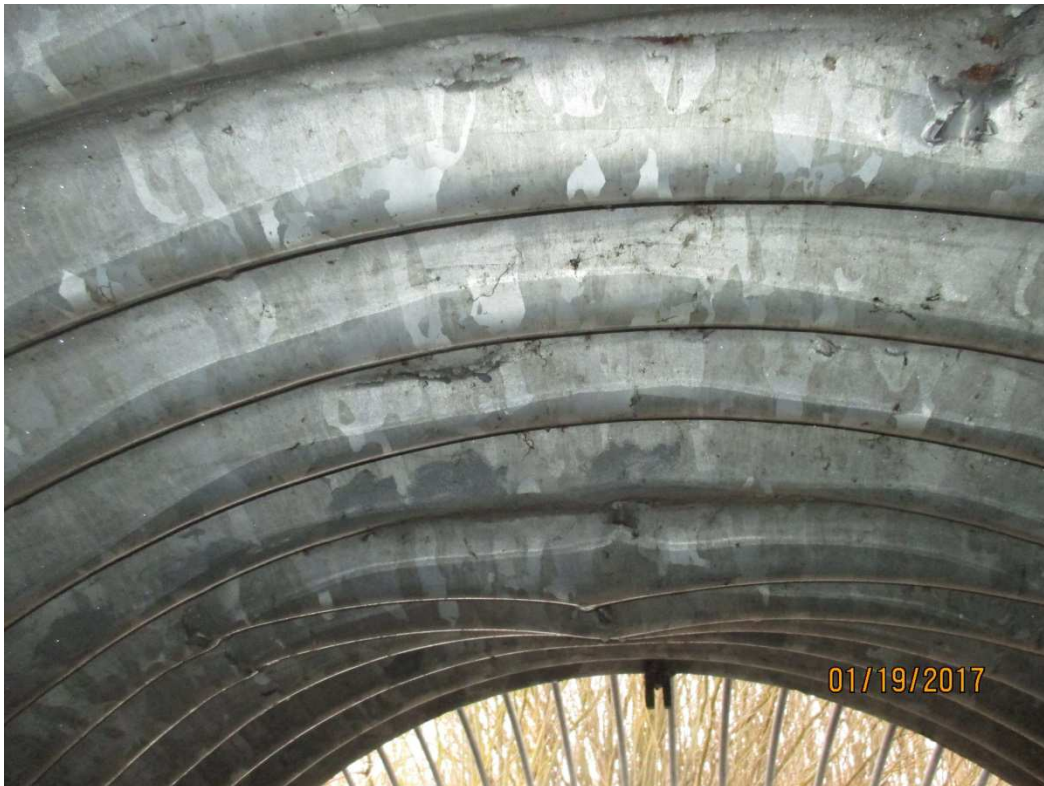
Photo 8 – Deformation of Culvert Soffit near Inlet

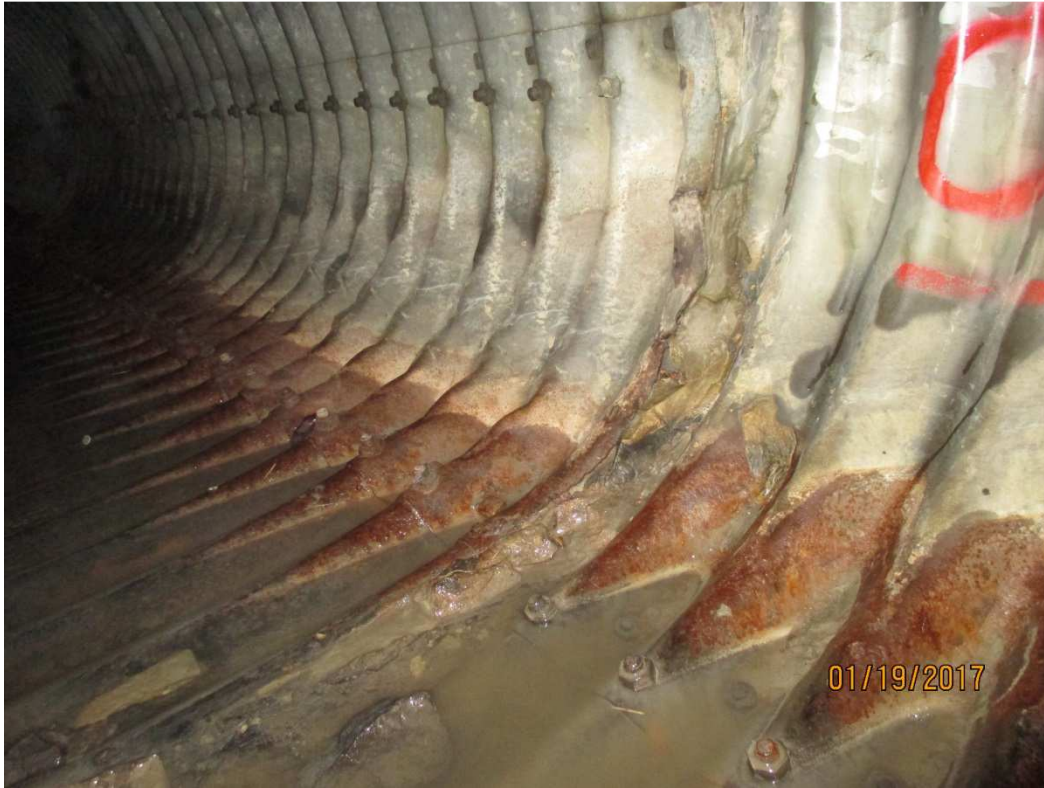
Photo 9 – Connection between Section 1 and Section 2 of East Culvert Pipe

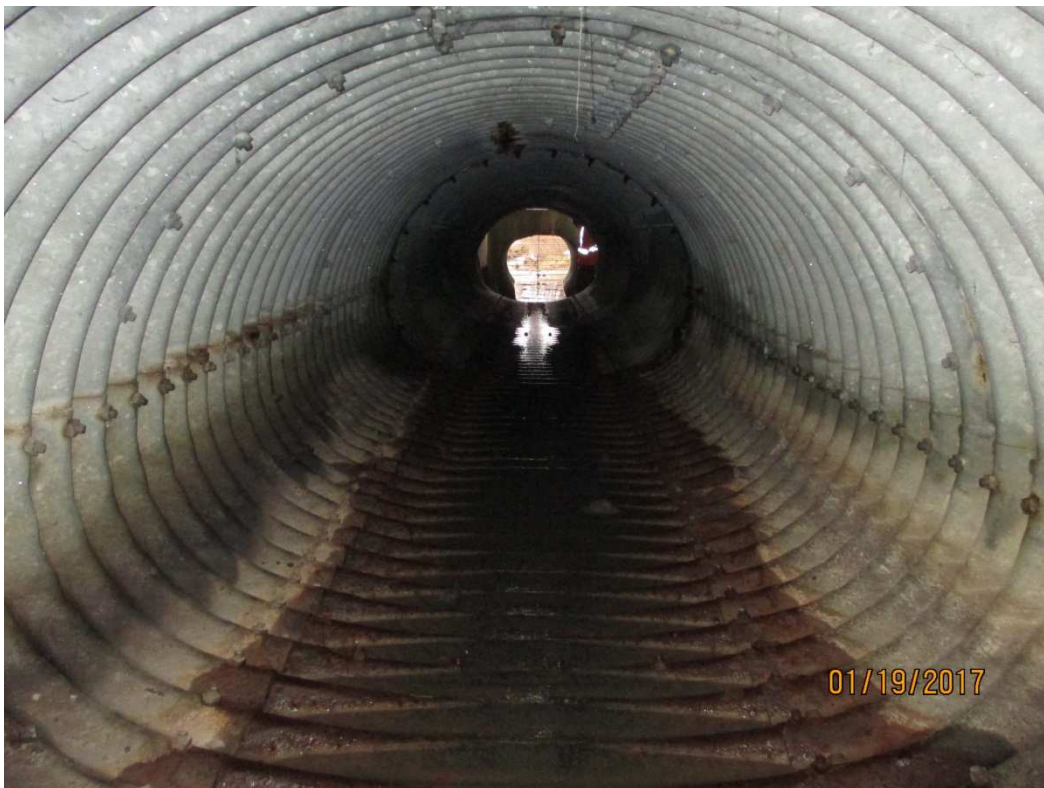
Photo 10 –Section 2 of East Culvert Pipe – Multi Plate CSPA Looking Towards Outlet

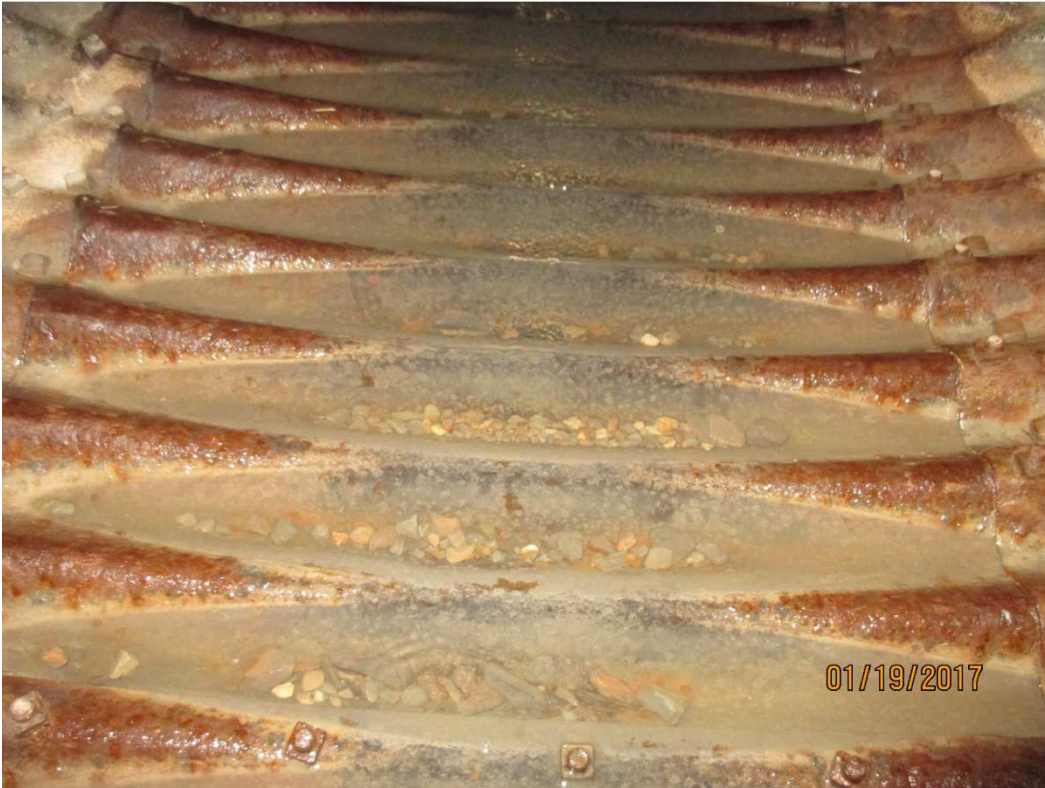
Photo 11 –Corrosion of Section 2 of East Culvert Pipe Invert

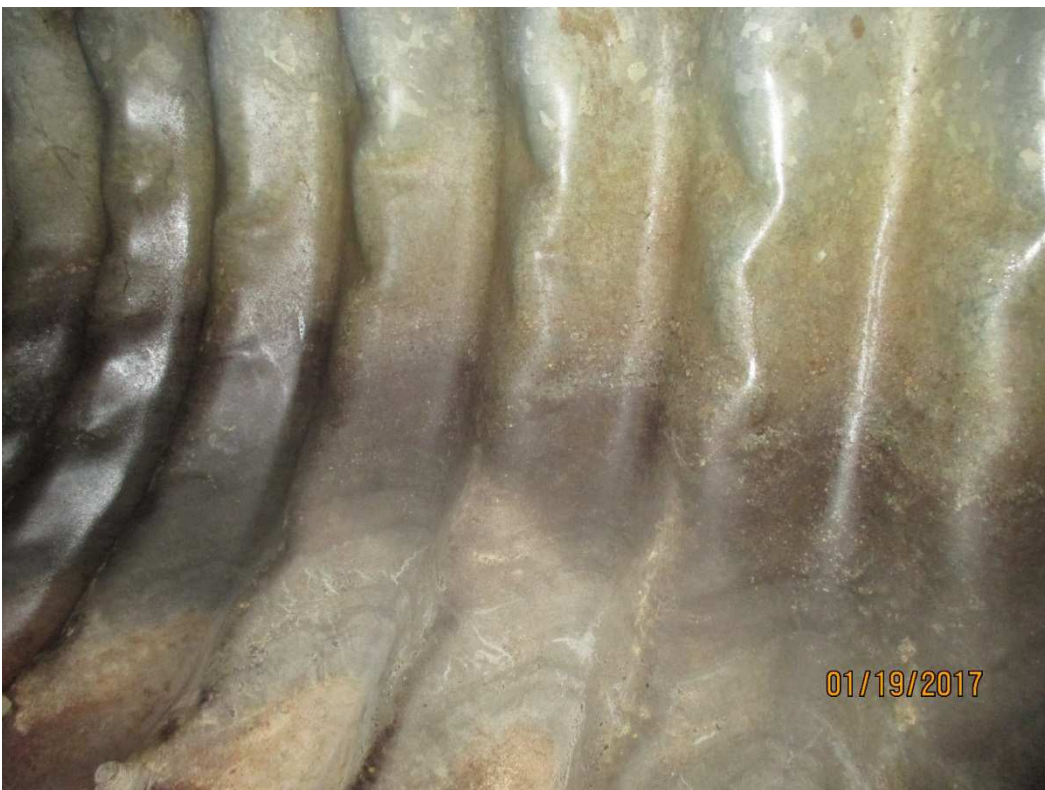
Photo 12 – Medium to Severe Crimping of Section 2 of East Culvert Pipe

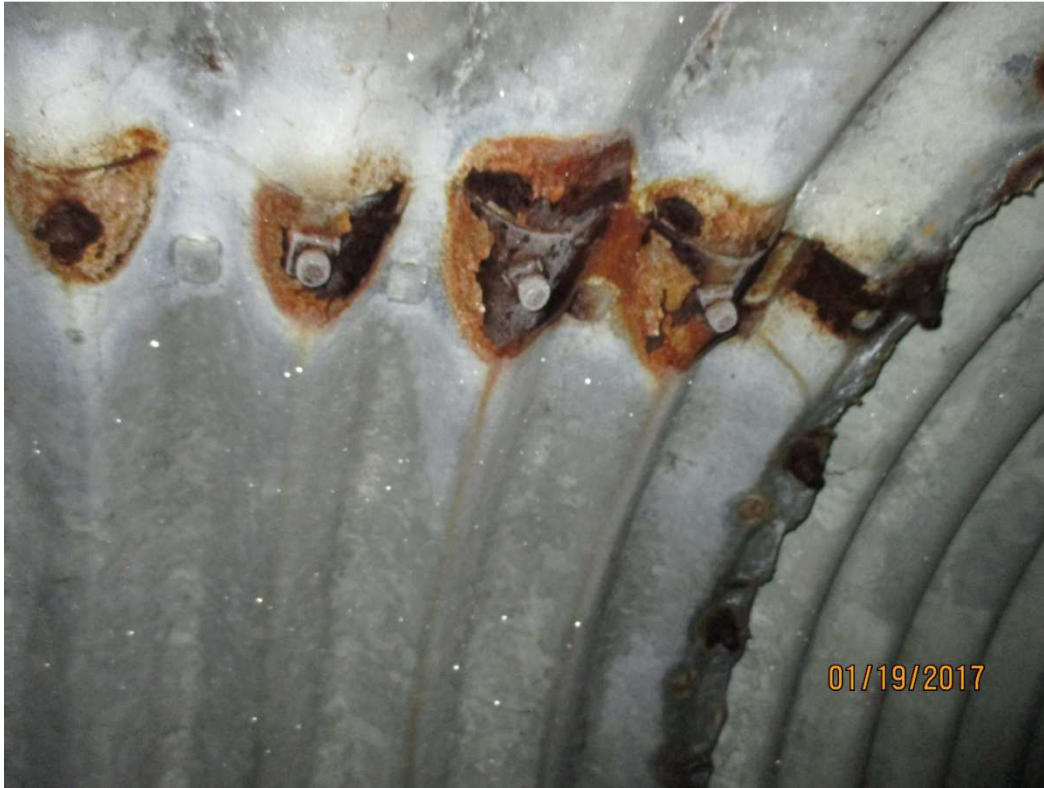
Photo 13 – Corrosion of Bolt Connections of Section 2 of East Culvert Pipe

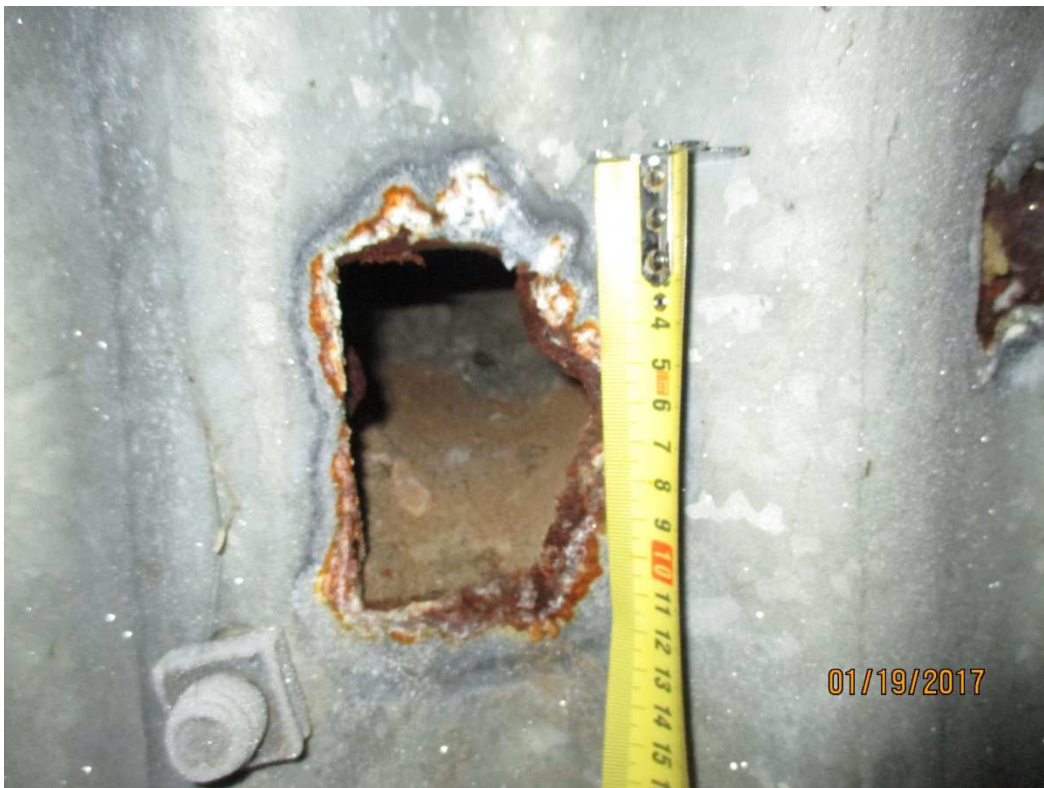
Photo 14 – Perforation of Section 2 of East Culvert Pipe

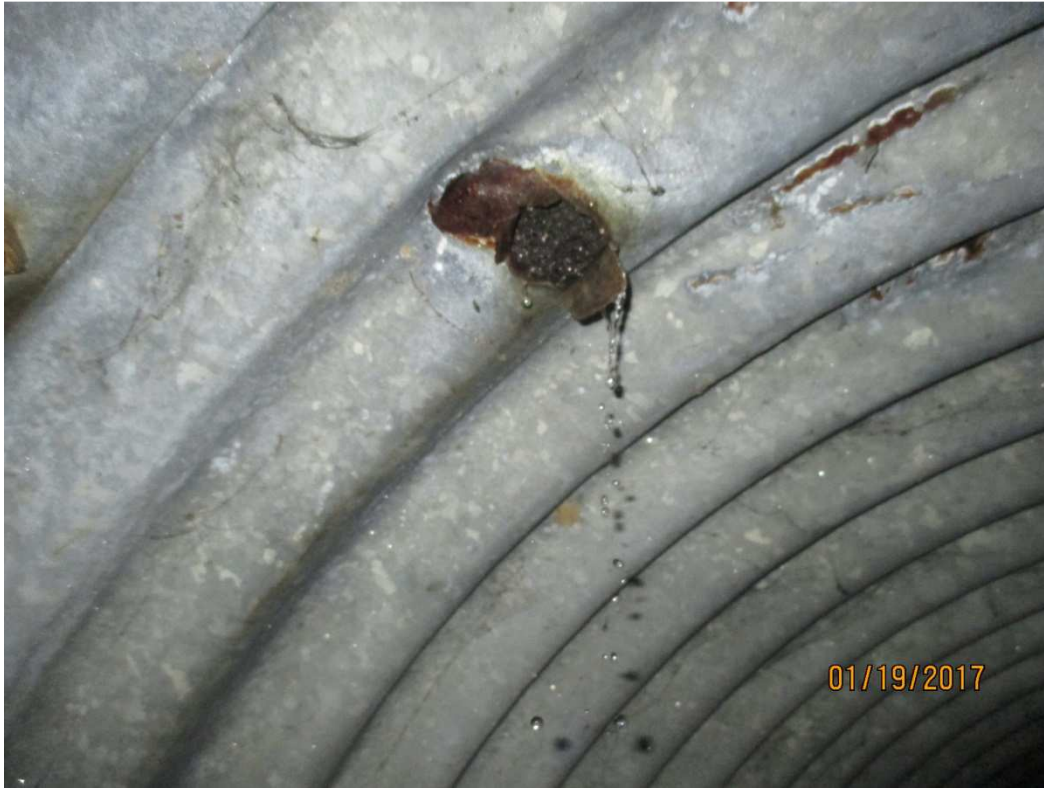
Photo 15 – Perforation & Leakage of Section 2 of East Culvert Pipe

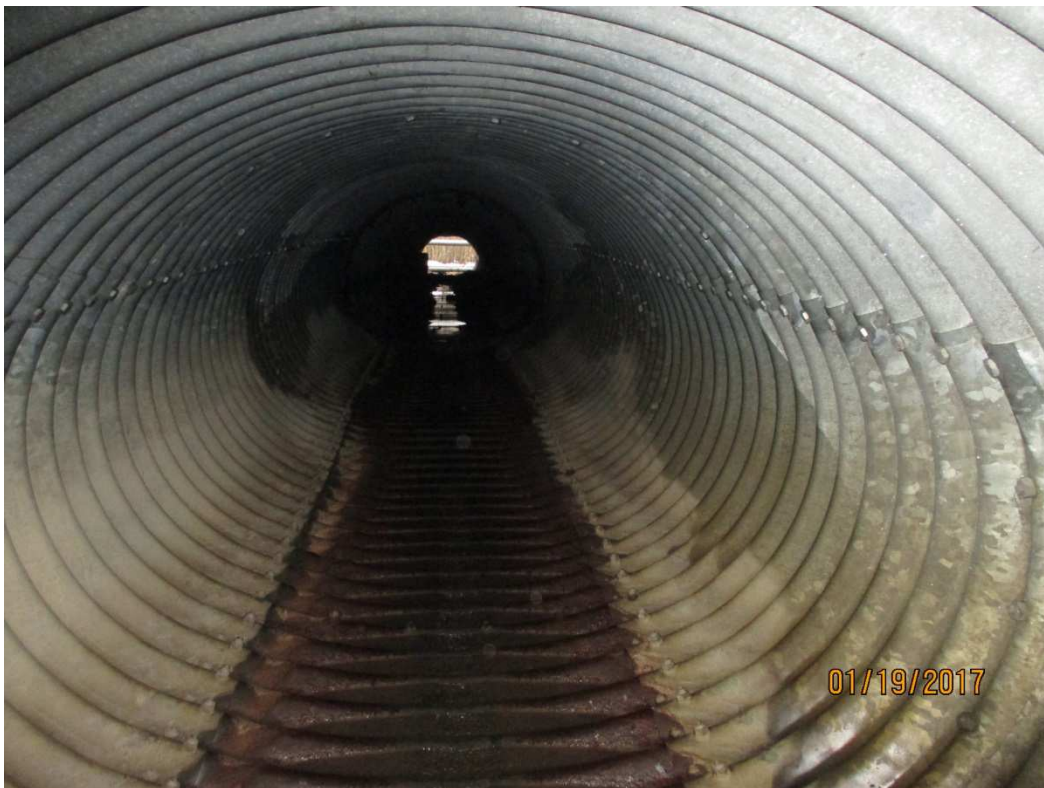
Photo 16 –Section 3 of East Culvert Pipe – Multi Plate CPSA Looking Towards Inlet

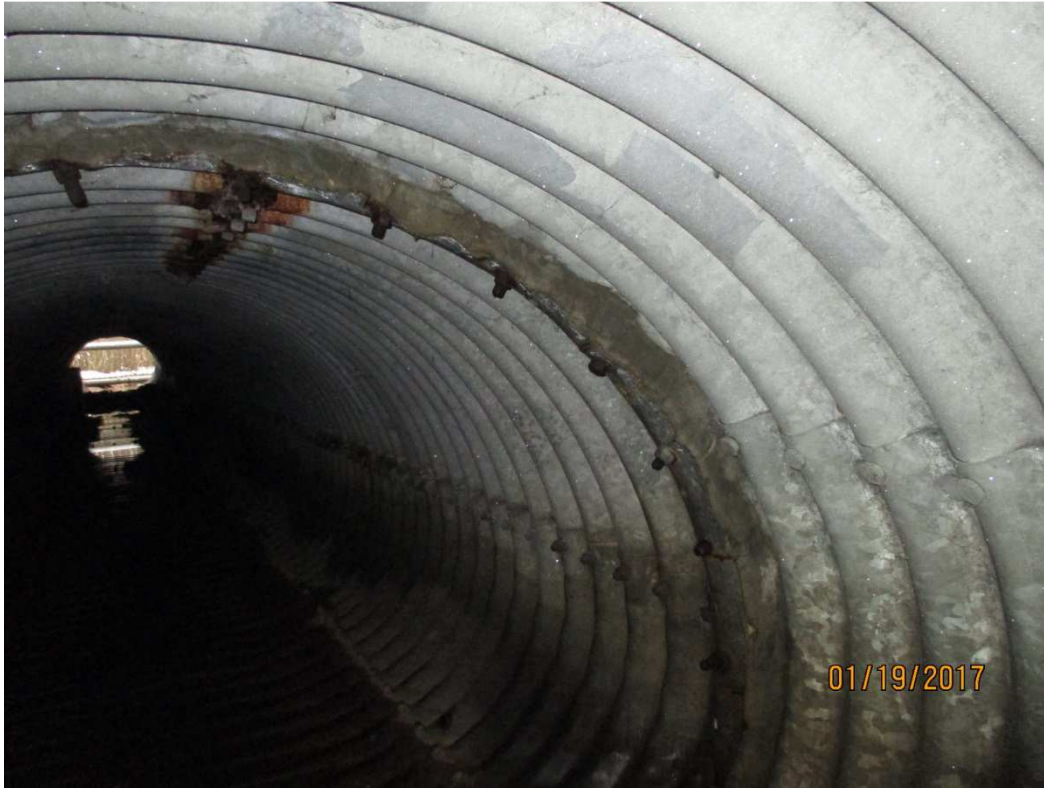
Photo 17 – Connection between Section 2 and Section 3 of East Culvert Pipe

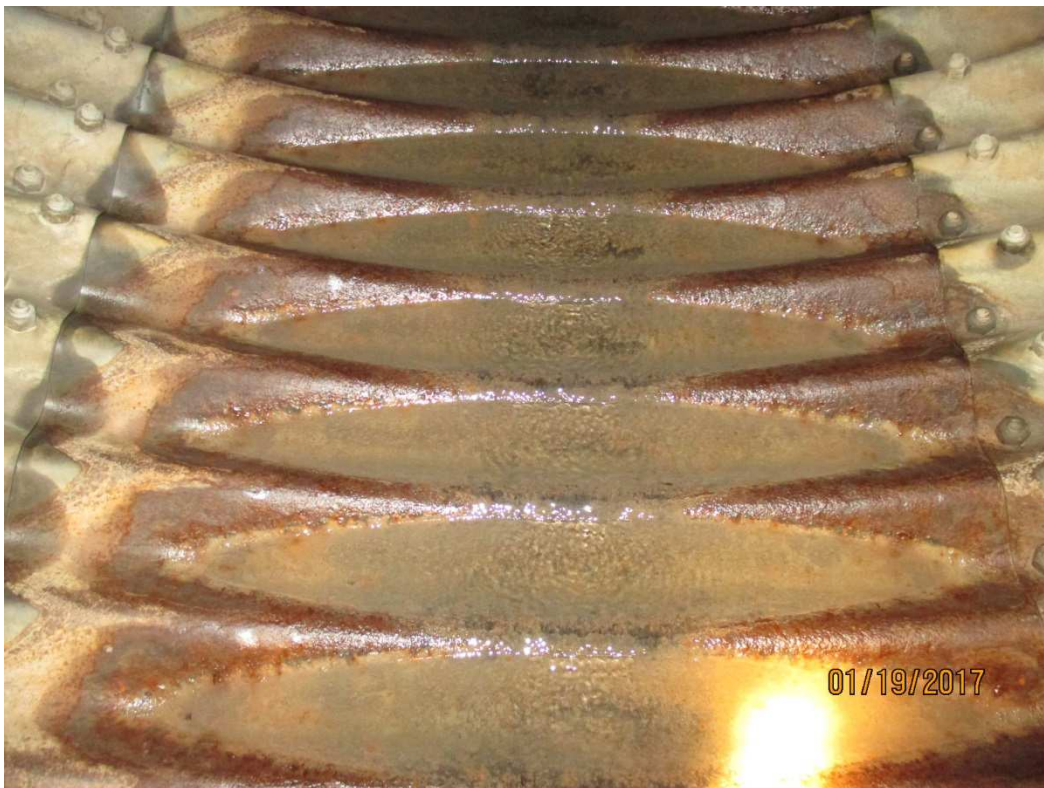
Photo 18 –Corrosion of Section 3 of East Culvert Pipe

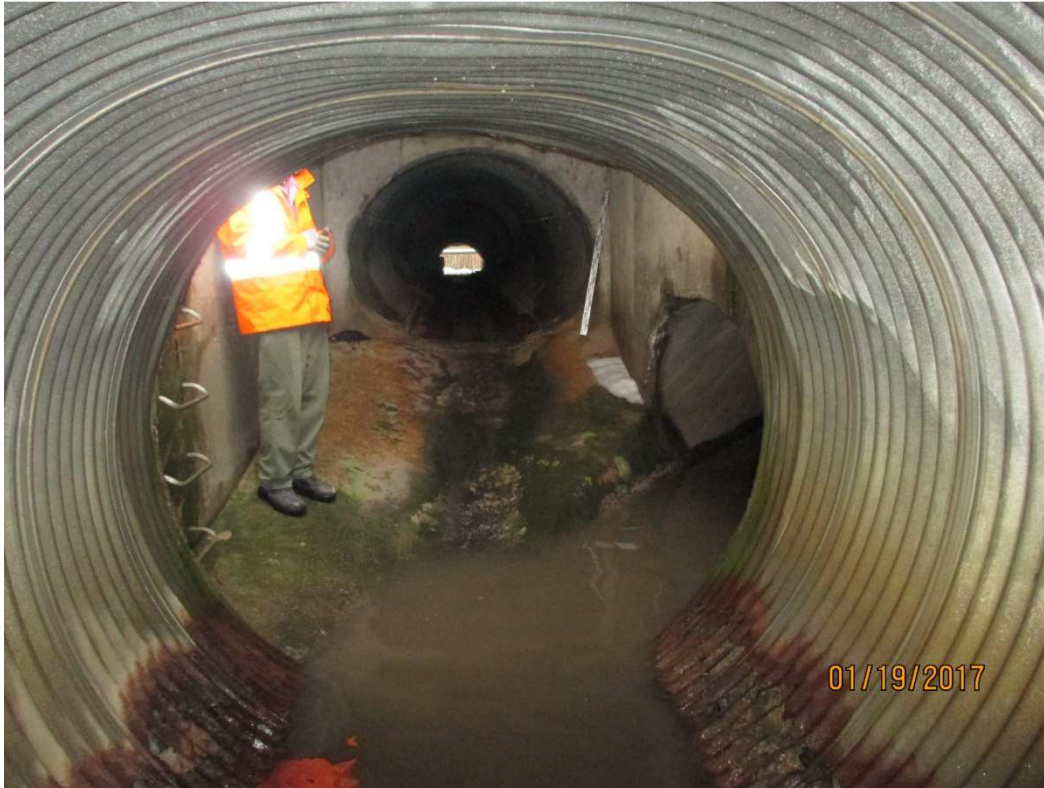
Photo 19 – Concrete Drop Maintenance Hole Structure Looking from Section 4 (Outlet) of East Culvert Pipe

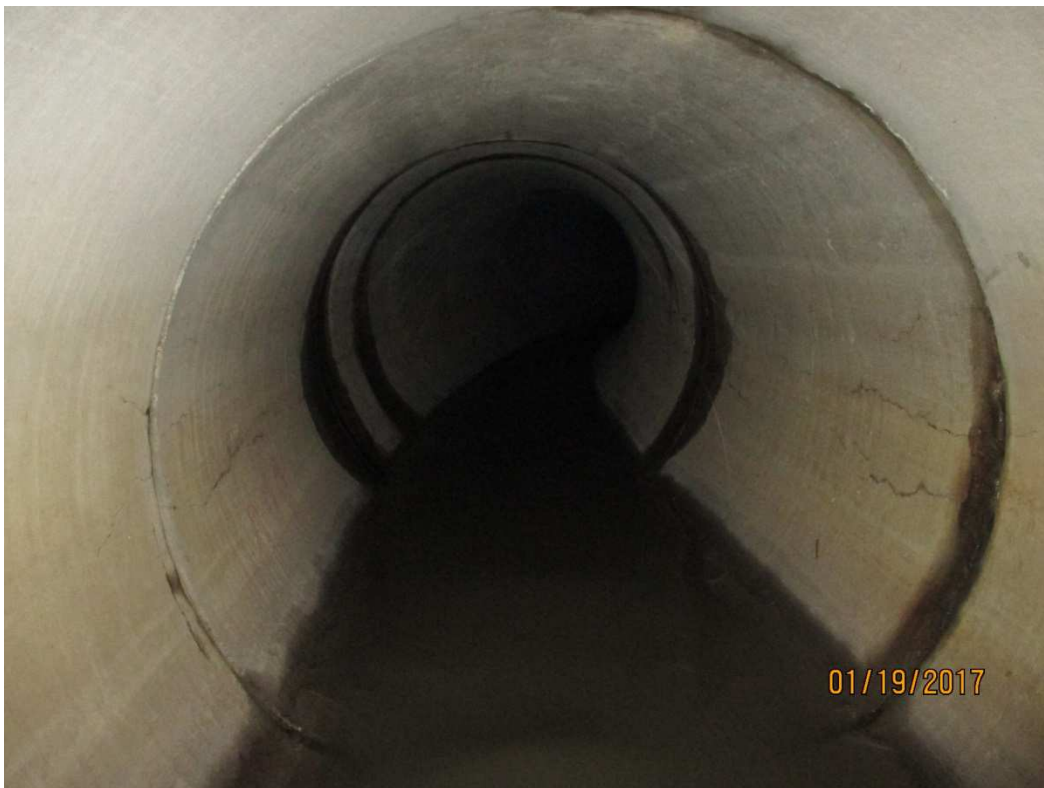
| Comments: | <ul style="list-style-type: none"> <li>• East culvert pipe enters and exits drop maintenance hole structure</li> <li>• West culvert pipe does <u>NOT</u> pass through drop maintenance hole structure</li> <li>• 1350 mm diameter concrete storm pipe connects to drop maintenance hole structure</li> <li>• Large amount of granular noted within 1350 mm diameter storm pipe</li> </ul> | | | | | |

Photo 20 – Looking Up 1350 mm Diameter Storm Pipe Inlet from Drop Maintenance Hole Structure

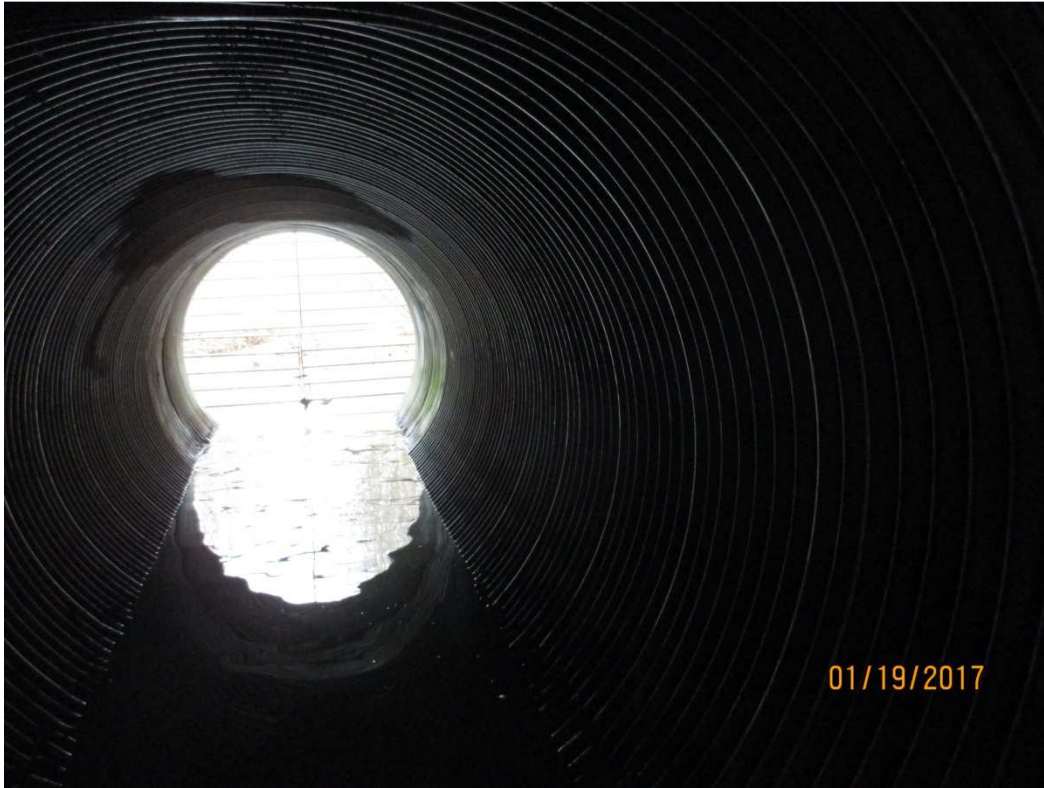
Photo 21 – Section 4 of East Culvert Pipe – CSP (Looking Towards Outlet)

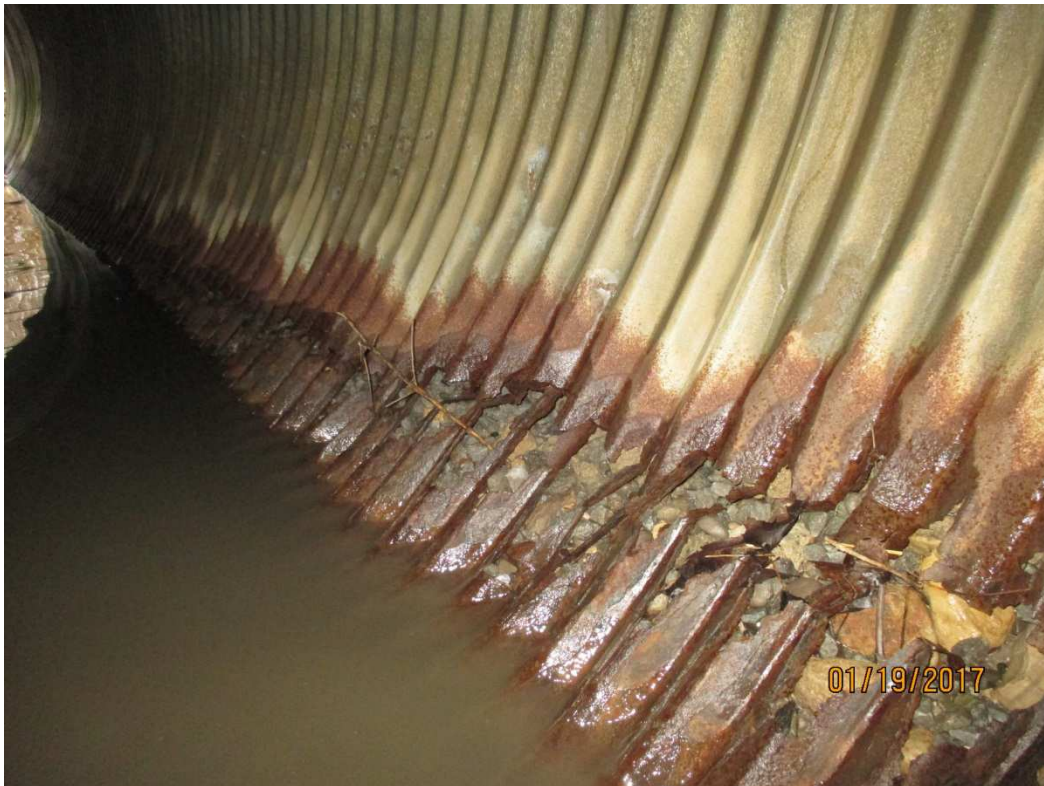
| Comments: | <ul style="list-style-type: none"> <li>• 2000 mm diameter corrugated steel pipe (based on construction drawings)</li> <li>• Critical perforations and section loss due to rusting at waterline</li> <li>• Deformation of soffit near drop maintenance hole structure</li> <li>• Large amount of granular noted on east side of outlet</li> </ul> | | | | | |

Photo 22 – Corrosion with Critical Perforations & Section Loss – East Side of Section 4 of East Culvert Pipe

| Recommendations: | <ul style="list-style-type: none"> <li>• Camera inspection of concrete ellipse – (east pipe) to verify condition</li> <li>• Camera inspection of storm sewer beyond upstream MH and CBMH</li> <li>• Replace culverts and drop structure (URGENT)</li> </ul> |

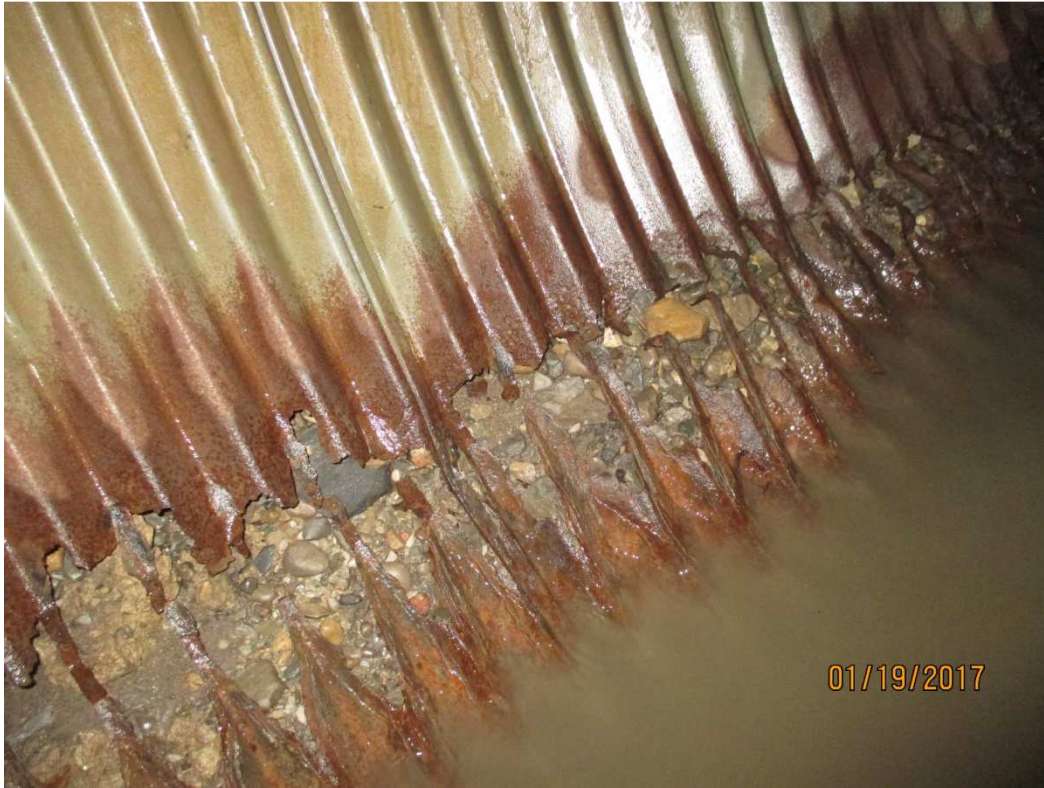
Photo 23 – Corrosion with Critical Perforations & Section Loss – West Side of Section 4 of East Culvert Pipe

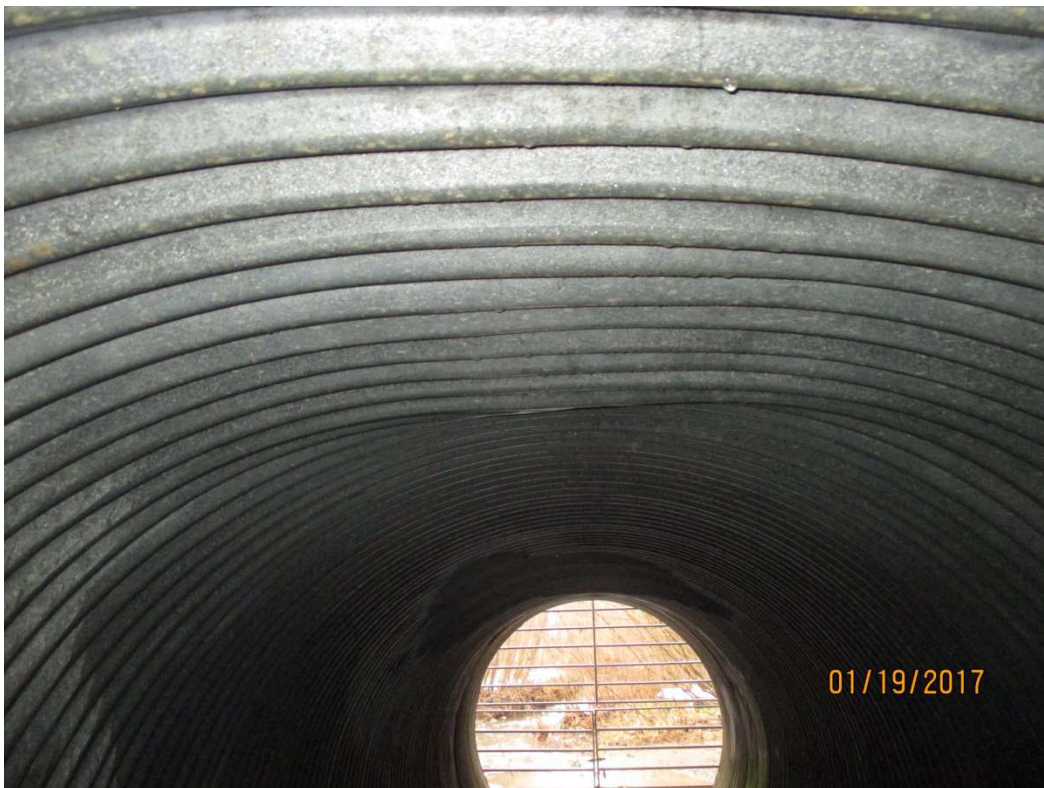
Photo 24 – Deformation of Culvert Obvert at Outlet of East Culvert Pipe
