Fenestration Assessment

425 Davis Drive
Newmarket, Ontario

Prepared for:
The Arten Group
2162 Major Mackenzie Drive
Vaughan, ON

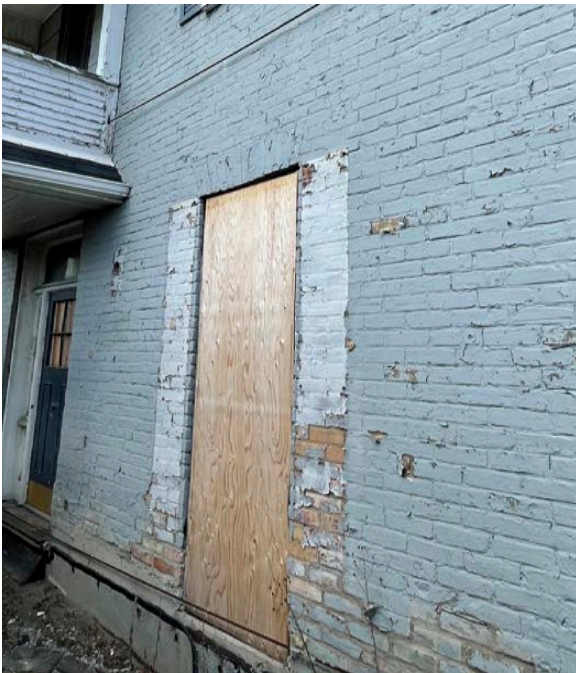
Door 425-a (Exterior)

Glass does not exhibit the surface irregularities of historic glass production methods, which indicates that it was produced either by the float glass method (post 1960) or possibly the rolled glass method (post 1920).

Door and frames are painted Wood. Multiple coats of paint which are evident in peeling and chipped areas would have been applied throughout the service life up until the 1990s. Most or all of the layers of paint are lead based, as was ubiquitous during this period.

Glazing is single pane, sealed with putty, resulting in very poor energy performance.

Wood substrate is chipped and warped.

The element was installed long after the original building was constructed and has no historical value.

Remove and replace with new historically inspired energy efficient wood door and transom which is part of a comprehensively designed fenestration style.

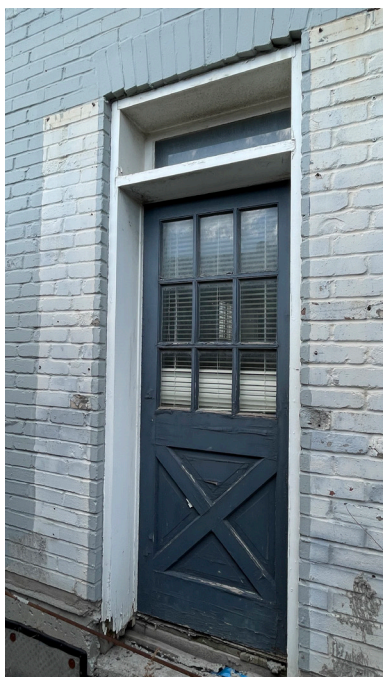
Door 425-c (Exterior)

Glass does not exhibit the surface irregularities of historic glass production methods, which indicates that it was produced either by the float glass method (post 1960) or possibly the rolled glass method (post 1920).

Door and frames are painted Wood. Multiple coats of paint which are evident in peeling and chipped areas would have been applied throughout the service life up until the 1990s. Most or all of the layers of paint are lead based, as was ubiquitous during this period.

Glazing is single pane, sealed with putty, resulting in very poor energy performance.

Wood substrate is chipped and warped.

The element was installed long after the original building was constructed and has no historical value.

Remove and replace with new historically inspired energy efficient wood door and transom which is part of a comprehensively designed fenestration style.

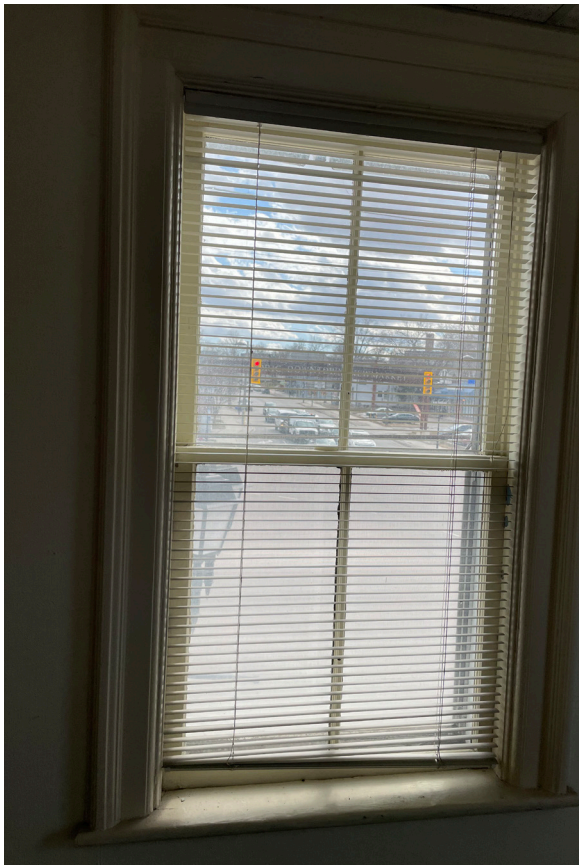
Window 425-d (Interior)

-Inner window glass does not exhibit the surface irregularities of historic glass production methods, which indicates that it was produced either by the float glass method (post 1960) or possibly the rolled glass method (post 1920).

-Glazing is single pane, sealed with putty, resulting in very poor energy performance.

- Door and frames are painted Wood. Multiple coats of paint which are evident in peeling and chipped areas would have been applied throughout the service life up until the 1990s. Most or all of the layers of paint are lead based, as was ubiquitous during this period.

- Outer window frame is painted extruded aluminium, <50 years old.

Sill height is 28 1/2" above floor which is a falling safety hazard when the sash is open.

The element was installed long after the original building was constructed and has no historical value.

Remove and replace with new historically inspired energy efficient wood window with insect screen. Wood muntins shall replicate the existing configuration which divides each sash vertically into two.

Limit sash opening travel to <4" to eliminate falling hazard at low sill.

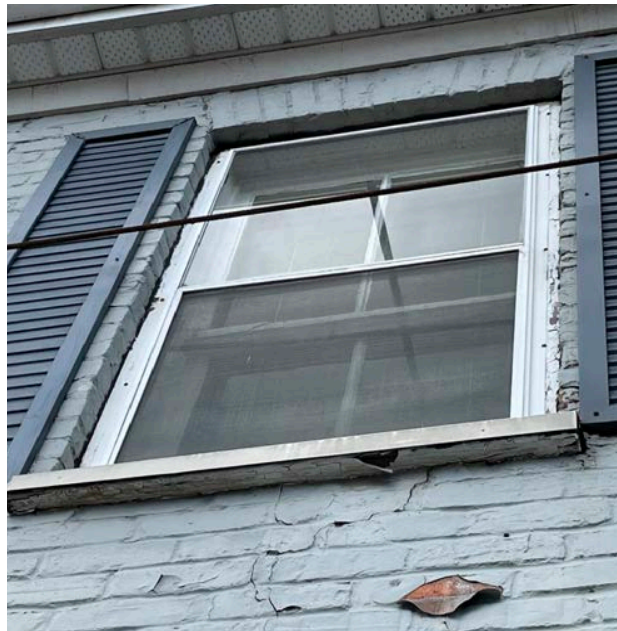
Window 425-d (Exterior)

Exterior wood sill paint is extensively deteriorated and wood is exposed to the elements and rotted on the ends. Sill is embedded into brick which will be removed and so cannot be retained.

Provide new composite Hardie-Trim sill and apron over new Hardie Board cladding.

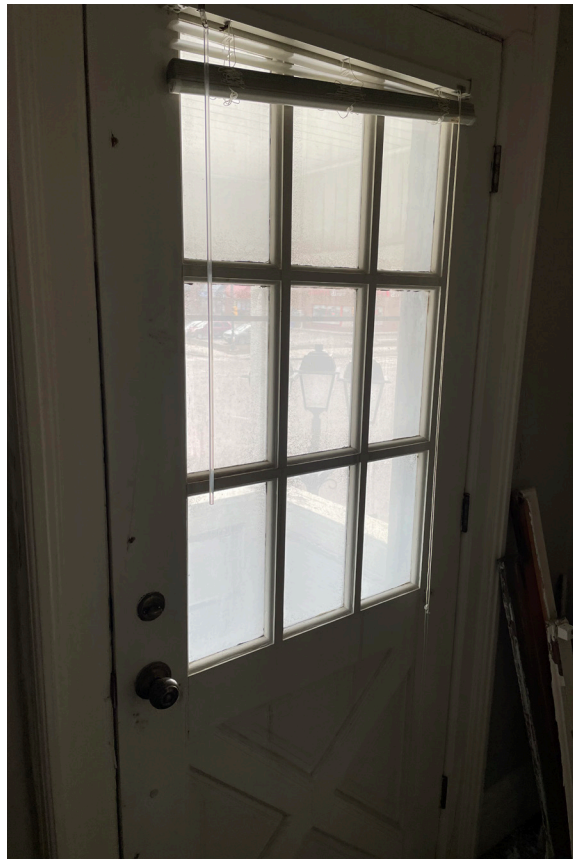
Window 425-e (Interior)

Glass does not exhibit the surface irregularities of historic glass production methods, which indicates that it was produced either by the float glass method (post 1960) or possibly the rolled glass method (post 1920).

Door and frames are painted Wood. Multiple coats of paint which are evident in peeling and chipped areas would have been applied throughout the service life up until the 1990s. Most or all of the layers of paint are lead based, as was ubiquitous during this period.

Glazing is single pane, sealed with putty, resulting in very poor energy performance.

Wood substrate is chipped and warped.

Remove and replace with new historically inspired energy efficient wood door which is part of a comprehensively designed fenestration style.

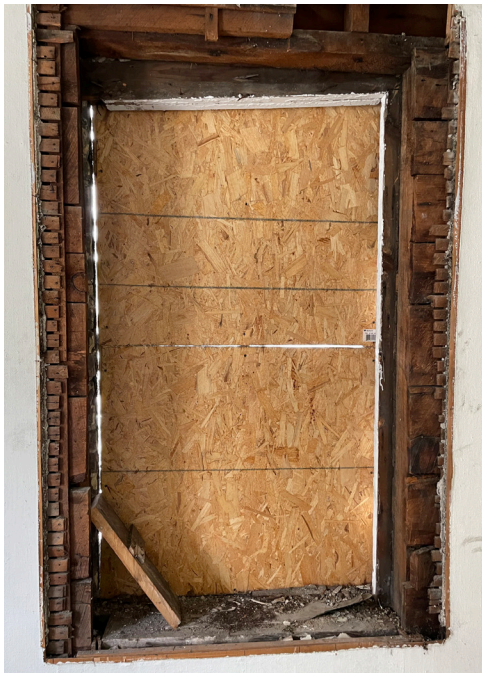
Window 425-f (Interior)

Window is missing.

Install new, historically inspired energy efficient wood window with insect screen. Wood muntins shall replicate the existing configuration of the building's typical windows, which divides each sash vertically into two. Limit sash opening travel to <4" to eliminate falling hazard at low sill. Provide new composite Hardie-Trim sill and apron over new Hardie Board cladding.

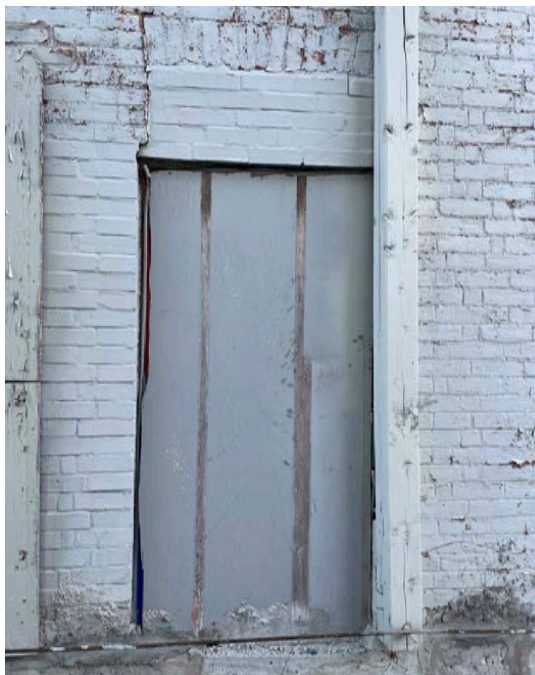
Window 425-g (Exterior)

Window is missing.

Install new, historically inspired energy efficient wood window with insect screen. Wood muntins shall replicate the existing configuration of the building's typical windows, which divides each sash vertically into two. Limit sash opening travel to <4" to eliminate falling hazard at low sill.

Reconstruct sill

Provide new composite Hardie-Trim sill and apron over new Hardie Board cladding.

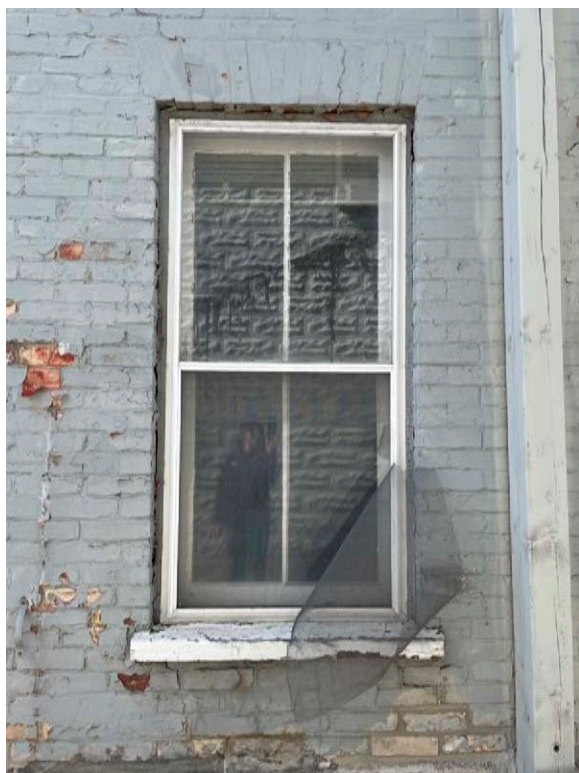
Window 425-h (Exterior)

Sill height is 27 1/4" above floor which is a falling safety hazard when the sash is open.

Exterior wood sill paint is extensively deteriorated and wood is exposed to the elements and rotted on the ends. Sill is embedded into brick which will be removed and so cannot be retained.

Remove and replace with new historically inspired energy efficient wood window with insect screen. Wood muntins shall replicate the existing configuration which divides each sash vertically into two.

Limit sash opening travel to <4" to eliminate falling hazard at low sill.

Provide new composite Hardie-Trim sill and apron over new Hardie Board cladding.

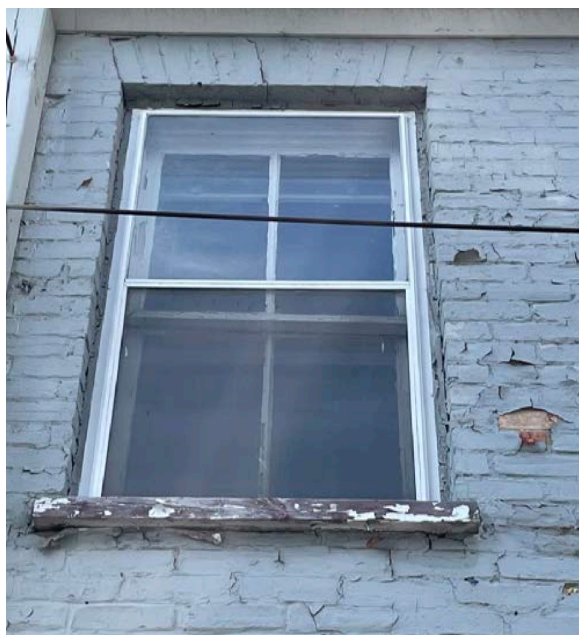
Window 425-i (Exterior)

Sill height is 28 1/2" above floor which is a falling safety hazard when the sash is open.

Exterior wood sill paint is extensively deteriorated and wood is exposed to the elements and rotted on the ends. Sill is embedded into brick which will be removed and so cannot be retained.

Remove and replace with new historically inspired energy efficient wood window with insect screen. Wood muntins shall replicate the existing configuration which divides each sash vertically into two.

Limit sash opening travel to <4" to eliminate falling hazard at low sill.

Provide new composite Hardie-Trim sill and apron over new Hardie Board cladding.

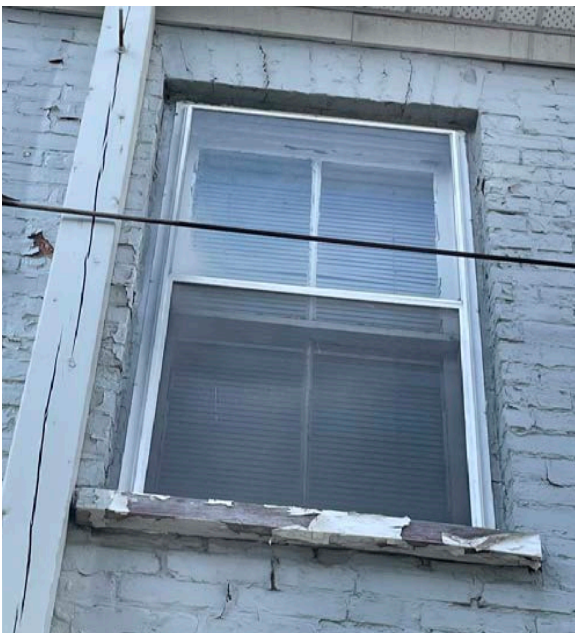
Window 425-j (Exterior)

Sill height is 28 1/2" above floor which is a falling safety hazard when the sash is open.

Exterior wood sill paint is extensively deteriorated and wood is exposed to the elements and rotted on the ends. Sill is embedded into brick which will be removed and so cannot be retained.

Remove and replace with new historically inspired energy efficient wood window with insect screen. Wood muntins shall replicate the existing configuration which divides each sash vertically into two.

Limit sash opening travel to <4" to eliminate falling hazard at low sill.

Provide new composite Hardie-Trim sill and apron over new Hardie Board cladding.

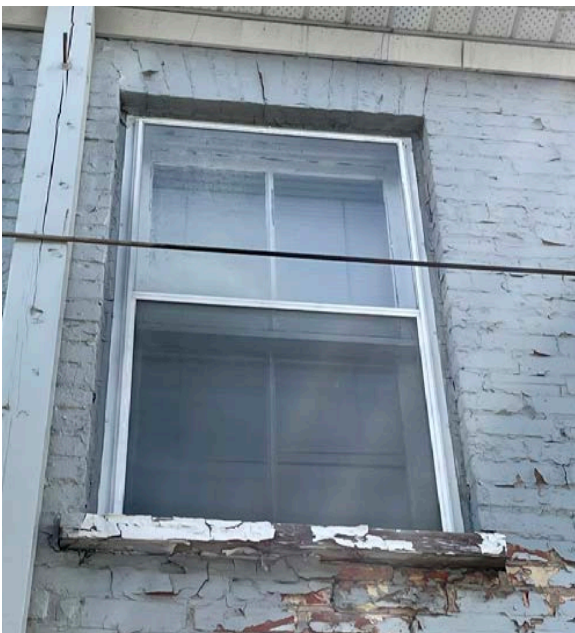
Window 425-k (Exterior)

Sill height is 28 1/2" above floor which is a falling safety hazard when the sash is open.

Exterior wood sill paint is extensively deteriorated and wood is exposed to the elements and rotted on the ends. Sill is embedded into brick which will be removed and so cannot be retained.

Remove and replace with new historically inspired energy efficient wood window with insect screen. Wood muntins shall replicate the existing configuration which divides each sash vertically into two.

Limit sash opening travel to <4" to eliminate falling hazard at low sill. Provide new composite Hardie-Trim sill and apron over new Hardie Board cladding.

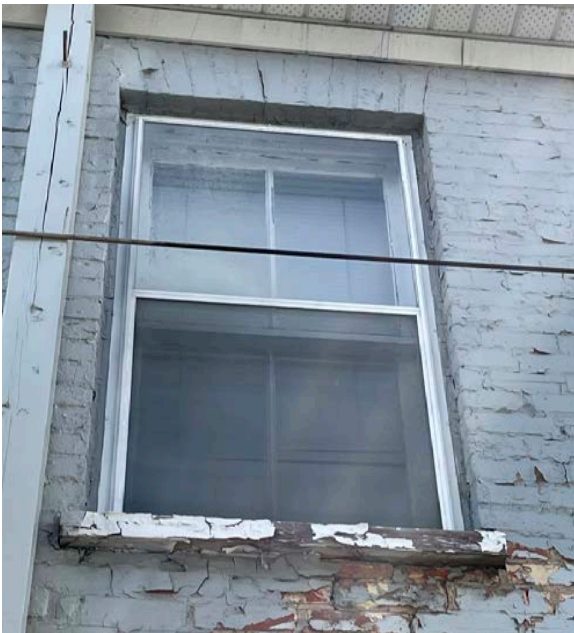
Window 425-l (Exterior)

Sill height is 28 1/2" above floor which is a falling safety hazard when the sash is open.

Exterior wood sill paint is extensively deteriorated and wood is exposed to the elements and rotted on the ends. Sill is embedded into brick which will be removed and so cannot be retained.

Remove and replace with new historically inspired energy efficient wood window with insect screen. Wood muntins shall replicate the existing configuration which divides each sash vertically into two.

Limit sash opening travel to <4" to eliminate falling hazard at low sill.

Provide new composite Hardie-Trim sill and apron over new Hardie Board cladding.

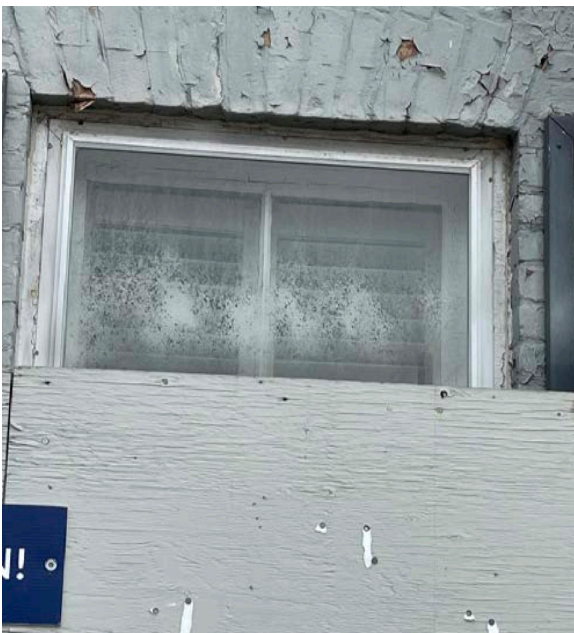
Window 425-m (Exterior)

Sill height is 27 1/4" above floor which is a falling safety hazard when the sash is open.

Exterior wood sill paint is extensively deteriorated and wood is exposed to the elements and rotted on the ends. Sill is embedded into brick which will be removed and so cannot be retained.

Remove and replace with new historically inspired energy efficient wood window with insect screen. Wood muntins shall replicate the existing configuration which divides each sash vertically into two.

Limit sash opening travel to <4" to eliminate falling hazard at low sill.

Provide new composite Hardie-Trim sill and apron over new Hardie Board cladding.

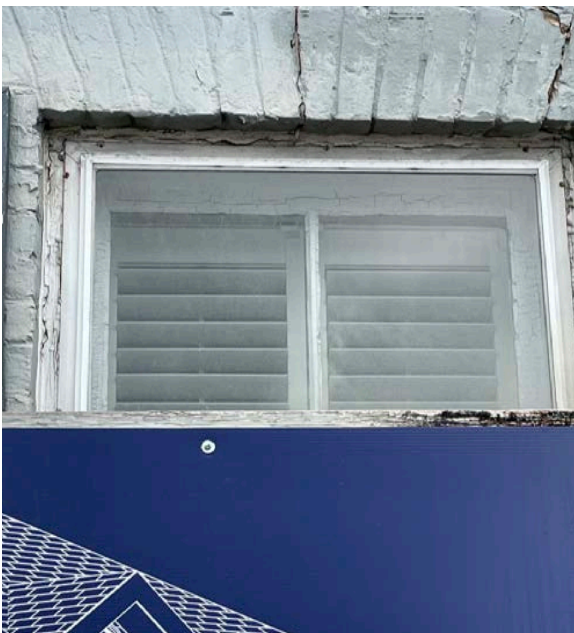
Window 425-n (Exterior)

Sill height is 27 1/4" above floor which is a falling safety hazard when the sash is open.

Exterior wood sill paint is extensively deteriorated and wood is exposed to the elements and rotted on the ends. Sill is embedded into brick which will be removed and so cannot be retained.

Remove and replace with new historically inspired energy efficient wood window with insect screen. Wood muntins shall replicate the existing configuration which divides each sash vertically into two.

Limit sash opening travel to <4" to eliminate falling hazard at low sill.

Provide new composite Hardie-Trim sill and apron over new Hardie Board cladding.

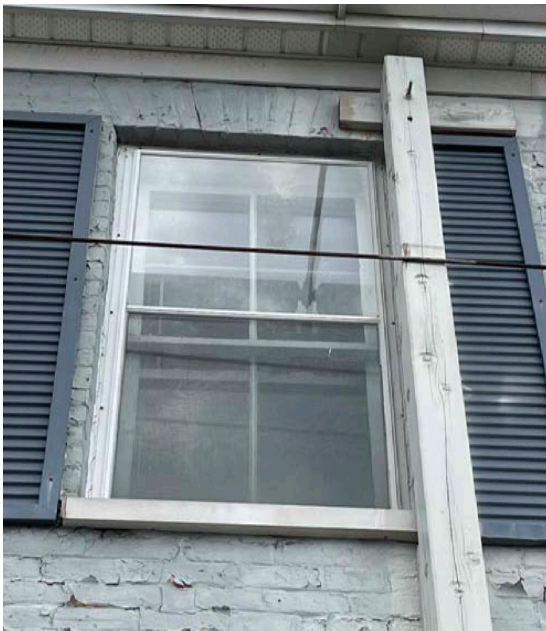
Window 425-p (Exterior)

Sill height is 28 1/2" above floor which is a falling safety hazard when the sash is open.

Remove and replace with new historically inspired energy efficient wood window with insect screen. Wood muntins shall replicate the existing configuration which divides each sash vertically into two.

Limit sash opening travel to <4" to eliminate falling hazard at low sill.

Provide new composite Hardie-Trim sill and apron over new Hardie Board cladding.

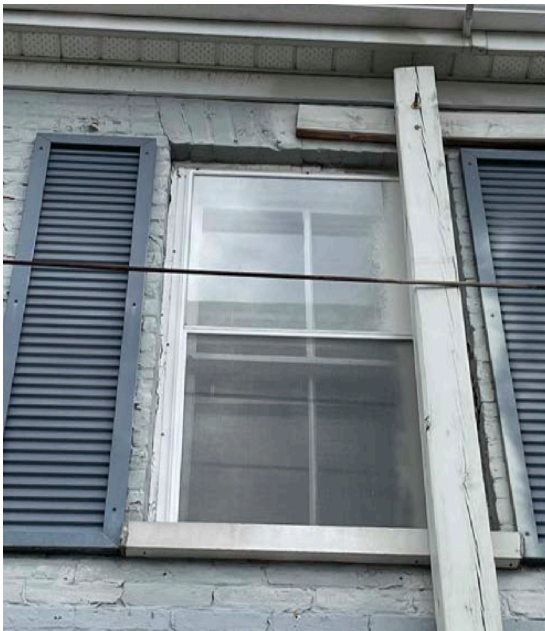
Window 425-q (Exterior)

Sill height is 28 1/2" above floor which is a falling safety hazard when the sash is open.

Remove and replace with new historically inspired energy efficient wood window with insect screen. Wood muntins shall replicate the existing configuration which divides each sash vertically into two.

Limit sash opening travel to <4" to eliminate falling hazard at low sill.

Provide new composite Hardie-Trim sill and apron over new Hardie Board cladding.

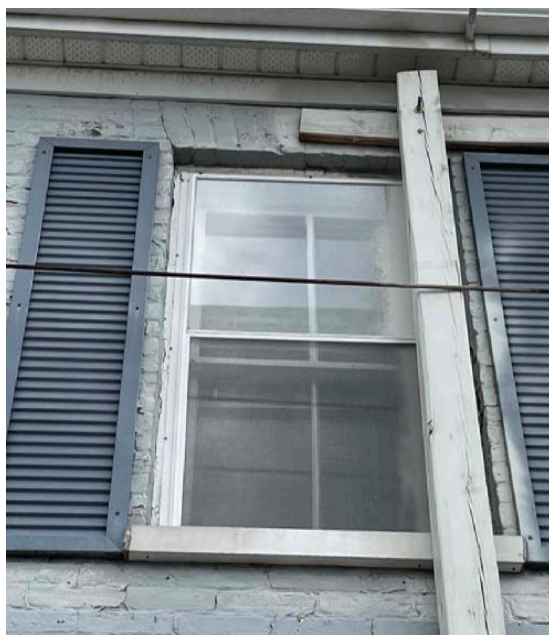
Window 425-r (Exterior)

Sill height is 28 1/2" above floor which is a falling safety hazard when the sash is open.

Remove and replace with new historically inspired energy efficient wood window with insect screen. Wood muntins shall replicate the existing configuration which divides each sash vertically into two.

Limit sash opening travel to <4" to eliminate falling hazard at low sill.

Provide new composite Hardie-Trim sill and apron over new Hardie Board cladding.

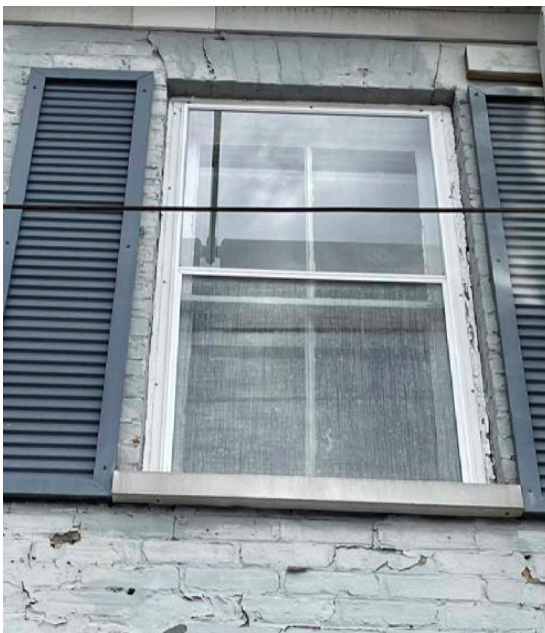
Window 425-s (Exterior)

Sill height is 28 1/2" above floor which is a falling safety hazard when the sash is open.

Remove and replace with new historically inspired energy efficient wood window with insect screen. Wood muntins shall replicate the existing configuration which divides each sash vertically into two.

Limit sash opening travel to <4" to eliminate falling hazard at low sill.

Provide new composite Hardie-Trim sill and apron over new Hardie Board cladding.

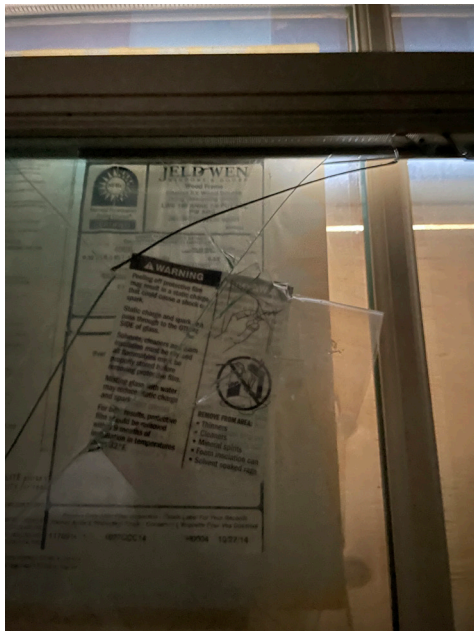
Window 425-t (Interior Detail)

Modern window technology which provides good energy performance. U=1.82 (SI), SHGC = 0.53, Transmittance = 0.60, Air leakage = 0.5 (SI).

Sill height is 27 1/2" above floor which is a falling safety hazard when the bottom sash is open.

Retain this item. Paint to match other fenestration. Provide new composite Hardie-Trim sill and apron over new Hardie Board cladding. Limit sash opening travel to <4" to eliminate falling hazard at low sill.

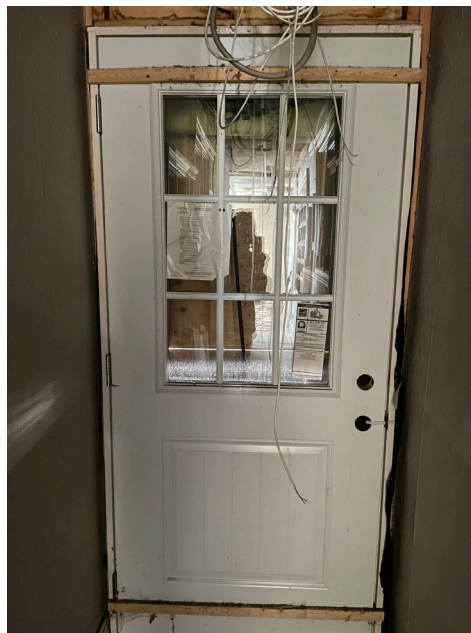
Door 425-u (Interior)

Door with divided lites and wood muntins.

Modern window technology which provides good energy performance.
U=1.82 (SI), SHGC = 0.53, Transmittance = 0.60, Air leakage = 0.5 (SI).

Retain this item. Paint to match other fenestration. Provide new composite Hardie-Trim over new Hardie Board cladding.

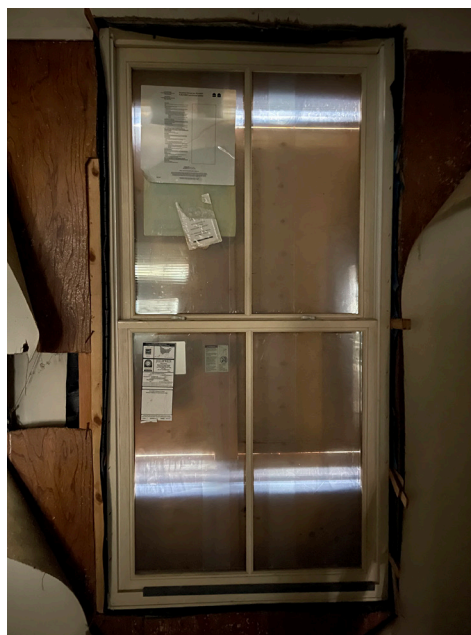
Window 425-v (Interior)

Modern window technology which provides good energy performance. U=1.82 (SI), SHGC = 0.53, Transmittance = 0.60, Air leakage = 0.5 (SI).

Sill height is 27 1/2" above floor which is a falling safety hazard when the bottom sash is open.

Retain this item. Paint to match other fenestration. Provide new composite Hardie-Trim sill and apron over new Hardie Board cladding. Limit sash opening travel to <4" to eliminate falling hazard at low sill.

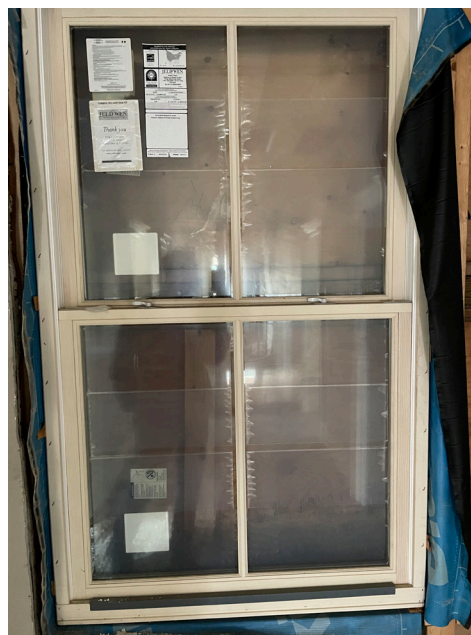
Window 425-x (Interior)

Modern window technology which provides good energy performance. U=1.82 (SI), SHGC = 0.53, Transmittance = 0.60, Air leakage = 0.5 (SI).

Sill height is 28 1/2" above floor which is a falling safety hazard when the bottom sash is open.

Retain this item. Paint to match other fenestration. Provide new composite Hardie-Trim sill and apron over new Hardie Board cladding. Limit sash opening travel to <4" to eliminate falling hazard at low sill.

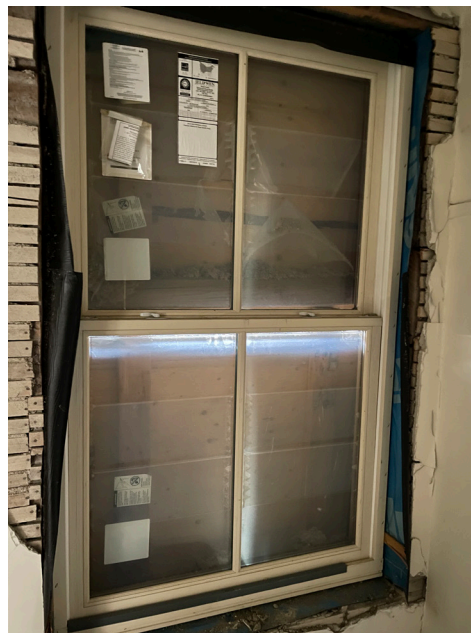
Window 425-y (Interior)

Modern window technology which provides good energy performance. U=1.82 (SI), SHGC = 0.53, Transmittance = 0.60, Air leakage = 0.5 (SI).

Sill height is 28 1/2" above floor which is a falling safety hazard when the bottom sash is open.

Retain this item. Paint to match other fenestration. Provide new composite Hardie-Trim sill and apron over new Hardie Board cladding. Limit sash opening travel to <4" to eliminate falling hazard at low sill.

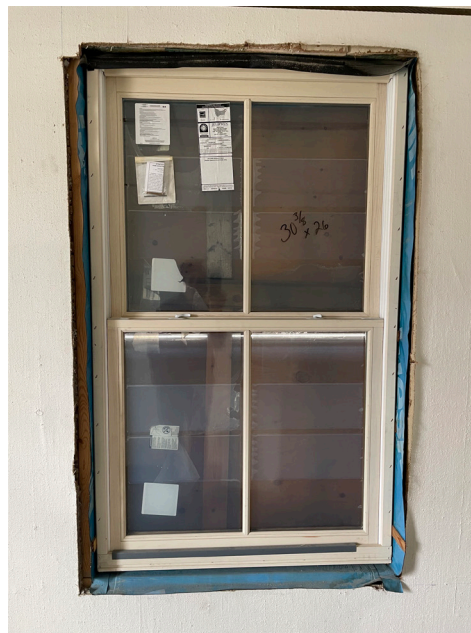
Window 425-z (Interior)

Modern window technology which provides good energy performance. U=1.82 (SI), SHGC = 0.53, Transmittance = 0.60, Air leakage = 0.5 (SI).

Sill height is 28 1/2" above floor which is a falling safety hazard when the bottom sash is open.

Retain this item. Paint to match other fenestration. Provide new composite Hardie-Trim sill and apron over new Hardie Board cladding. Limit sash opening travel to <4" to eliminate falling hazard at low sill.
