Urban Forest Innovations Inc.
1331 Northaven Drive
Mississauga ON L5G 4E8

Re: 116 Eden Court – Application for Minor Variance – Arborist Peer Review

A site visit was undertaken on November 17, 2022, to assess the site and verify the tree inventory details.

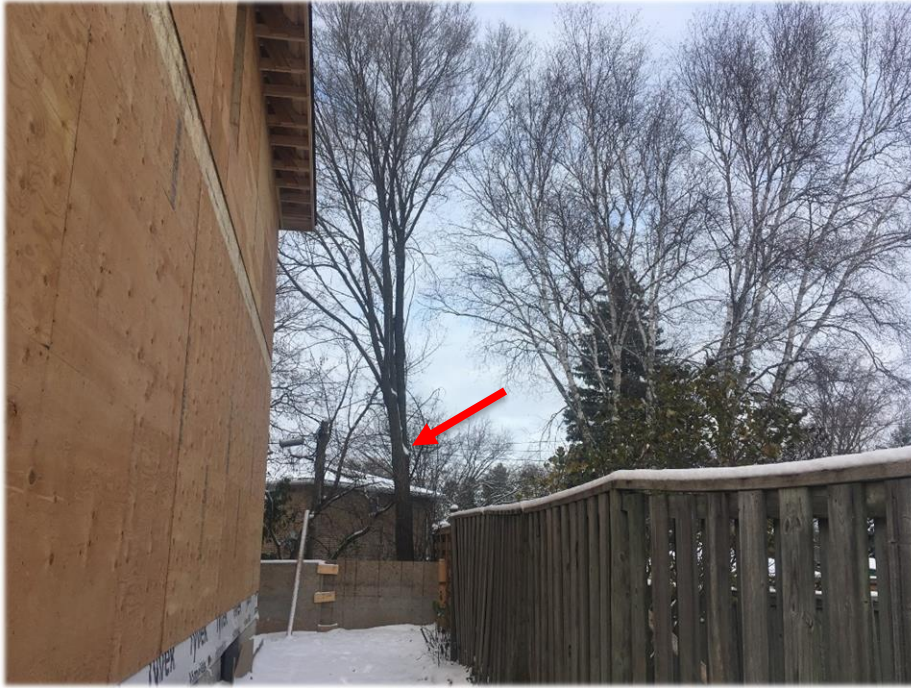
Figure 1: Location of Siberian elm not represented in the tree report form.

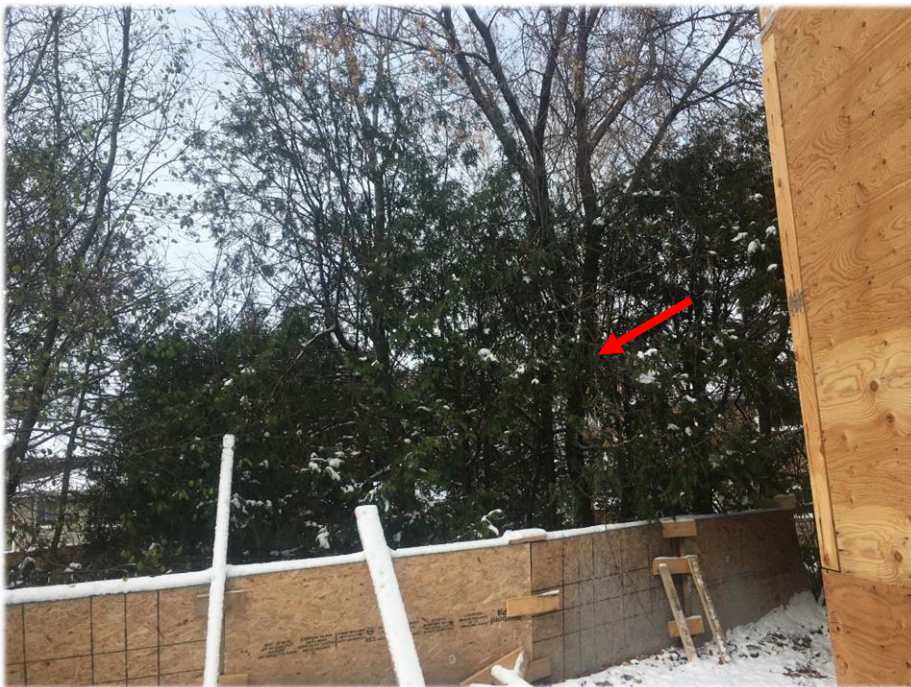
Figure 2: Location of a Manitoba maple not represented in the tree report form.

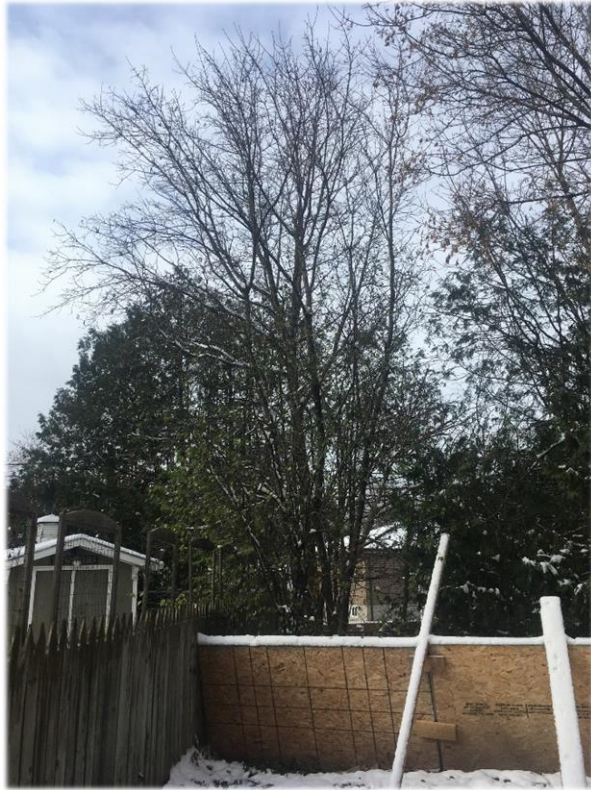
Figure 3: Location of a black walnut not represented in the tree report form.

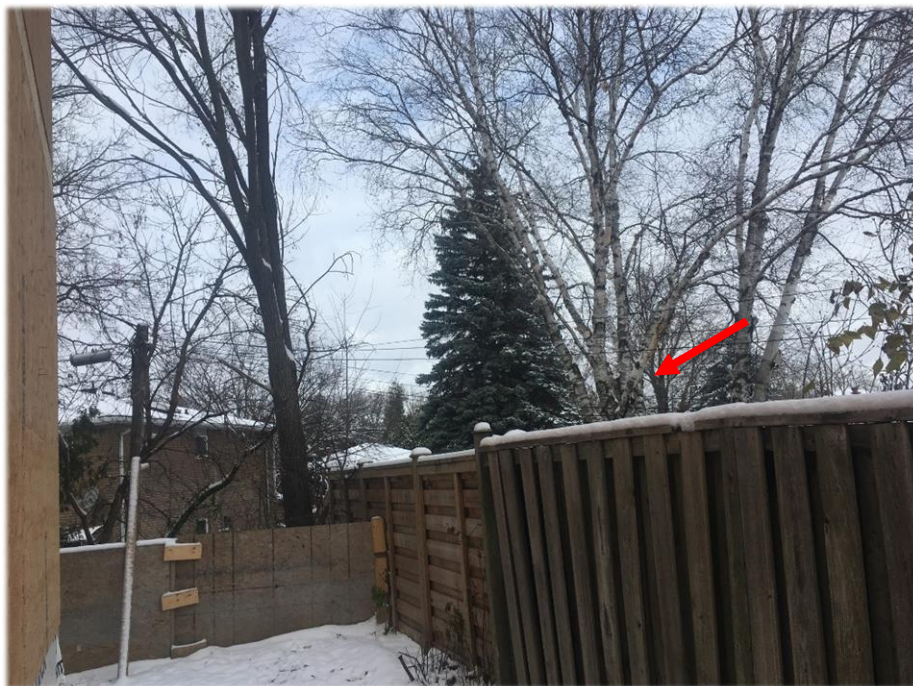
Figure 4: Location of a white birch not represented in the tree report form.

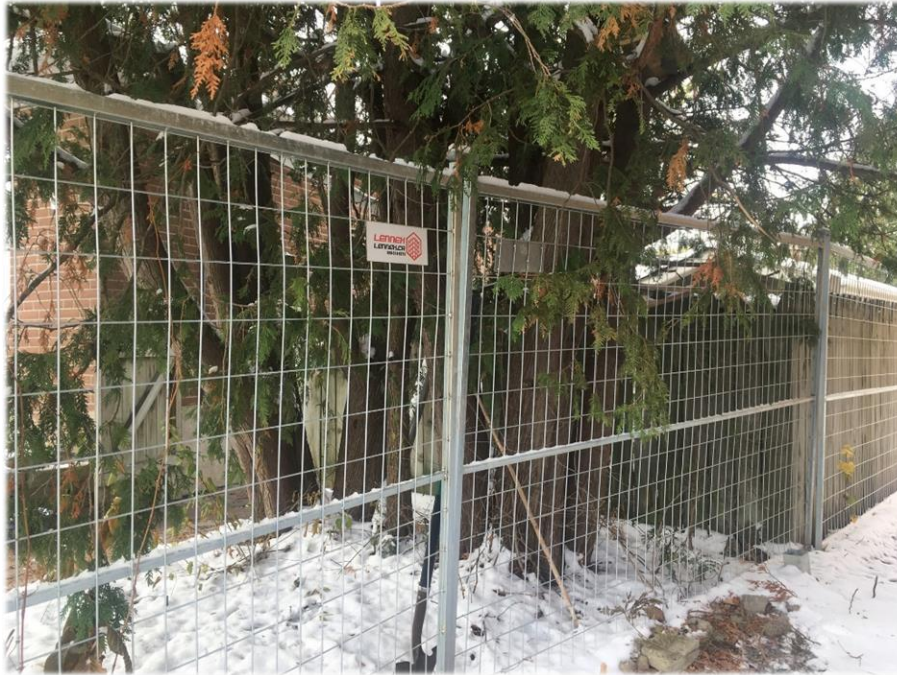
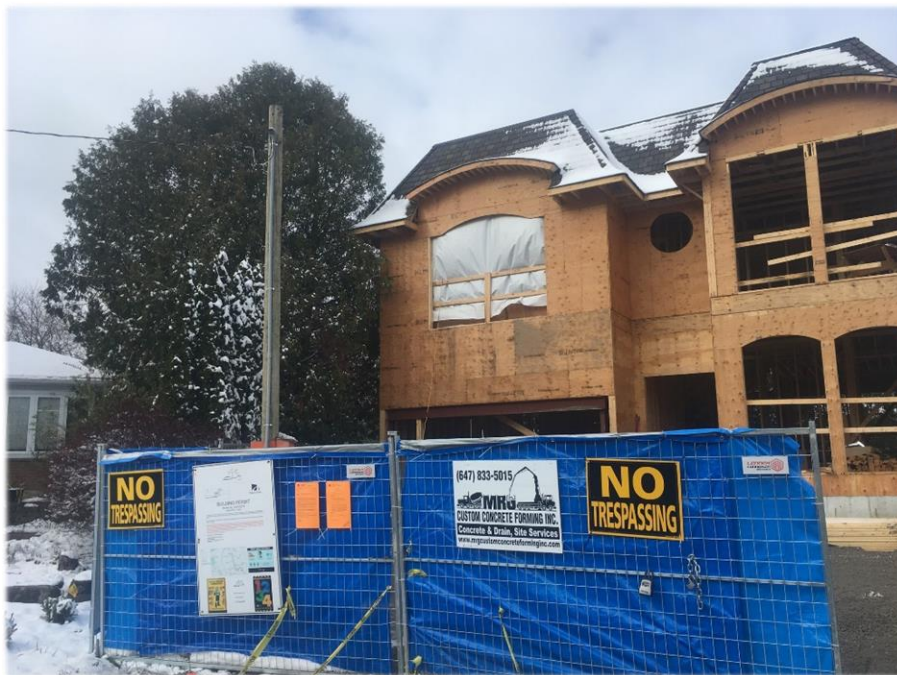
Figure 5a & 5b: Location of two eastern white cedars not represented in the tree report form.
