Urban Forest Innovations Inc. 1331 Northaven Drive Mississauga ON L5G 4E8

May 19, 2021

Re: 753 Srigley Street – Committee of Adjustment – Arborist Peer Review 2

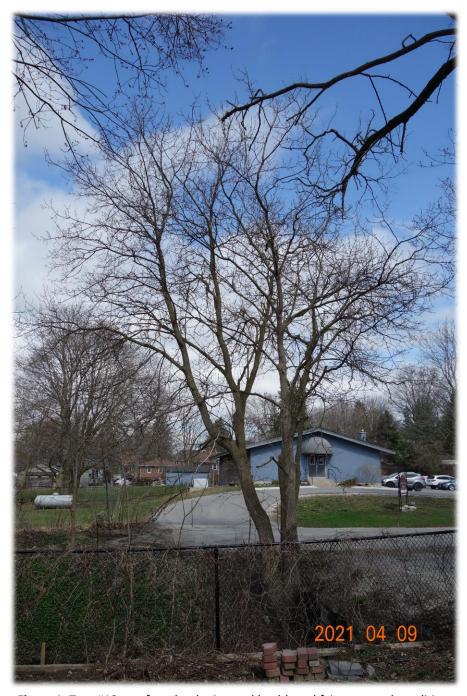
1. The current arborist report has listed tree #18 as being in fair health and poor structural condition (i.e., poor "Overall Condition"), whereas our site visit showed the tree to be in good health and fair structural condition (Fig. 1). The revised arborist report must update/upgrade the tree #18 condition factor used as input to the tree replacement calculations provided in section 'Tree Replacement Information' (page 7).

Figure 1: Tree #18 was found to be in good health and fair structural condition. Although assessed during the leaf-off season, the number and distribution of live buds indicate a vigorously healthy tree.

May 2021 Update: This has been addressed, no further comment.
