Urban Forest Innovations Inc.
1331 Northaven Drive
Mississauga ON L5G 4E8

Re: 753 Srigley Street – Committee of Adjustment – Arborist Peer Review

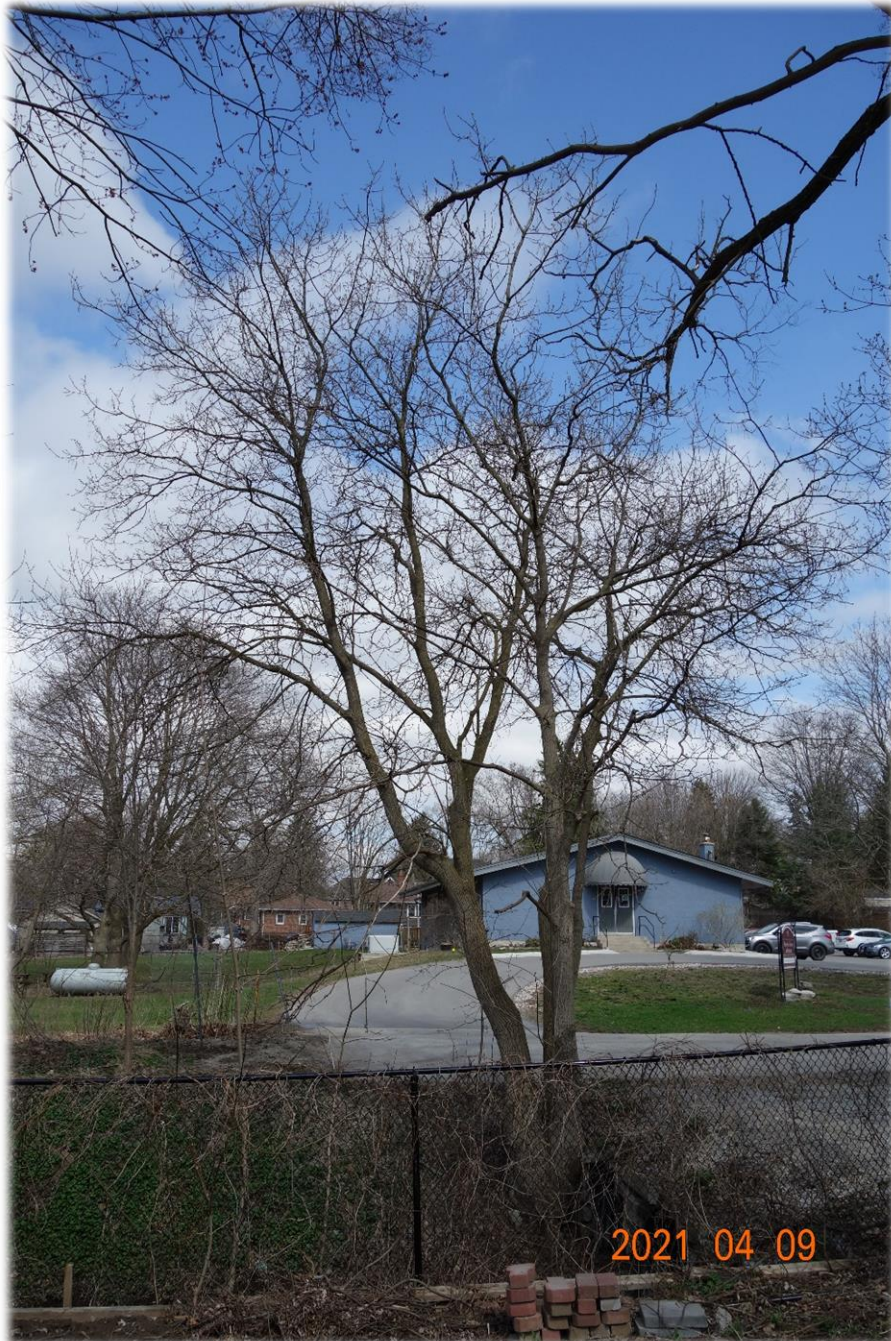
1. The current arborist report has listed tree #18 as being in fair health and poor structural condition (i.e., poor “Overall Condition”), whereas our site visit showed the tree to be in good health and fair structural condition (Fig. 1). The revised arborist report must update/upgrade the tree #18 condition factor used as input to the tree replacement calculations provided in section ‘Tree Replacement Information’ (page 7).

Figure 1: Tree #18 was found to be in good health and fair structural condition. Although assessed during the leaf-off season, the number and distribution of live buds indicate a vigorously healthy tree.
