Re: 301 Primrose Lane – Application for Minor Variance – Arborist Peer Review

As you have requested, Urban Forest Innovations, Inc. (UFI) has reviewed the arborist report and related application information submitted in support of an Application for Minor Variance - Relief from Zoning By-law 2010-40 for the construction of an 'Accessory Dwelling Unit' within the existing residential dwelling at 301 Primrose Lane, Newmarket, Ontario.

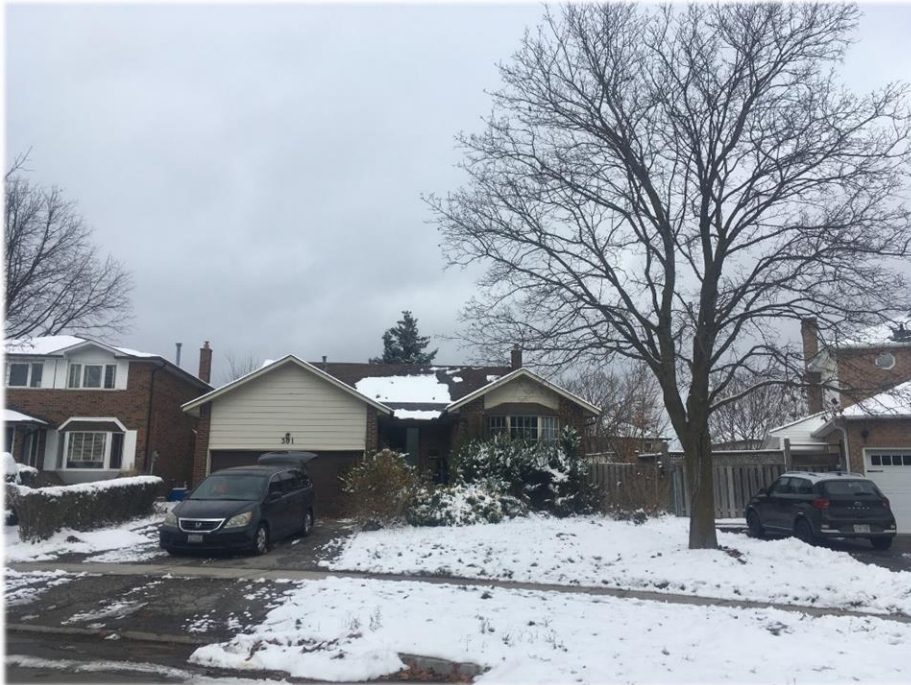
- a Norway maple (*Acer platanoides*), located on the subject property (Figure 1)
 - a Colorado blue spruce (*Picea pungens*), located on the subject property (Figure 2)

Figure 1: Location of Norway maple not represented in the tree report form.

- a Town-owned Norway maple (*Acer platanoides*), located within 4.5m of the subject land (Figure 3)
2. An arborist report must be provided to identify appropriate tree injury mitigation measures for trees designated for injury on or within 4.5 metres of the subject lands. Refer to the *Policy* for appropriate mitigation measures.

3. A tree protection plan must be provided to show the correct location of all significant trees located on or within 4.5 metres of the subject lands. The tree protection plan must depict the minimum tree protection zone for each significant tree located on or within 4.5 metres of the subject lands, and the location of tree protection fencing. The Town's standard detail for tree protection fencing must be included on the tree protection plan.

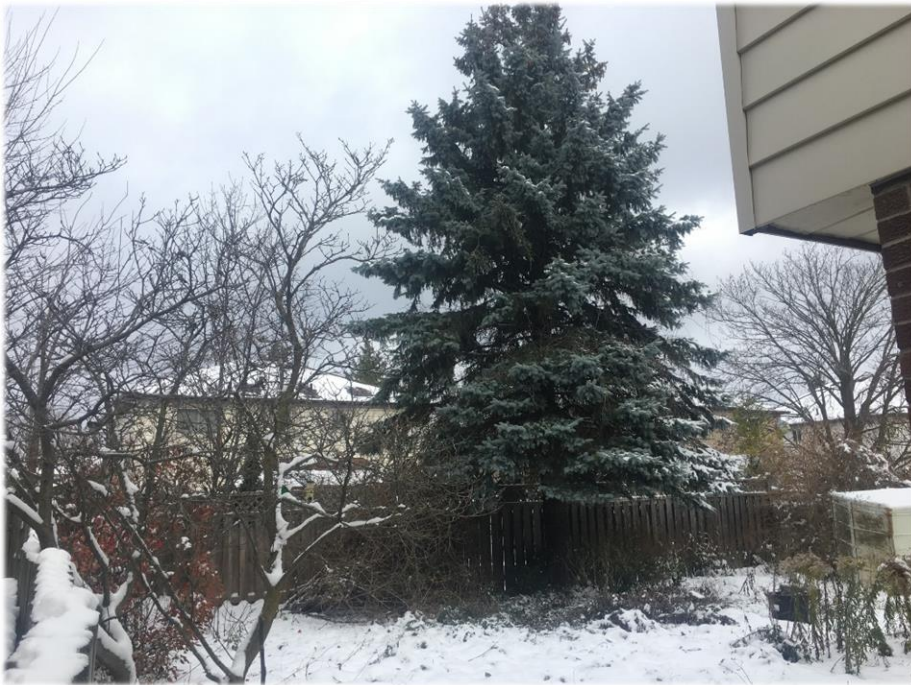
Figure 2: Location of a Colorado blue spruce not represented in the tree report form.

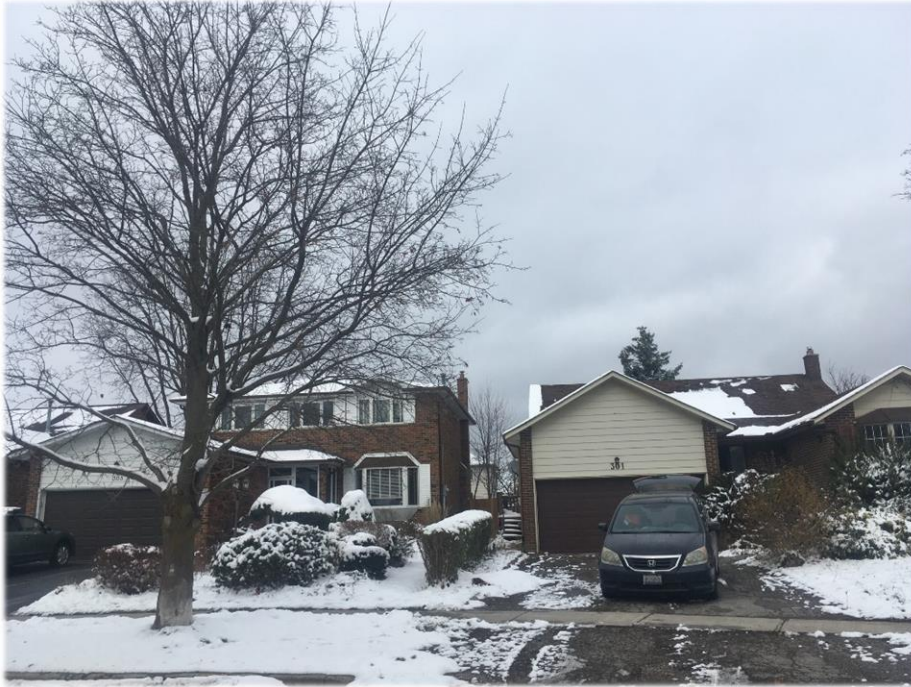
Figure 3: Location of a Town-owned Norway maple not represented in the tree report form.
