November 22, 2022

Re: 384 Dixon Blvd – Application for Minor Variance – Arborist Peer Review

Methodology

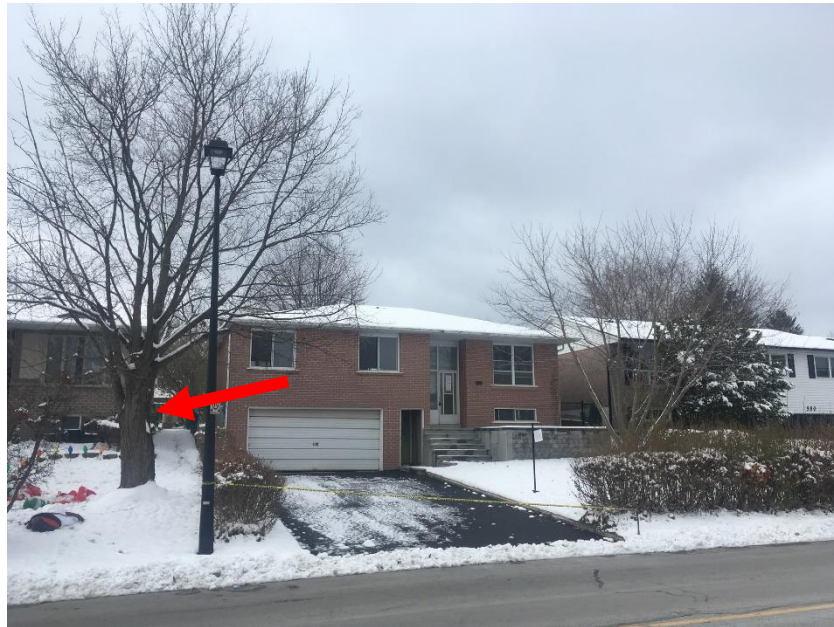
1. The tree report form indicated that there were no trees over 20cm DBH on the subject property or within 4.5m from the subject property line. However, one significant tree was noted during site observations and is not included in the tree report form: a sugar maple (*Acer saccharum*) located on an adjacent property within 4.5m of the subject land (figure below).

2. A tree protection plan must be provided to show the correct location of all significant trees located on or within 4.5 metres of the subject lands. The tree protection plan must depict the minimum tree protection zone for each significant tree located on or within 4.5 metres of the subject lands, and the location of tree protection fencing. The Town's standard detail for tree protection fencing must be included on the tree protection plan.
