Urban Forest Innovations Inc.
1331 Northaven Drive
Mississauga ON L5G 4E8

April 16, 2024

Re: 693 Sunnypoint Drive – Committee of Adjustment Application for Consent - Peer Review

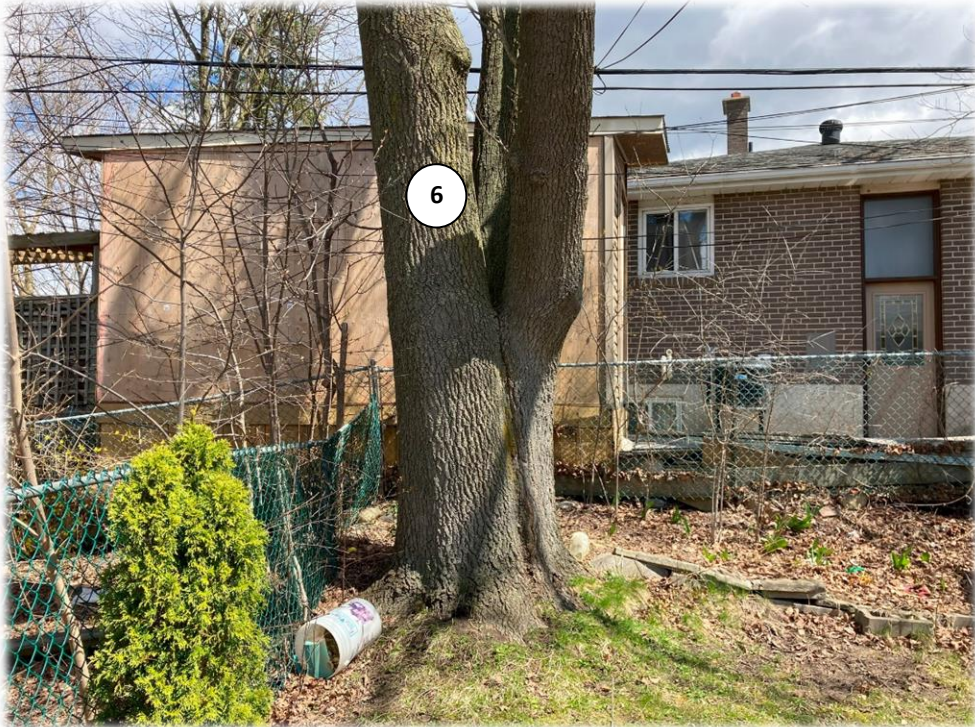
1. The root zone of by-law regulated tree #6 has been impacted by excavation to enable the installation of sonotubes for the new shed (Figure 1). Neither tree protection fencing nor root protection measures appear to have been undertaken during the shed construction (as documented on page 7-8 of the Arborist Report). The revised arborist report must identify appropriate tree injury amelioration measures to be undertaken post-construction and which will ensure the health and survival of tree #6. Refer to the *Policy* for appropriate measures.

Figure 1: The new shed is located within the critical root zone of regulated tree #6.

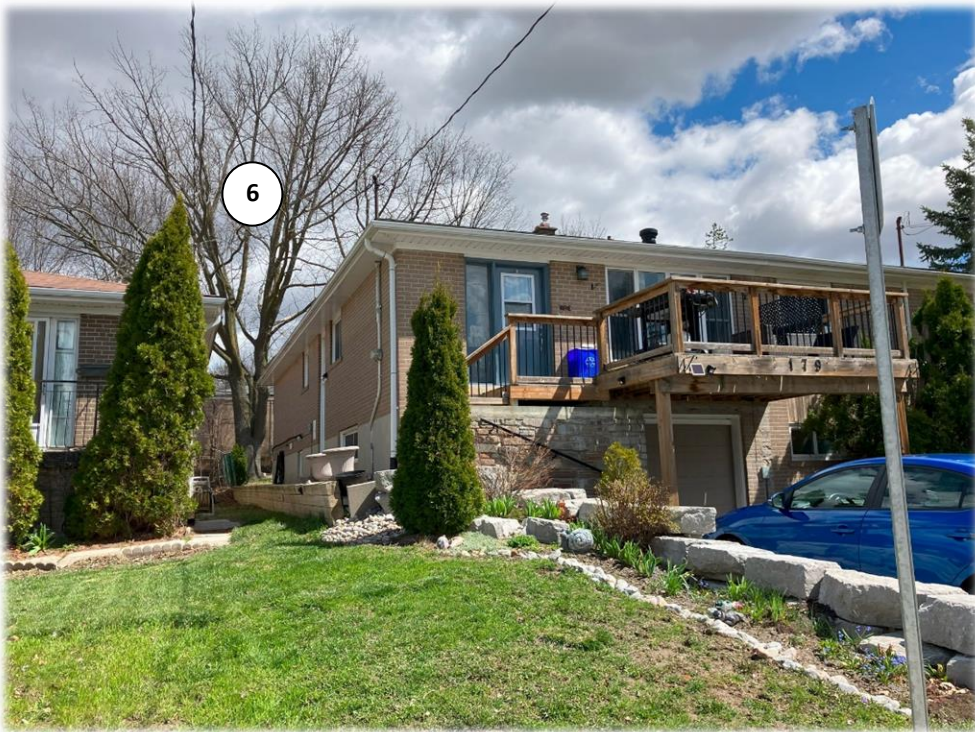
5. The tree plan shows that tree #6 is located at the backyard of 181 Patterson Street, whereas site observation shows that it is located at the backyard (northeast) of 179 Patterson St (Figure 2). The revised tree protection plan must show the correct location of all significant trees located on or within 4.5 metres of the subject lands.
6. The revised tree protection plan must depict the minimum tree protection zone for each significant tree located on or within 4.5 metres of the subject lands.
7. The revised tree protection plan must depict the location of tree protection fencing.

Figure 2: Regulated tree #6 is located at the backyard of 179 Patterson St.
