Urban Forest Innovations Inc.
1331 Northaven Drive
Mississauga ON L5G 4E8

Re: 165 Carlson Drive – Consent Application and Minor Variance Application (CON-2024-004, MV-2024-020, MV-2024-021) - Arborist Peer Review

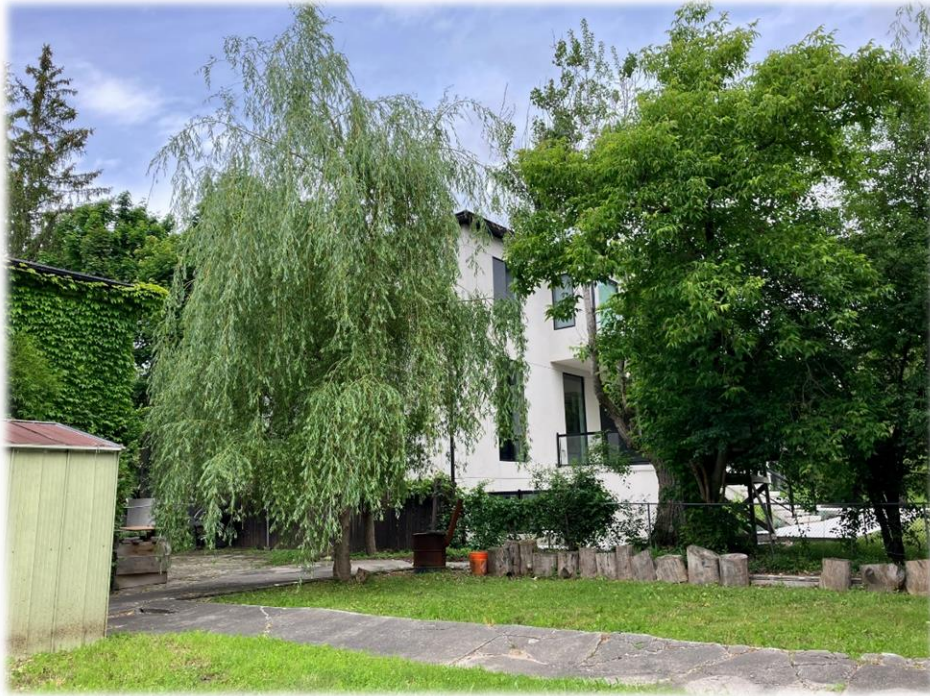
- a multi-stemmed (15,13 cm diameters) white willow (*Salix alba*), located southwest of tree #10 (Figure 1)
 - a 60cm diameter (DBH estimated) poplar (*Populus* sp.), located north of tree #B1 (Figures 2a & 2b)

Figure 1: Location of white willow (*Salix alba*).

2. The revised tree protection plan must show the correct location of all significant trees located on or within 4.5 metres of the subject lands. The following significant trees found during site observations are not included in the arborist report and inventory:

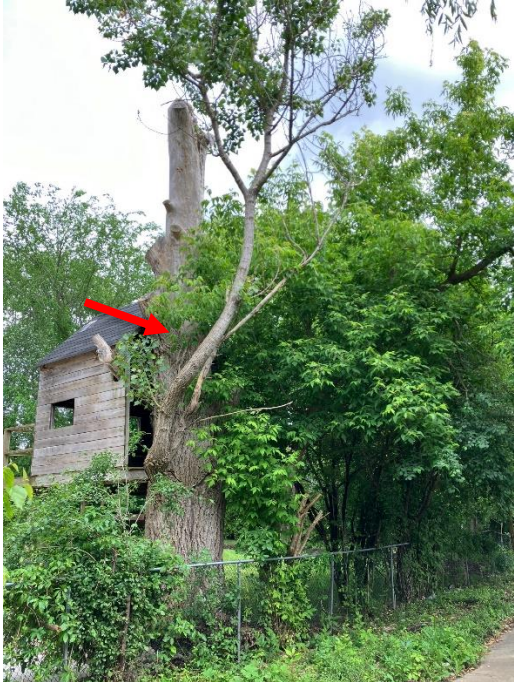
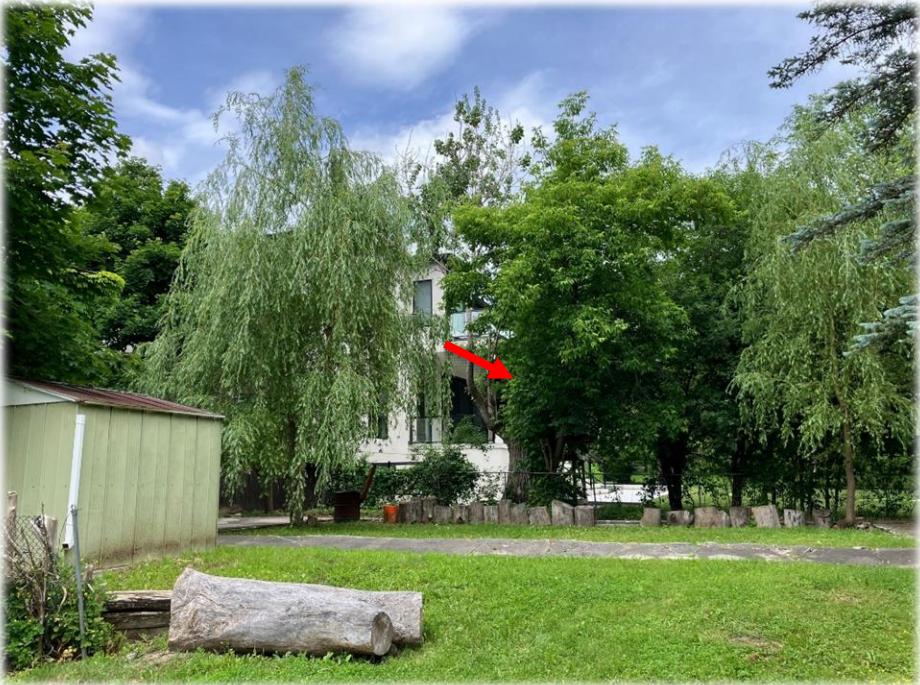
Figures 2a & 2b: Location of poplar (*Populus* sp.).
