## 1075 Gorham St. Newmarket On.

## PROJECT 1: DETAILS OF A 19TH CENTURY BUILDING

# DREW RESIDENCE

## Reasons for Designation

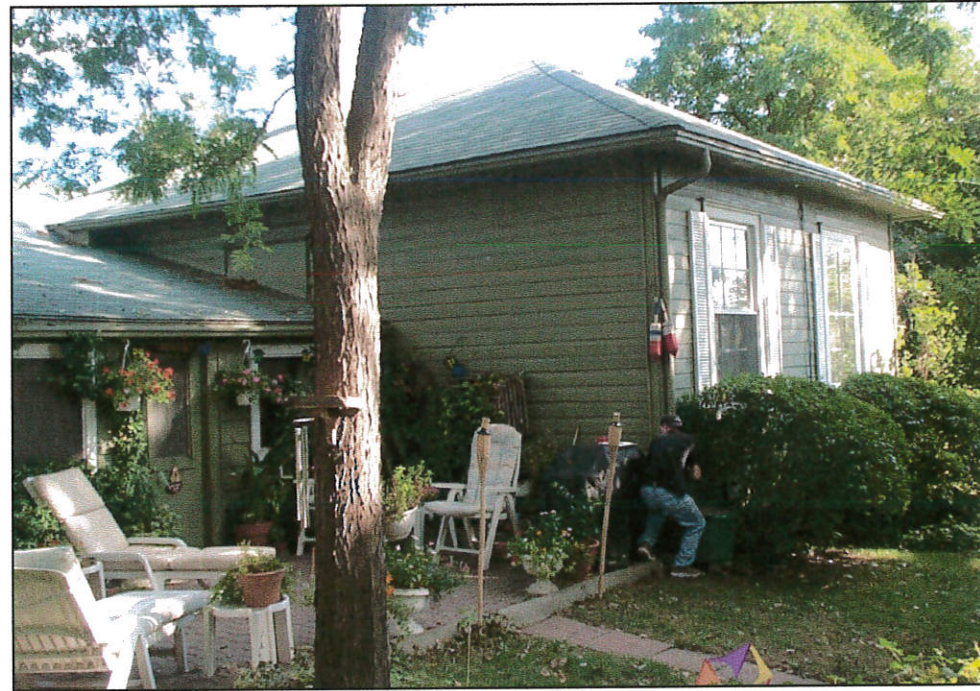
THIS HOUSE IS LOCATED IN NEW MARKET AT 1075 GORHAM STREET. IT IS ASSUME THE ORIGINAL OWNER, A CARPENTER, BUILT THE HOUSE FOR HIS FAMILY.

ALTHOUGH THE HOUSE HAS BEEN BUTCHERED BY RENOVATIONS AND ALTERATION THE ARCHITECTURAL STYLE OF THIS BUILDING SEEMS TO BE A CROSS BETWEEN NEO-CLASSICAL AND REGENCY.

THE SYMMETRICAL SQUARE SHAPED BUILDING AND HIP ROOF PUTS THIS BUILDING IN THE REGENCY STYLE. IT IS MISSING THE VERANDA THAT IS A TRADEMARK OF THE REGENCY STYLE. HOWEVER DURING A RENOVATION THE FRONT ENTRY WAS REMOVED AND FILLED IN WITH A 1950's BAY WINDOW. THE NEW ENTRY IS ON THE SIDE OF THE HOUSE. IT IS POSSIBLE THE VERANDA WAS REMOVE AT THIS TIME AS WELL.

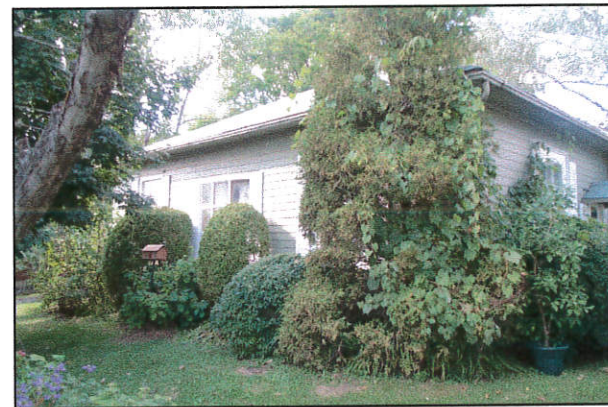
THE FRONT ENTRY IS THE FIRST PLACE WHERE YOU CAN FIND DETAILS TO PLACE A BUILDING IN A PARTICULAR STYLE. SINCE THE FRONT ENTRY HAS BEEN REMOVED IT MAKES THIS HOUSE HARD TO PLACE.

THE HOUSE CAN BE PLACED IN BOTH NEO-CLASSICAL AND REGENCY BECAUSE OF THE TYPICAL DETAILS USED IN BOTH STYLES FOUND ON THE BUILDING. THE CHARACTERISTIC STYLES OF REGENCY FOUND ON THIS HOUSE IS FOUND IN THE SYMMETRICAL SQUARE SHAPED FLOOR PLAN (see pic. 4) AND HIP ROOF. TYPICALLY REGENCY STYLE BUILDINGS HAVE A VERANDAH. IT IS POSSIBLE THAT DURING A RENOVATION AND/OR ADDITION OF THE HOUSE THAT THE VERANDAH WAS REMOVED.

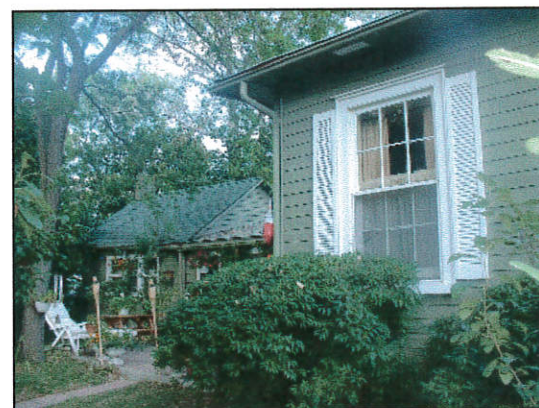
### DETAIL A DOOR MOULDING

THE NEO-CLASSICAL STYLE COMES FROM THE OLD ENTRANCEWAY AND ANTIQUE DETAILED MOULDINGS AROUND DOORS AND WINDOWS ON THE INTERIOR (DETAIL A). THE OLD ENTRANCEWAY APPEARS TO HAVE A BROAD FLAT-HEADED TRANSOM OVER THE DOOR.

WHAT PLACES THE BUILDING IN NEO-CLASSICAL IS THE ANTIQUE DETAILED MOULDINGS FOUND AROUND THE DOORS AND WINDOWS IN THE INTERIOR. IT IS FOR THIS REASON THAT I CHOSE TO DO DETAILS OF THE MOULDINGS. THE OLD ENTRY ALSO APPEARS TO HAVE A BROAD FLAT-HEADED TRANSOM OVER THE DOOR. EVEN THE EXPRESSIVE PRESENTATION OF THE STRUCTURE, SEEN AT THE EDGES OF THE BUILDING BY THE DETAILED COLUMNS(see pic. 3), EXPRESS THE IDEA OF NEO-CLASSICAL STYLE THAT THE BUILDING SHOULD CONSIST SOLELY OF THE ELEMENTS THAT SUPPORT THE BUILDING.

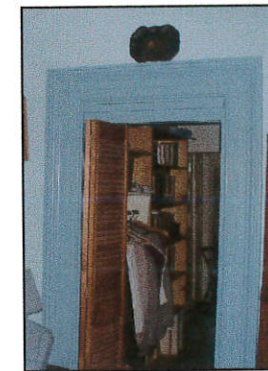
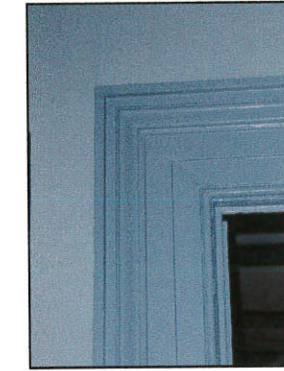
### DETAIL B EXTERIOR BUILDING CORNER DETAIL

ANOTHER ASPECT OF NEO-CLASSICAL IS THE EXPRESSION OF STRUCTURE. CLASSIC ARCHITECTURE DETERMINED THAT A BUILDING SHOULD CONSIST SOLELY OF THE ELEMENTS THAT SUPPORT THE BUILDING. AS SEEN IN THIS BUILDING THE COLUMNS AT THE EDGES OF THE BUILDING ARE DETAILED TO EXPRESS THIS CLASSIC IDEA (DETAIL B).

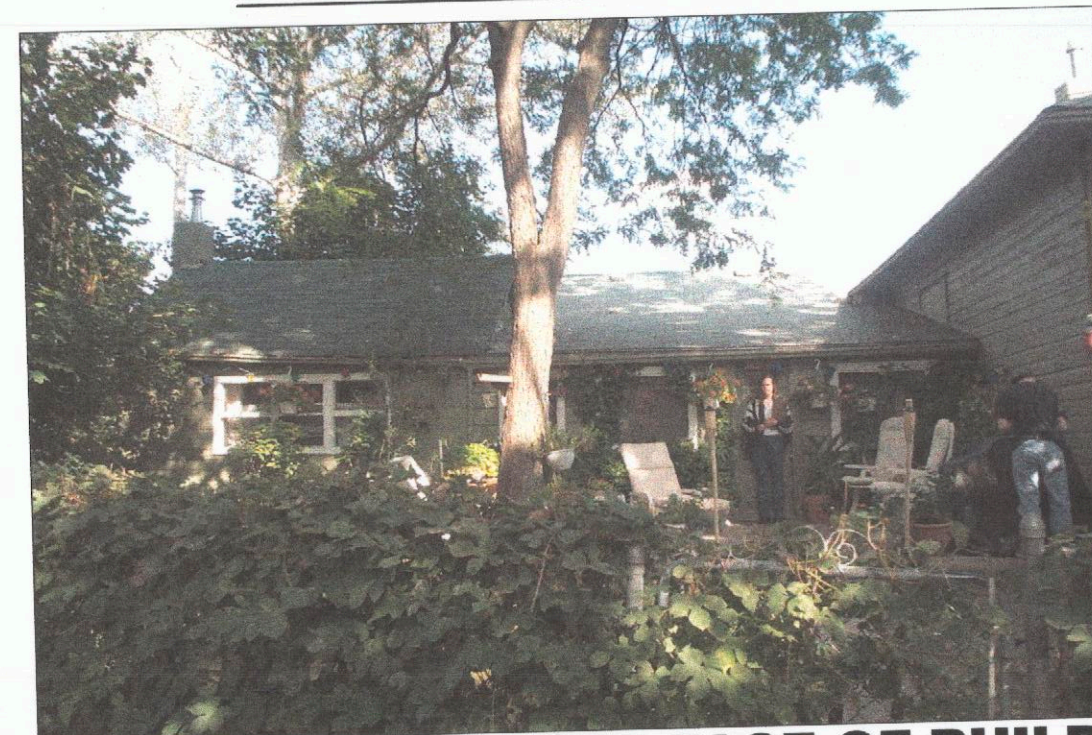
**MAIN ENTRANCE, WEST FACE OF BUILDING**

THIS NEO-CLASSICAL/REGENCY HOUSE IS LOCATED AT 1075 GORHAM ST. IN NEWMARKET ONTARIO AND IS OWNED BY TONY DREW. AS A RESULT OF THE UNKNOWN CONSTRUCTION DATE OF THE BUILDING, IT MAKES IDENTIFYING THE ARCHITECT OF THE HOUSE IMPOSSIBLE. WHAT IS SUSPECTED IS THE ORIGINAL OWNER OF THE BUILDING WAS A CARPENTER AND BUILT THE HOUSE USING THE REGENCY STYLE. THE BUILDING HAS GONE THROUGH MANY RENOVATIONS, AND AS A RESULT HAS ALTERED THE ORIGINAL FLOOR PLAN TO WHAT THEY ARE TODAY. FOR EXAMPLE DURING A RENOVATION THE FRONT ENTRY WAS REMOVED AND FILLED IN WITH A WINDOW (see pic.2). CAUSING THE WEST SIDE OF THE HOUSE TO BECOME THE NEW ENTRY(see pic.1).

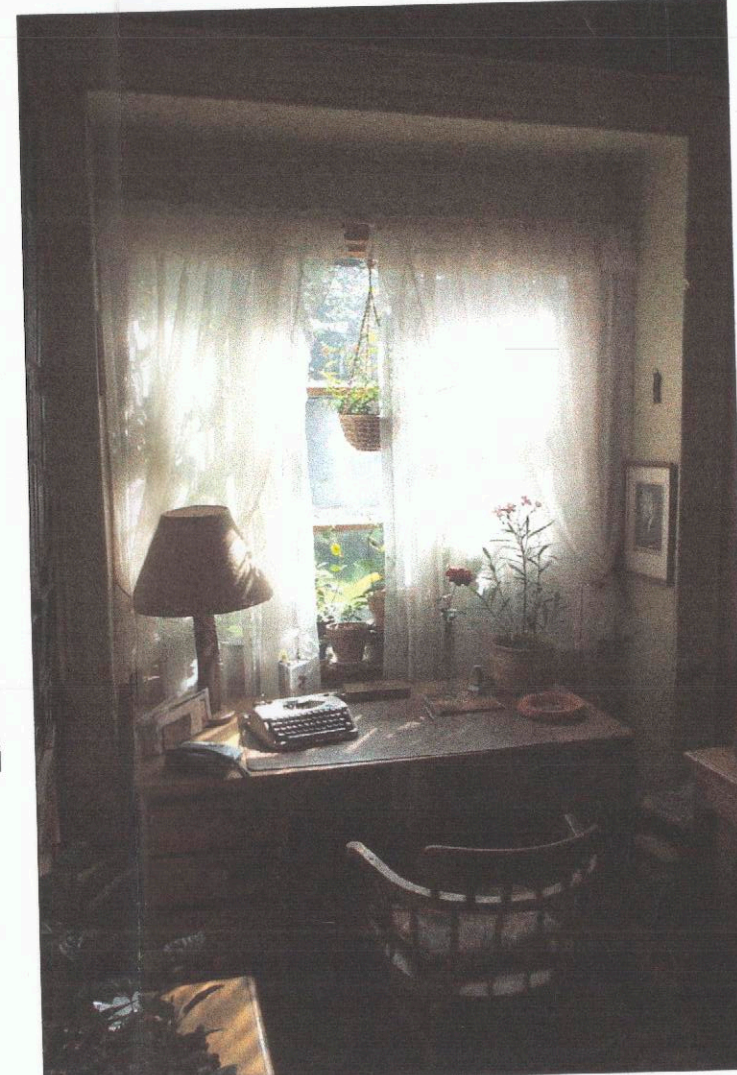
**OLD ENTRANCE**

Roof Shape:	Hipped roof
Roof Trim:	Wood trim, no decoration or detailing
Roofing Type:	New plywood and asphalt shingles (renovation)
Typical Window:	
Main Entrance:	Since remove. However, previously centrally located with evidence of a broad-flat headed transom remain. This is indicative of the Regency Style.

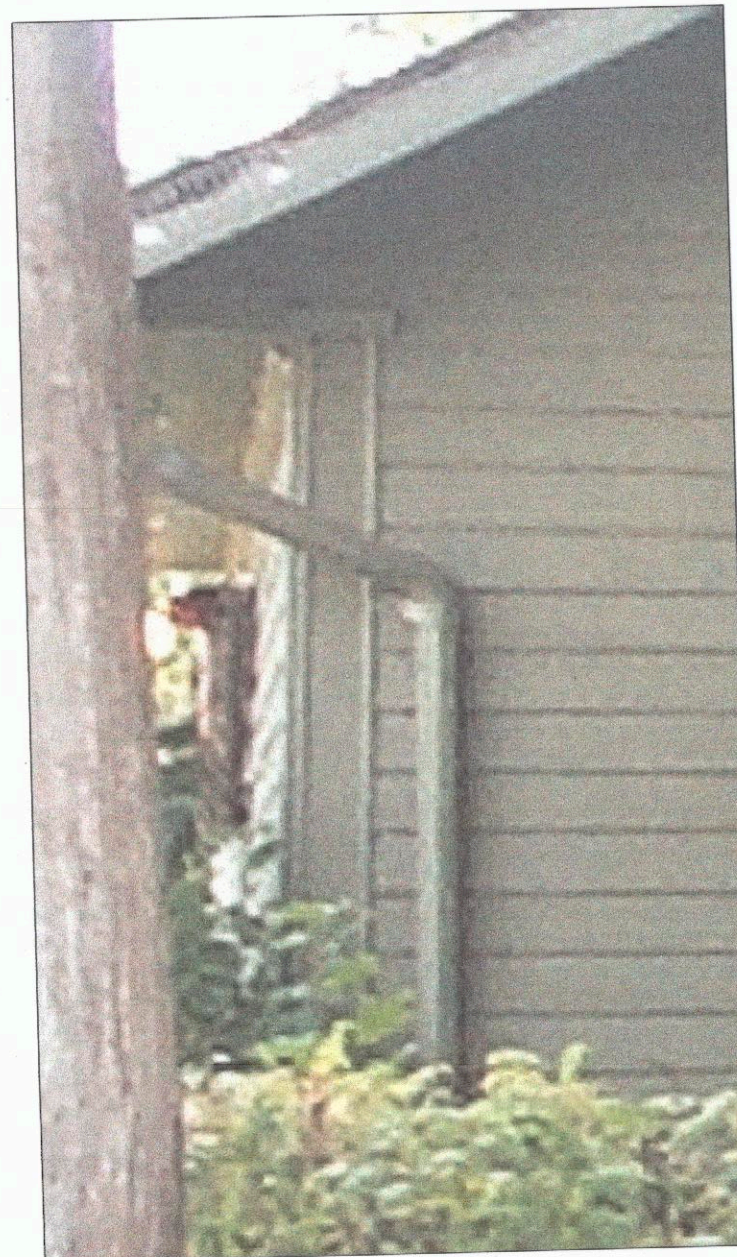
**CORNER COLUMN**

This residence has many great architectural features in both Neo-Classical and Regency. It has decorative false column in the corners of the existing exterior (Neo-Classical). Wooden cladding and large six/six hung windows with exaggerated head and sill profile (Regency). A recently removed board flat-headed transom entryway and a low hip roof with no attic space.

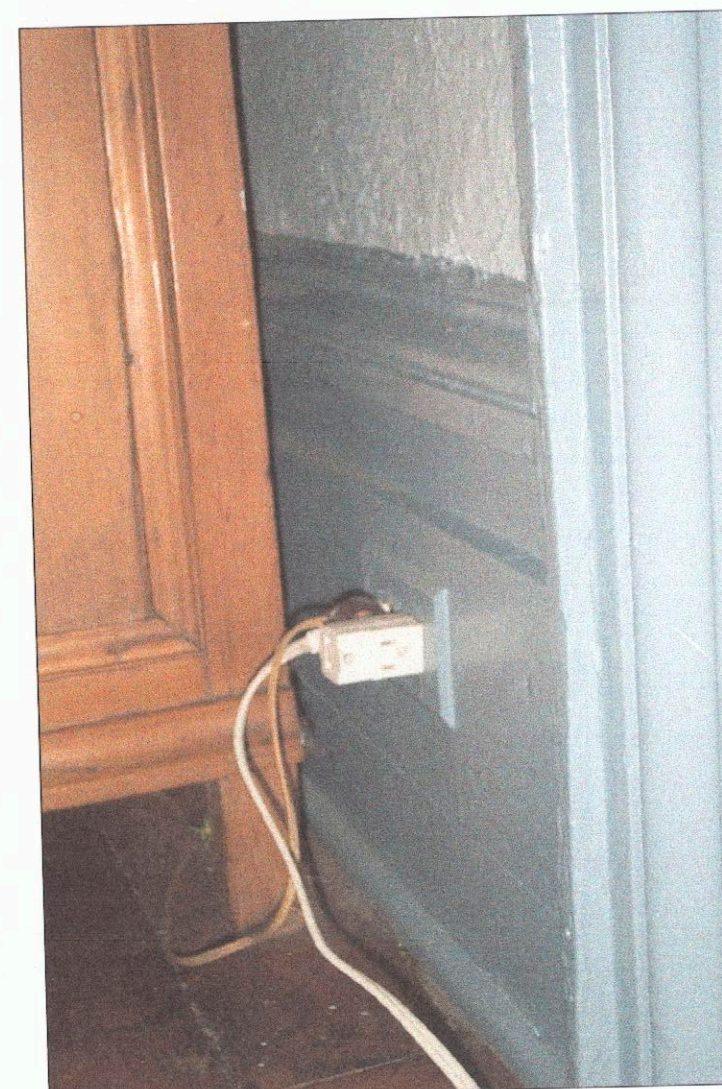
**BASEBOARD**  
NOT SCALED

The Neo-Classical and Regency style of this building is identified throughout this residence. The entranceway (recently removed) included a flat broad-headed transom. The finely detailed baseboard trim and window and door mouldings are straight from the Neo-Classical style. The quality of this woodwork is performed by Canadian craftsmen and should be kept intact.
