## Town of Newmarket

### Trail Inspection

August 14 2020

# INSPECTION OF TRAIL SYSTEM

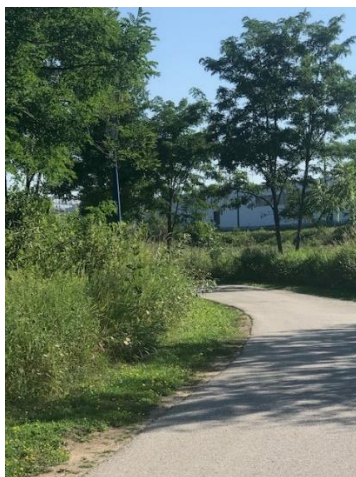
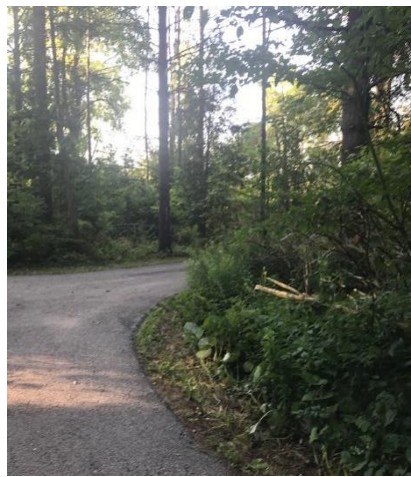
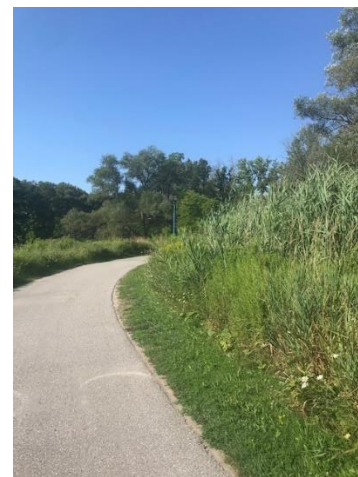
Throughout the trail system sight lines were blocked by trees, overgrown shrubs and high grasses. It was discussed that if some of the trees and shrubs could be cleared, and the areas where the grass was cut widened, this would greatly increase pedestrians and cyclists ability to see each other as they were coming around corners and travelling up and down hills. For reference purposes please see the pictures on the following page.

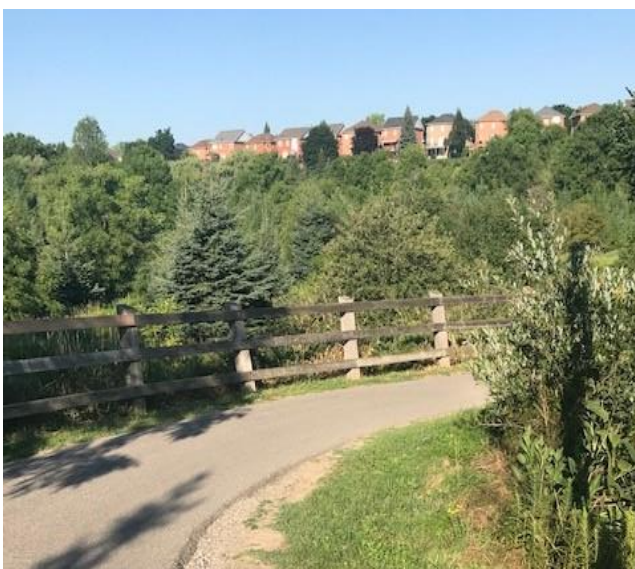
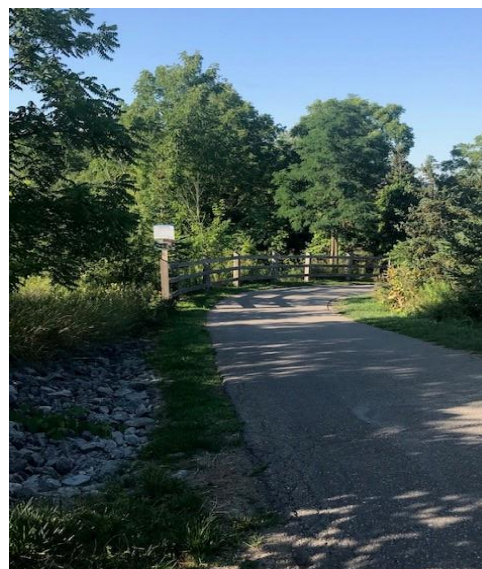
**Trail System @ South End, Looking towards Aurora:**

In particular there were two sections of the trail where the site lines were blocked by foliage as cyclists and pedestrians were coming around a steep hill. Please see the pictures directly below, and on the following page.

Since the date of the inspection Town staff have been proactively clearing foliage as recommended in this report.

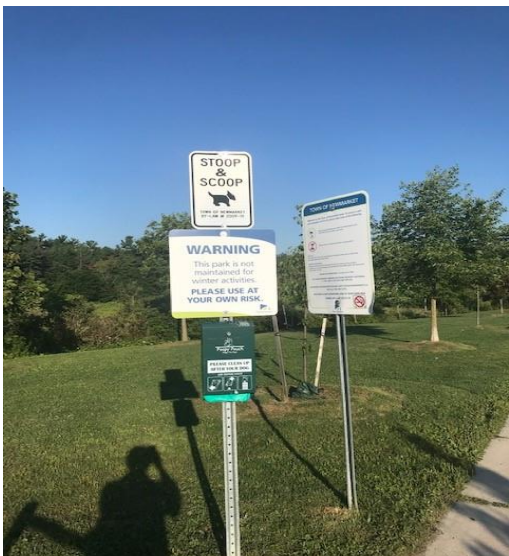
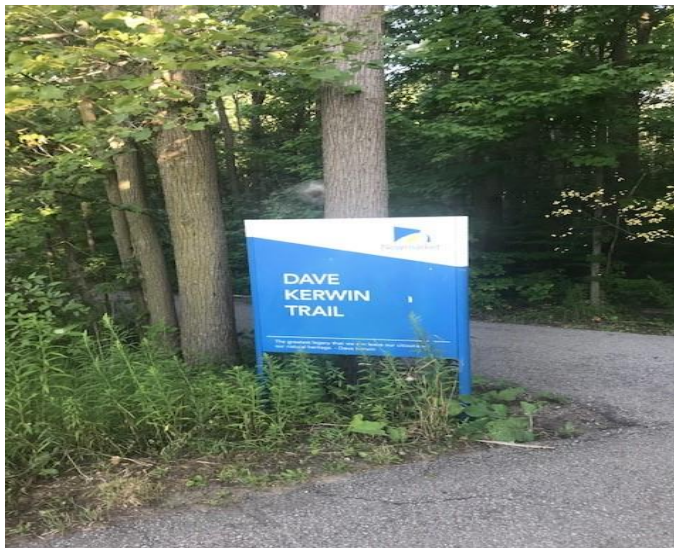
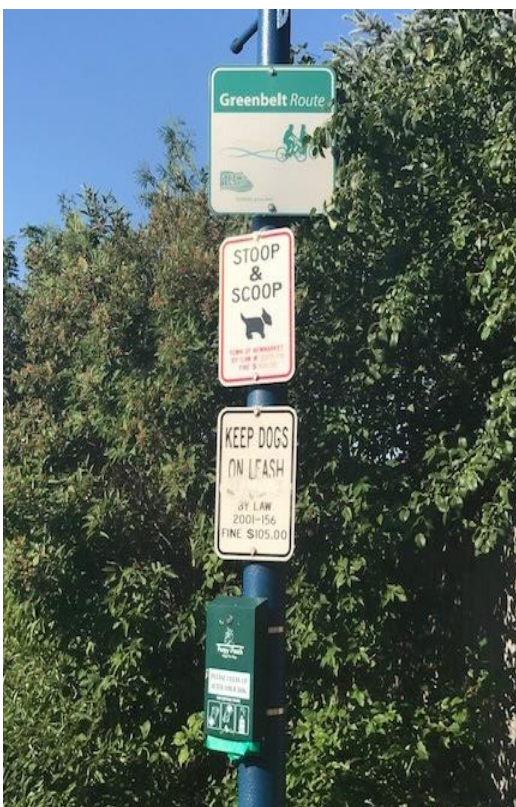
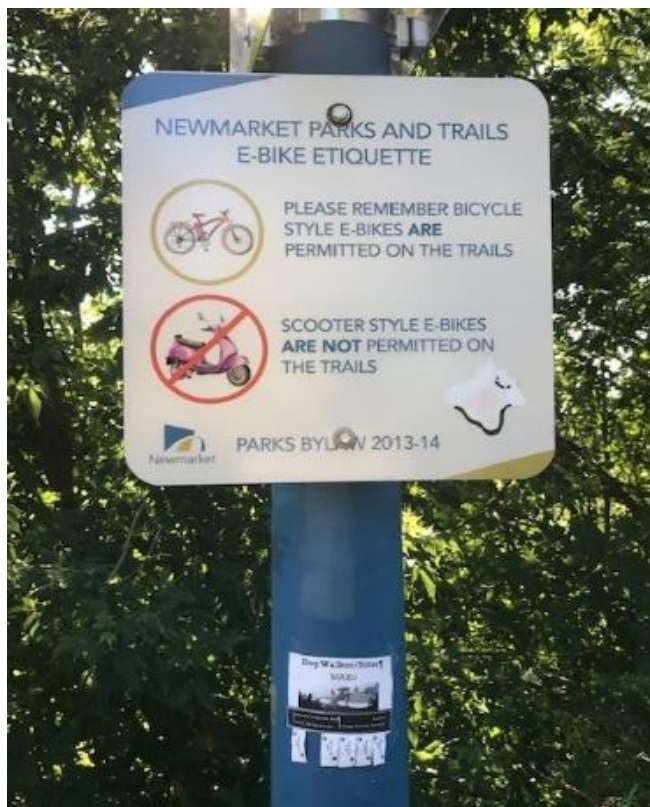
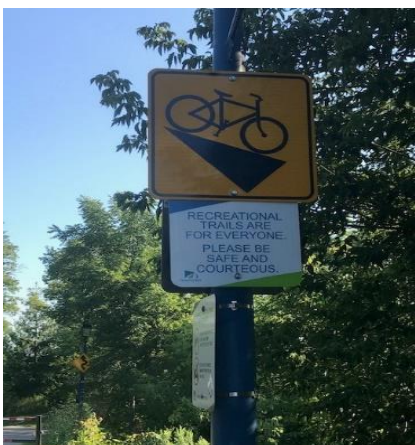
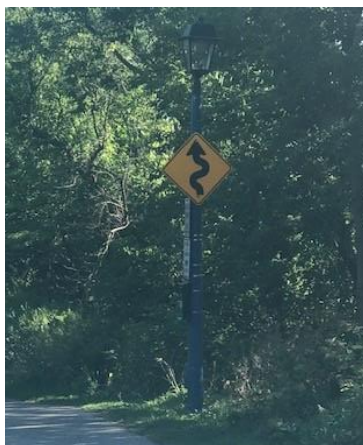
With respect to the signage currently on the Town’s trail system, it appeared to be inconsistent. In some sections of the trail it appeared to be the original signage, was faded, difficult to read.

Examples of signs being used to warn users a steep hill and winding section of the trail is ahead.

Therefore our recommendation would be that the Town complete an inventory of their current signage taking into consideration the following points:

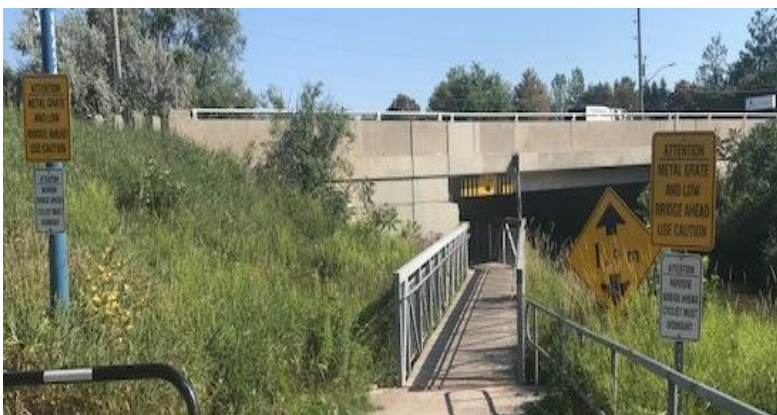
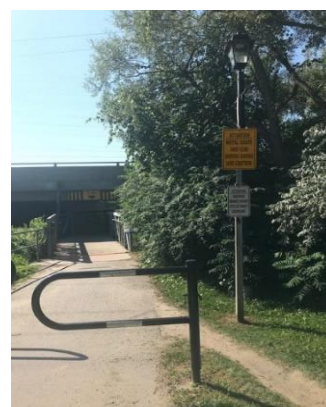
## MULOCK UNDERPASS

The pictures above show what pedestrians and cyclists see on each side when on the trail before going under the bridge. The first picture shows a single sign with an arrow on the top and bottom with verbiage indicating the height in the middle. The second picture does not have the same sign. What is consistent is the sign attached to the bridge showing the height.

In addition in the first picture the single sign depicting the height has foliage that could potentially be blocking the messaging.

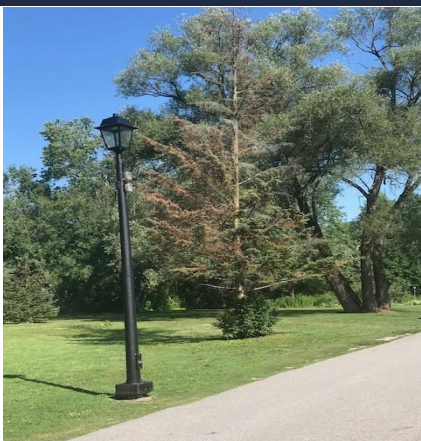
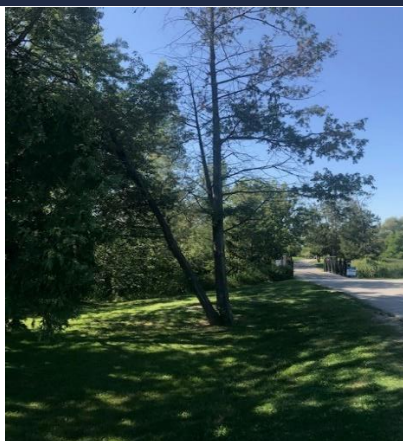
There were several trees that did not look very healthy with lots of dead branches on the day of the visit. In some cases the entire tree looked like it was dead. It is my understanding that the trees that were identified on the day of the visit have been removed.

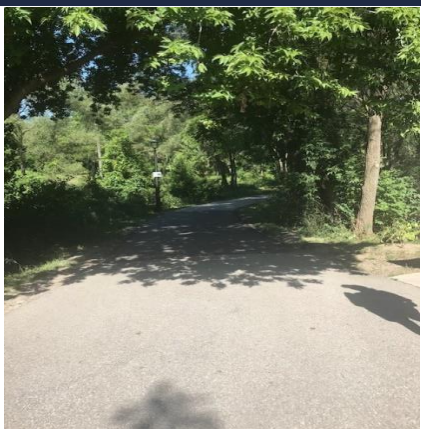
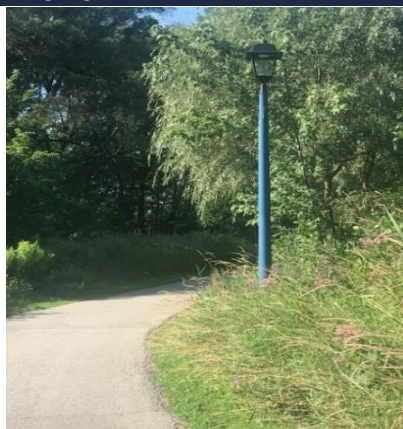
Low hanging foliage can reduce sight lines and cause injury when cyclists are moving through the trail system. The same could apply to pedestrians. Where necessary the foliage should be trimmed back.

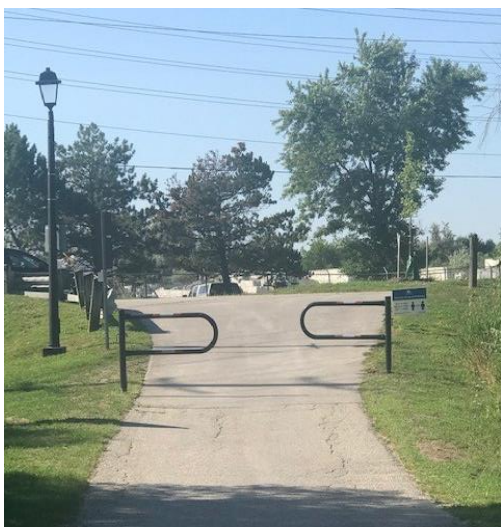
### SECTION OF TRAIL ENDING AT MULLOCK DRIVE

Using bollards to warn users that a section of the trail is ending directly onto a sidewalk or roadway, was not consistent throughout the trail system. This could place the Town in a difficult position if there was a loss and it was cited that the cyclist was expecting to see a bollard or a stop sign. Our recommendation would be speak with the Town's preferred legal counsel and ask if it would be in the Town's best interest to install bollards at all the sections of the trail where this would apply.

The same recommendation applies to signage.

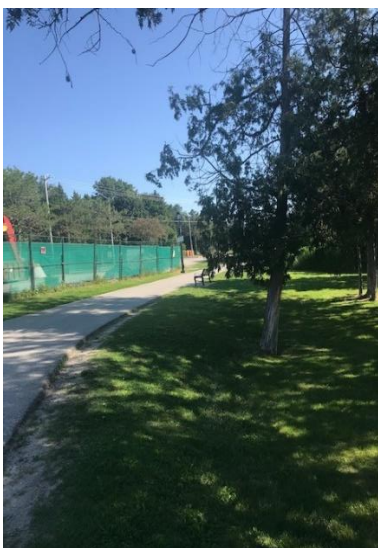
#### WESLEY BROOKS

In the first right there was a bit of a drop between the trail and park land. When staff are following their policies on inspecting and maintaining the trail, consideration should be given to filling in the gaps with dirt or gravel.

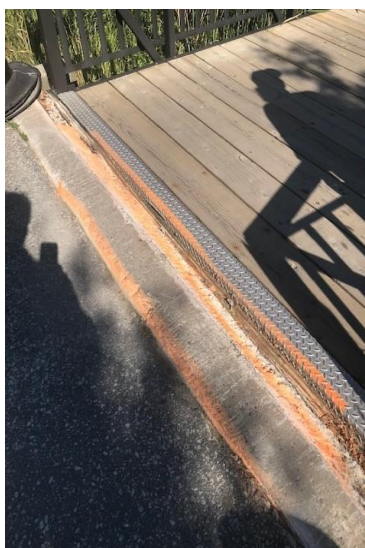
In the second picture, there were several sections on the trail where trip ledges painted in orange. This posed a potential hazard for cyclists. Claims & Risk Analyst to see when repairs were potentially scheduled.

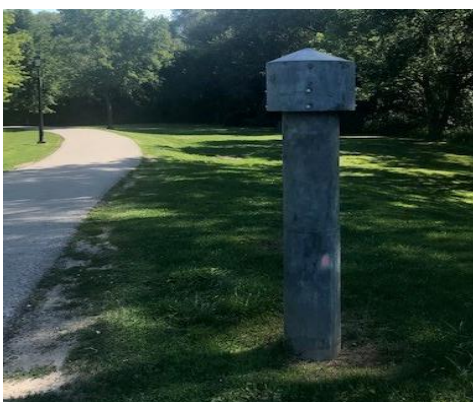
#### WESLEY BROOKS

On a clear day this object could be seen however at dusk or at night that may not be the case. It was recommended that consideration be given to painting the object with reflective paint and potentially planting around the bottom so that it could be better identified by cyclists.

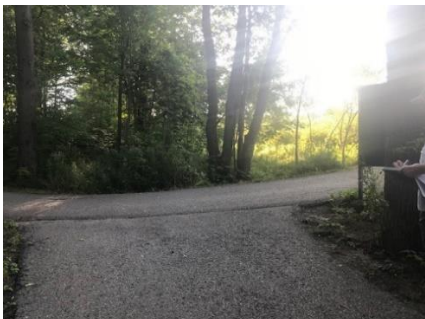
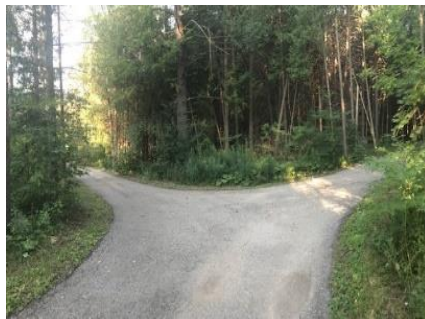
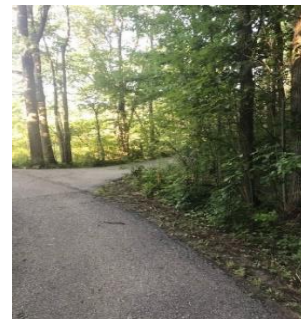
### DAVE KERWIN TRAIL

There were several areas throughout the trail systems where one trail would intersect with another. In many cases users of the trails had good sight lines, could see from a far distance. Therefore based on how good the sight lines are and how busy that section of the trail is, consideration could be given to installing stop signs or yielding signs where the least busy trail ends. To have a better understanding of what is the standard practice is, our recommendation would be speak with the Town's preferred legal counsel.

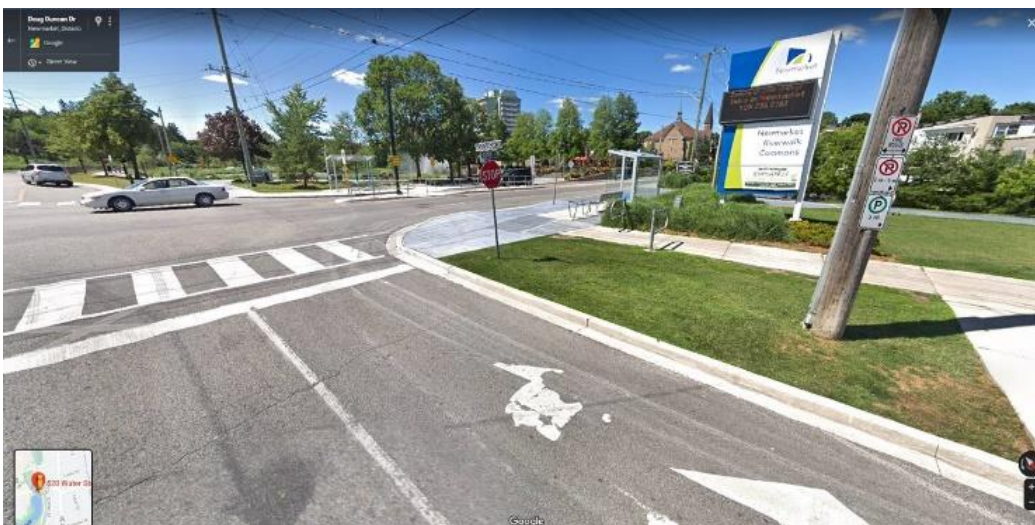
### WATER STREET + DOUG DUNCAN DRIVE

Overall while some improvements have been made to this intersection, but it is still a busy spot with lots of people and traffic coming and going. This is not about to change, especially during spring, summer and fall. Therefore we would suggest that consideration be given to building a full cross walk across that section of the road. It is our recommendation that this will be discussed with the Town's preferred legal counsel and with staff who would be responsible for erecting a crosswalk. My thought is staff would need to work with the MTO.
