**Re: Our Project File No. 2020-4262C
 900 Mulock Dr., Newmarket, ON
 Cursory Visual Review of the Barn**

Building No. 1

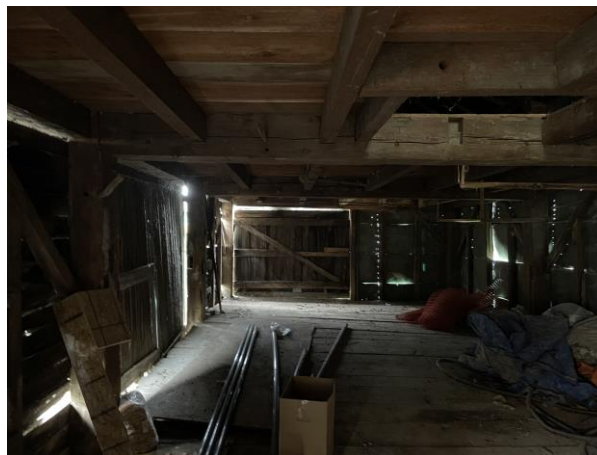
Photo #1

1. The existing building consists of a 2-storey building (approximately 47' long and 18'wide) timber framing on a raised concrete piers.
2. The building is accessible at the ground level.
3. The ground floor is in poor condition and unlevelled. (Photo # 1)
4. Some collar ties were missing from the roof framing. (Photo #2)
5. The wood posts are temporary braced at the top. (Photo #3)
6. The foundations are shifted and sinking. (Photos 4&5)

1. Given the conditions of the building observed from the lower level and outside, it is likely that the foundation is in poor condition and is unstable. This building is currently unsafe and should be demolished. A demolition procedure should be submitted for review, and a demolition permit should be obtained.
