**Re:    Our Project File No. 2020-4262C  
       900 Mulock Dr., Newmarket, ON  
       Cursory Visual Review of the Barn**

As per your request the writer visited the site mentioned above on Friday, October 14, 2022. The purpose of the site visit was to provide a cursory visual examination of the existing Barn.

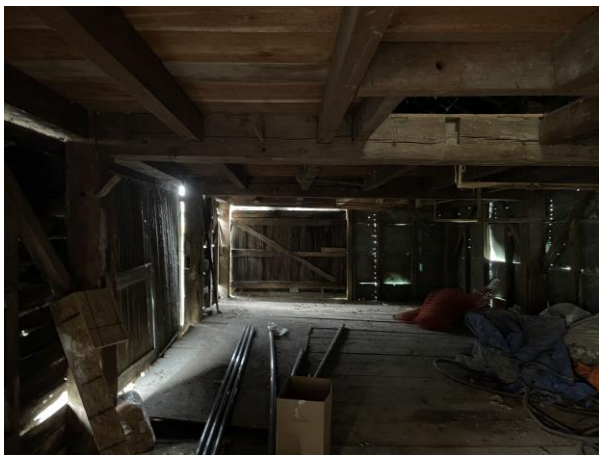
Photo #1

1. The existing building consists of a 2-storey building (approximately 47' long and 18'wide) timber framing on a raised concrete piers.
2. The building is accessible at the ground level.
3. The ground floor is in poor condition and unlevelled. (Photo # 1)
4. Some collar ties were missing from the roof framing. (Photo #2)
5. The wood posts are temporary braced at the top. (Photo #3)
6. The foundations are shifted and sinking. (Photos 4&5)

1. Given the conditions of the building observed from the lower level and outside, it is likely that the foundation is in poor condition and is unstable. This building is currently unsafe and should be demolished. A demolition procedure should be submitted for review, and a demolition permit should be obtained.
