Town of Newmarket Agenda

Heritage Newmarket Advisory Committee

- 6.1. 425/431 Davis Drive (Union Hotel) - Fenestration Assessment

Condition and Recommendations for 425-a

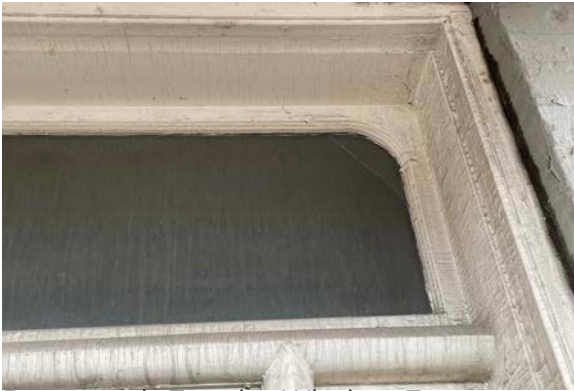
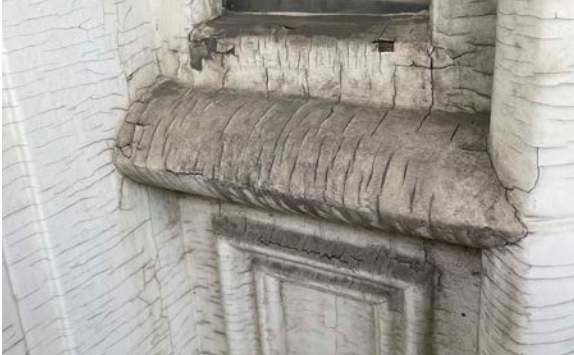
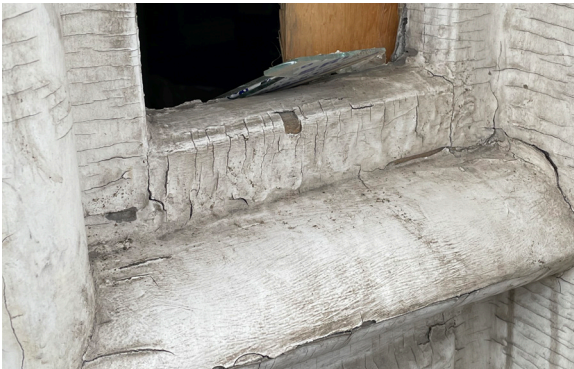
Door 425-b Exterior Window Frame

Glass does not exhibit the surface irregularities of historic glass production methods, which indicates that it was produced either by the float glass method (post 1960) or possibly the rolled glass method (post 1920). Some glass lites are broken.

Remove and replace sidelights and transom using solid wood construction which replicates the existing design. Paint wood to coordinate with other fenestration elements.
