Fenestration Assessment

425 Davis Drive
Newmarket, Ontario

Prepared for:
The Arten Group
2162 Major Mackenzie Drive
Vaughan, ON

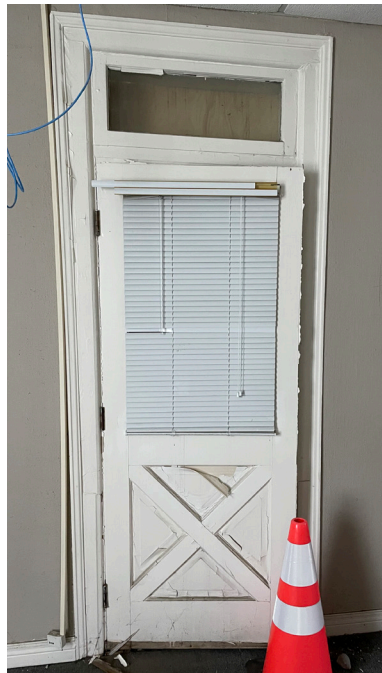
Door 425-a (Interior)

Wood substrate is chipped and warped.

Remove and replace with new historically inspired energy efficient wood door and transom which is part of a comprehensively designed fenestration style.

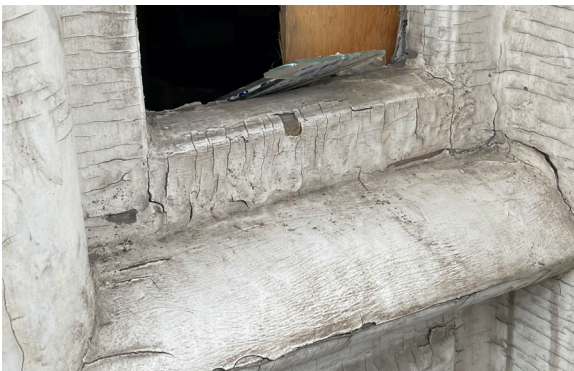
Door 425-b Exterior Window Frame

Glass does not exhibit the surface irregularities of historic glass production methods, which indicates that it was produced either by the float glass method (post 1960) or possibly the rolled glass method (post 1920). Some glass lites are broken.

Remove and replace sidelights and transom using solid wood construction which replicates the existing design. Paint wood to coordinate with other fenestration elements.
