**DEVELOPMENT & INFRASTRUCTURE SERVICES REPORT
ENGINEERING SERVICES 2013-52**

SUBJECT: Queen/Parkview (east leg) – All-way Stop Review
File No.: T08 T.30 Queen

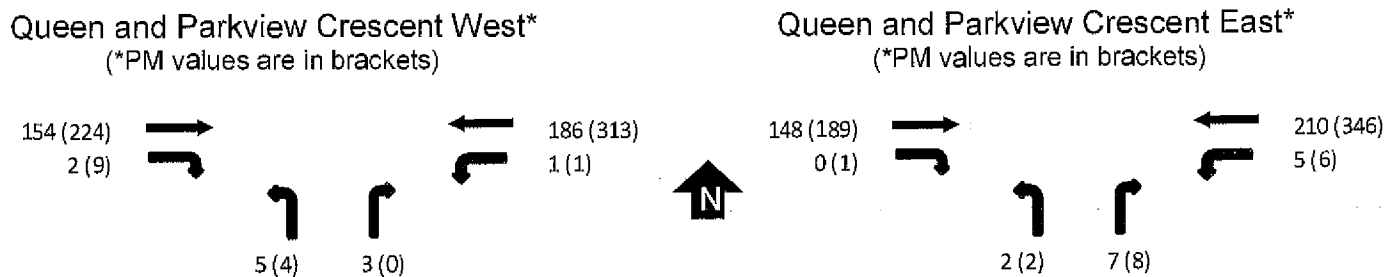
TURNING MOVEMENT DIAGRAM

All-way stop controls are intended to govern the right-of-way at an intersection. The very low vehicle counts (less than 10 vehicles in the peak hours) from both legs of Parkview Crescent would not create an effective or safe intersection control. The following "Turning Movement Diagram" shows the AM and PM peak hour traffic volumes and turning movements for both intersections.

The peak hour volumes are very low entering and exiting Parkview Crescent at either intersection.
