PLANNING AND BUILDING SERVICES

Town of Newmarket

SUBJECT: **Requests for Removal from the Heritage Registry of Non-Designated Properties**
578 Lydia Street
270 Prospect Street

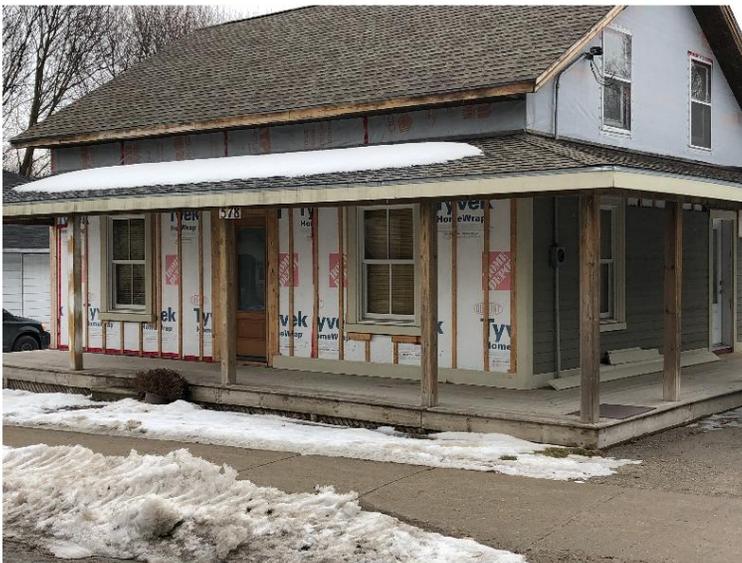
578 Lydia Street - Current

2 storey wood- frame, vernacular style, residence with vinyl clade exterior

- Gently sloped gable roof.
- Wrap-around porch covered by roof that is supported by Wooden columns.
- Many improvements and/or changes have been made to the house over the years.

Staff currently are recommending both properties be removed from the Registry of Non Designated Heritage Properties and the demolition be allowed.

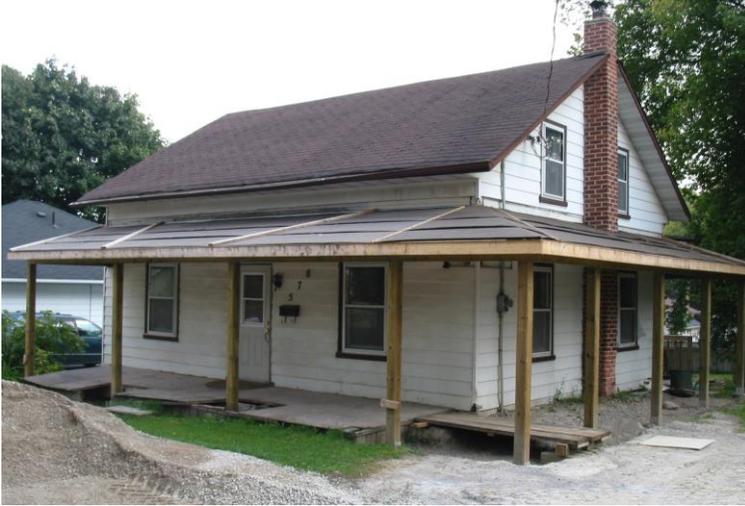
Undated file Photo

James Wetherill house (From Registry)
Plan 85, Lot 2
C. 1855

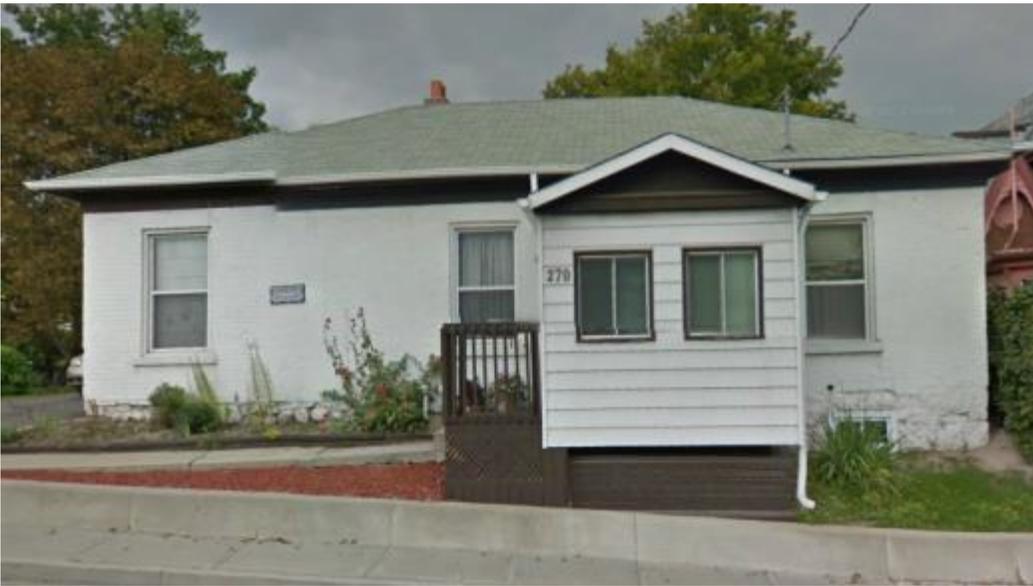
270 Prospect Street

John Mitchell House (From Registry)

Single-storey residence with painted brick exterior on a stone rubble foundation.

- Hip roof.
- Small enclosed veranda addition.
- All windows have been replaced.
